Coastal Adaptation Study &
Coastal Adaptation Strategy

VICTOR HARBOR CENTRAL

Cell
Fleurieu 11

For City of
Victor Harbor

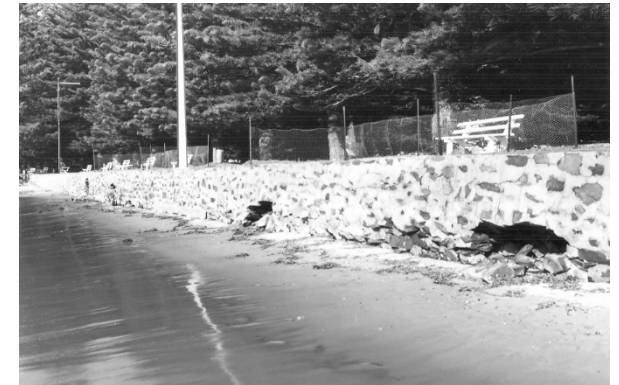
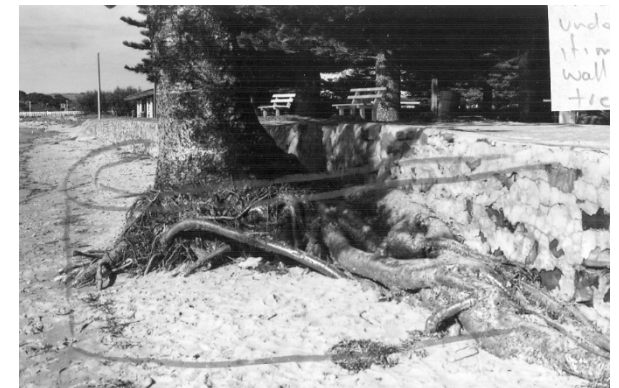
Damage to the sea wall was first identified by Coast Protection Board in January 1975. This damage is likely to have been caused over longer period of time and may relate to significant increase in tide levels in 1971.

Figures a-b: Damage to seawall – note the intention to retain the tree and to provide a 'planter box' edge (19750101, CPB).

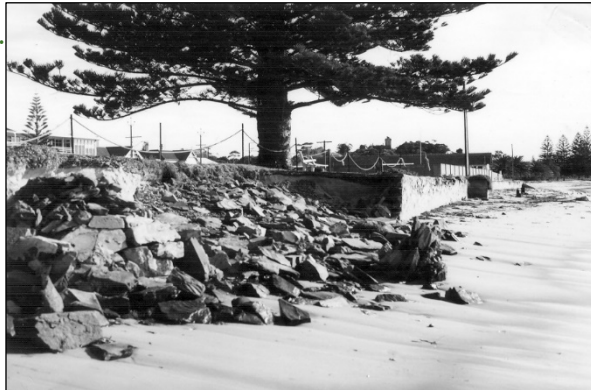
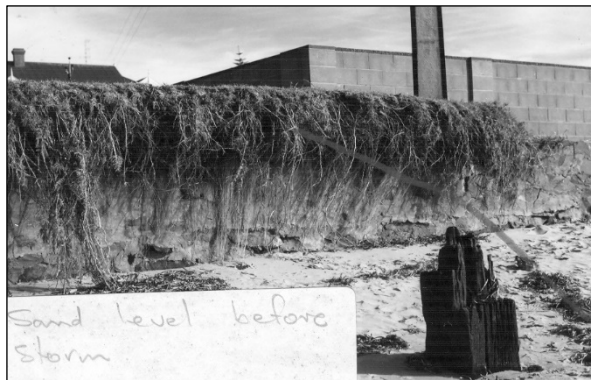
Storms in May 1975 caused damage along the foreshore, including a partial collapse of the tennis courts' fence and damage to the seawall²³. The wall was repaired, or sections rebuilt in September 1975. One section of wall was 'boxed out' to so that the Norfolk Pine could be retained.

Figures a-b: Damage to seawall – note the drawing on the photograph to indicate the profile of the embankment prior to the storm (19750521, CPB).

Project note: It is likely that the integrity of the wall was undermined over a longer period of time. A spike in very high tidal events occurred in period 1971 to 1972 which may have contributed to the undermining and then ultimate collapse of the wall.

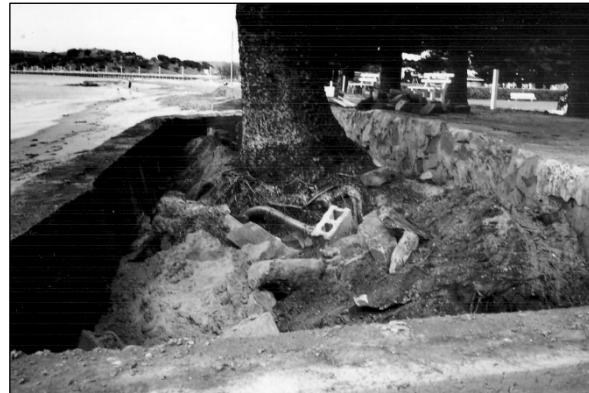
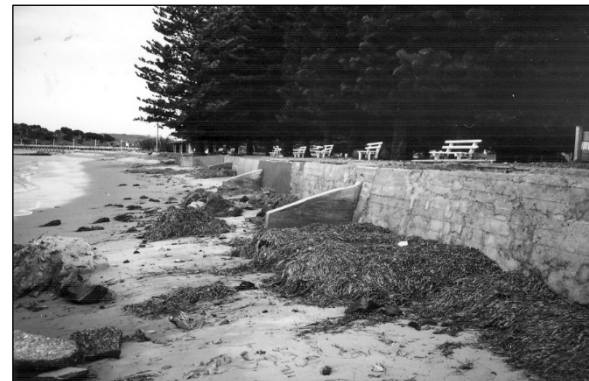
Figures c-d: The seawall was repaired or rebuilt with a section boxed out to maintain the Norfolk pine (19750901, CPB).

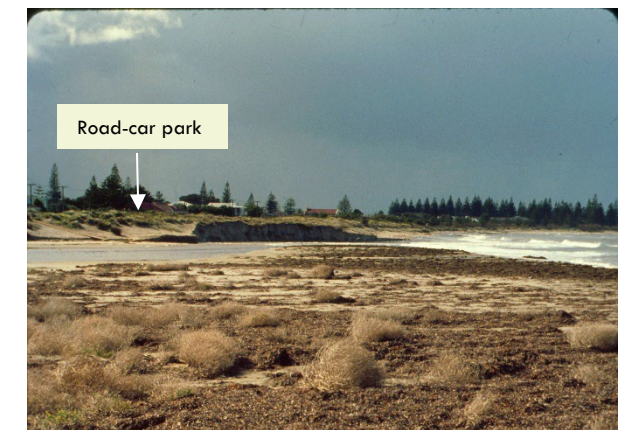
In August 1979, a combination of high tides, heavy rains and south-westerly winds caused the river mouth to move further east where it caused rapid erosion of the dunes (Figure e). Continued erosion was deemed likely to impact the road at the corner of Inman Street and The Esplanade. Emergency works were carried out with permission of Coast Protection Board to open the mouth of the river to the west (19791029).

Figure e: Severe erosion of embankment which left unchecked may have threatened road infrastructure on corner of Inman Road and the Esplanade (Photograph: Coast Protection Board, 1 Sept 1979).

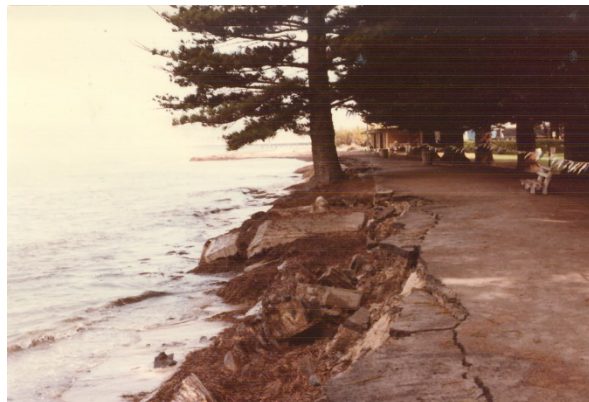
Approximately 240m of the wall collapsed or was severely undermined. Applications were made for funding to the Treasury by Coast Protection Board as emergency works (19860424). Options considered were to either rebuild the seawall or install a sloping rock wall.

Figure a: Storm event of 17 April 1986 caused collapse or serious undermining of 240m of the seawall (Photograph: Coast Protection Board, 1 May 1986).

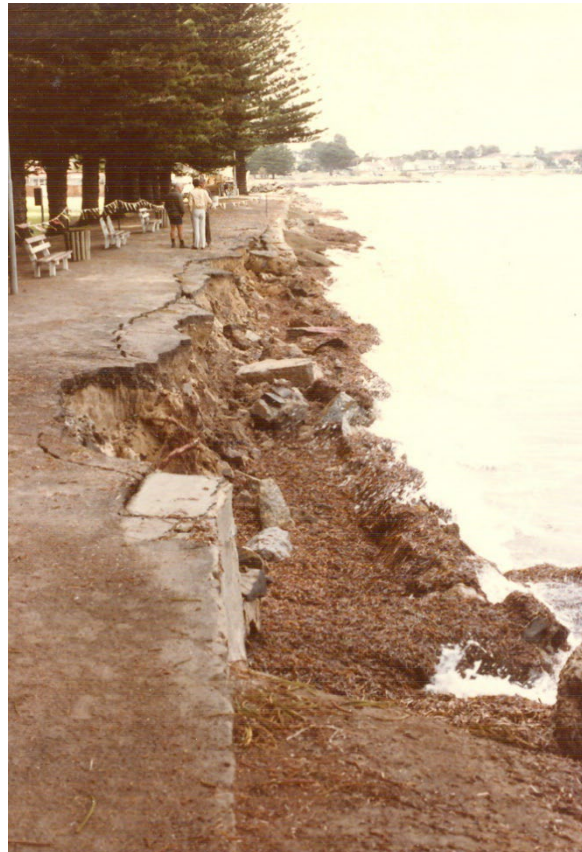
Figure b: Storm event of 17 April 1986 caused collapse or serious undermining of 240m of the seawall (Photograph: Coast Protection Board, 1 May 1986).

Rock revetment was installed in March 1987. It is likely that the promenade was raised to accommodate the appropriate height for the top of the sea wall.

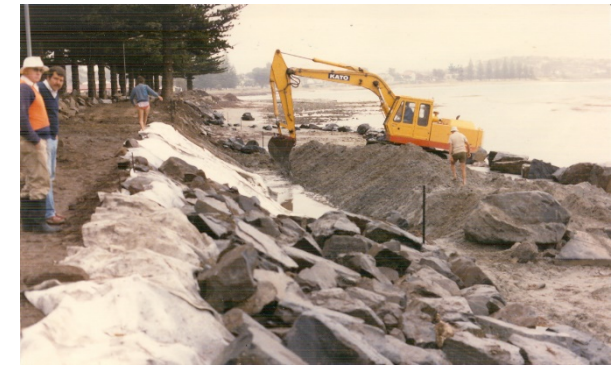
Figure c: Rock revetment installed (Photograph: CPB, 1 March 1987)

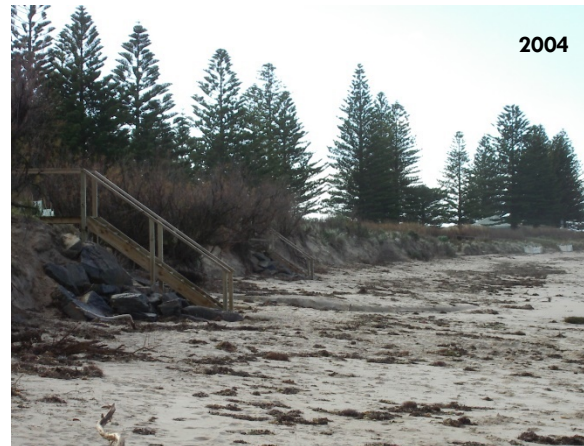
Tide heights for pictured events 4 June 2012 was 1.353m CD and 30 April 2014 was 1.458m CD. The likely cause of erosion was increased storminess in this time period. (See also exposure section for analysis).

Figure b: Foreshore in vicinity of King Street in 2004 (CPB, 20041008).

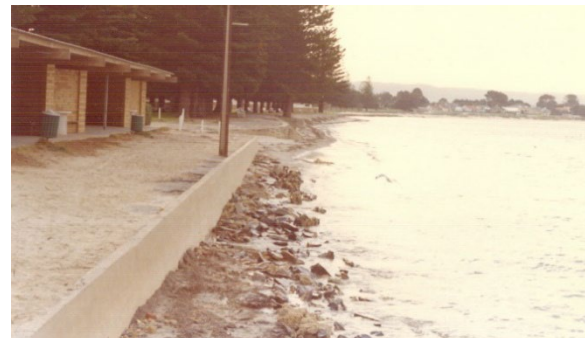
Figure c: Comparison – 4 months later (CPB, 19760701).

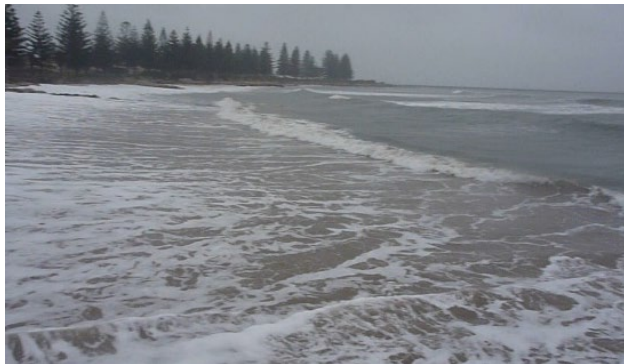
Figure c (above). Storm action on 4 June 2012 was not a significantly high tide (1.35 CD), but after 4-5 years of storm action, low sand levels on the beach means increased impact on the backshore

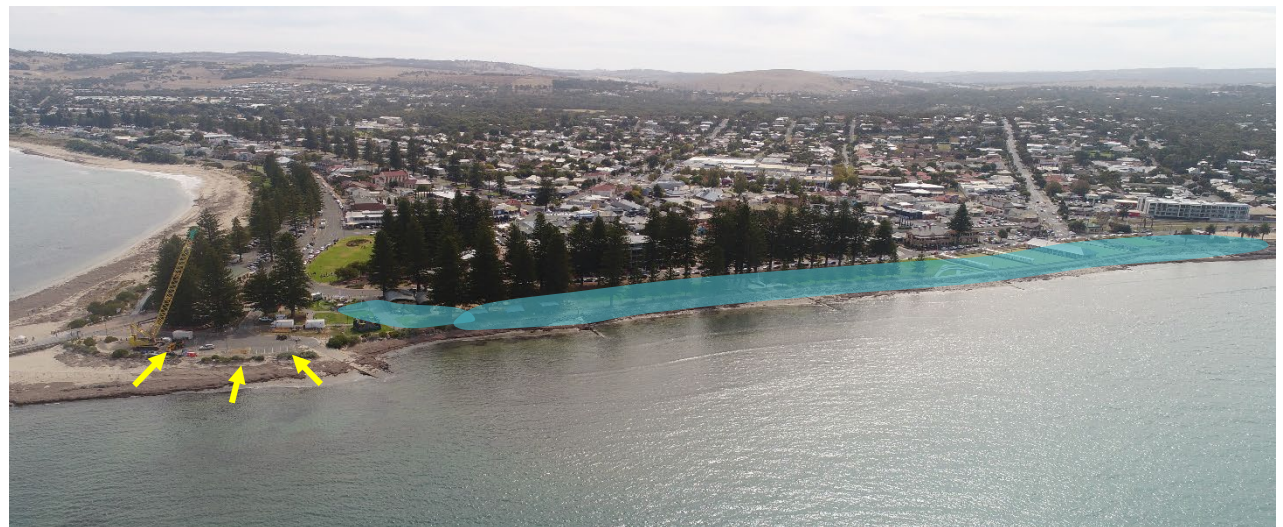
Figure b. The Esplanade Beach – erosion in the second half of this century is likely to impact carpark, reserve, visitor centre.
