Coastal Adaptation Study &
Coastal Adaptation Strategy

ENCOUNTER BAY

Cell
Fleurieu 12

For City of
Victor Harbor

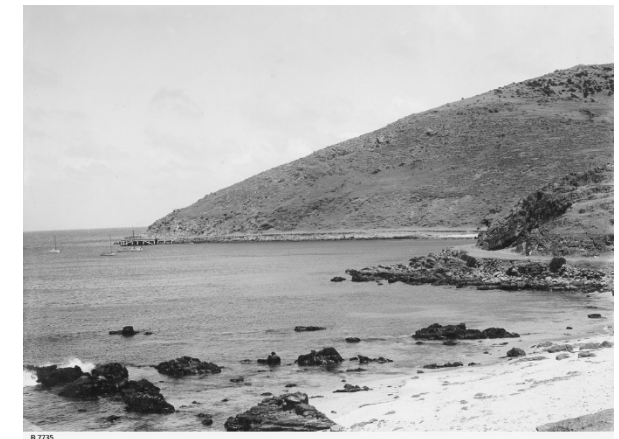
Figure b: Encounter Bay, 1920, Bluff jetty and seawall constructed 1850s (State Library of SA, B-7735).

Settlers arrived from 1839 onwards and District Council of Encounter Bay was founded in 1853. The South Australian Government instructed the Council in 1854 to construct the Lilliputian jetty and seawall (Figure b) on the eastern side of The Bluff and to build a road from the jetty to Yilki. However, it was not known that Governor Hindmarsh owned the land and he claimed damages. The South Australian Government argued that the South Australian Act (1836) reserved 100 feet from the high-water mark all around the coast for road or other public purposes. The matter was resolved when the Government purchased the land in 1858.

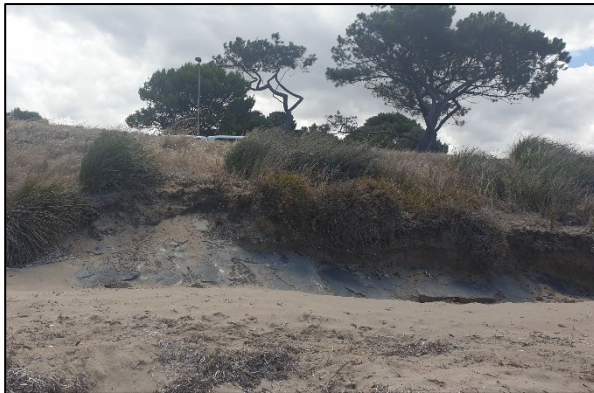
Figure a. Franklin Parade (Yilki). A sloping stone wall was installed in this region in 1949-1951. (M. Western, 2021)

The exact date for the installation of the sloping seawalls in the Encounter Bay region (Yilki) is unknown but these are likely to have been installed in period 1947 to 1951 (Figure a)⁹.

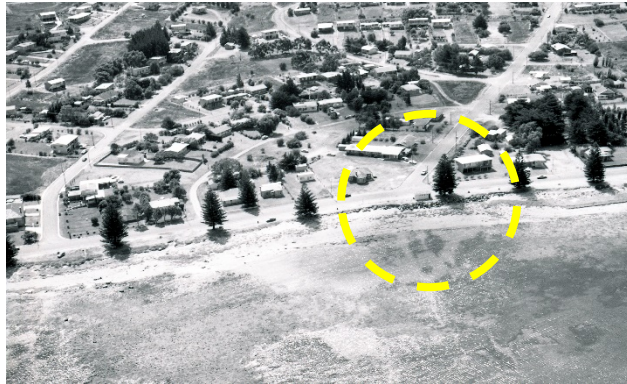
- Rock protection to toilet block.
- Minor protection (ad hoc?) to base of road embankment.
- Old stone walling, rock protection.

- Formal rock protection to foreshore toilet block (Figure a).
- Informal (ad hoc) minor protection works to the road embankment (Figure b).
- A combination of the stone wall from 1950s (including the work at the corner of Tabernacle Road) and newer installation of rock.

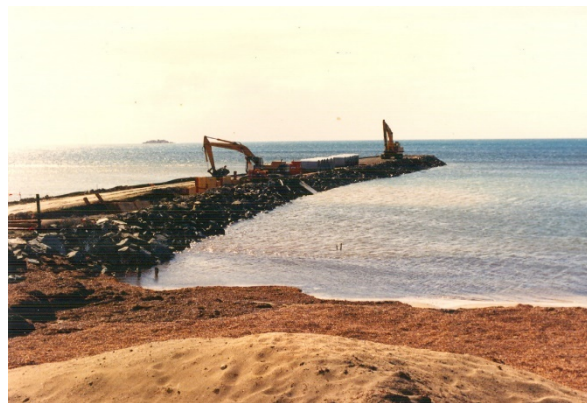
Figure a. Installation of pipe to ocean floor by way of temporary rock and earthen structure, pipe installed in the middle (Photograph - Coast Protection Board, 19860319).

Answers were not found within the archives, but it is likely that the design of the flushing pipe at 1.5m diameter to operate 400m offshore at depth -2m AHD controlled the level of water within the lakes irrespective of actions of the sea. A condition of approval (19871224) that the lake was not to receive storm water flows apart from those generated by the subject land (i.e. the proposed development).

In 1988, approvals were obtained to reduce the length of the flushing pipe from 400m to 260m (19881214).

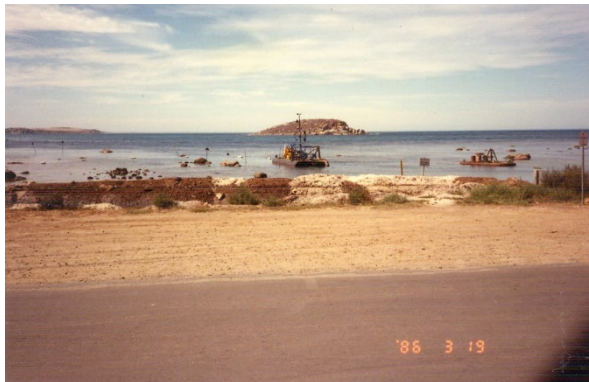
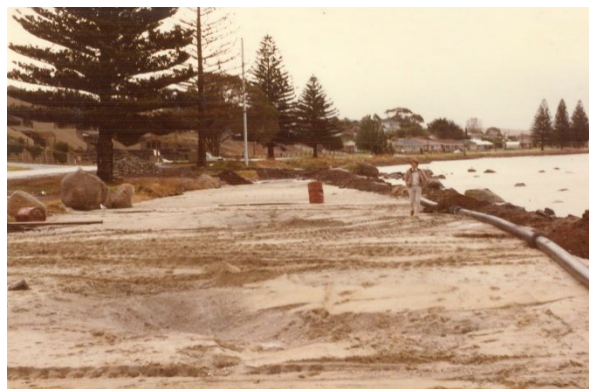
Figure a, b. Dredging of Encounter Bay boat ramp (Photographs - Coast Protection Board, 19860319).

The boat ramp facilities at Encounter Bay were first upgraded in 1987 (Figure c). Prior to the work the channel was dredged, and the spoil used to raise the area under which the current car park is situated.

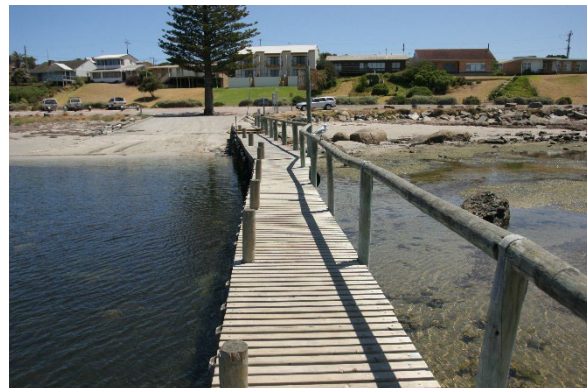
Figure c. Boat ramp constructed in 1987, jetty added in 1998 (Photograph – Coast Protection Board, 20061205)

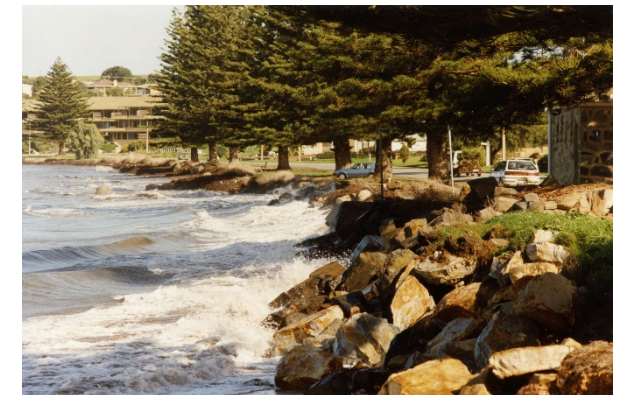
Figure d. Storm in Encounter Bay 1st October 1992 (Photograph - Coast Protection Board, 19921001).

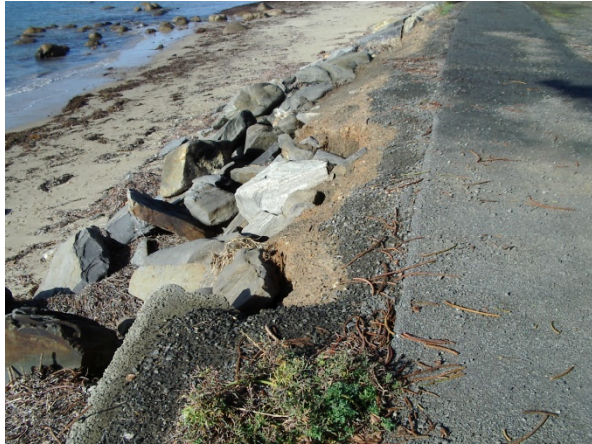
Figure a. Erosion damage near Nevin Ave, 3 August 2004, 1.925CD (Photograph - Coast Protection Board, 20040810).

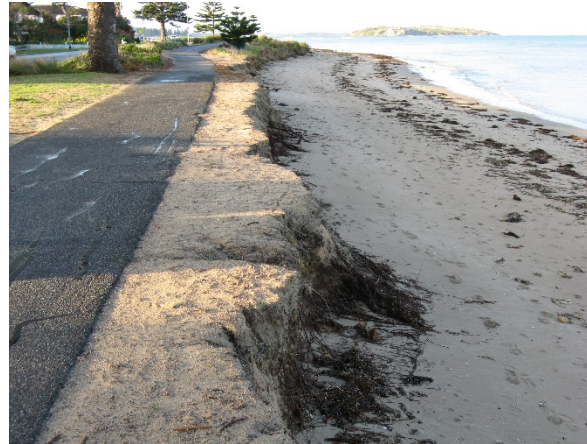
Figure c. Erosion damage between Fell Street and Fountain Ave, June 2011 (Photograph - Coast Protection Board, 20110616).

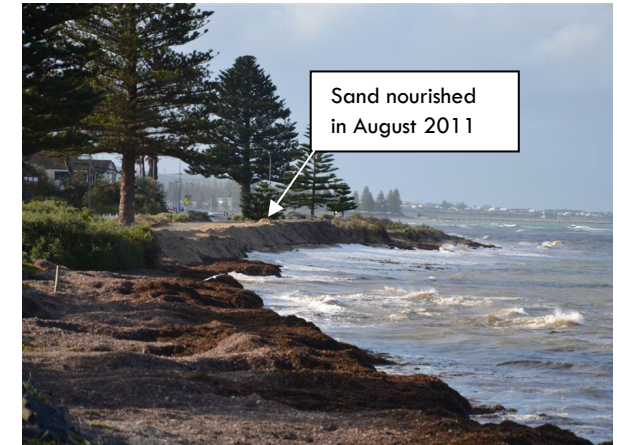
Figure e. Storm impact between Fell Street and Fountain Ave, 4 June 2012 (Photograph - Coast Protection Board, 20120604).

Tide heights for pictured events 4 June 2012 was 1.353m CD and 30 April 2014 was 1.458m CD. The likely cause of erosion was increased storminess in this time period. (See also exposure section for analysis).

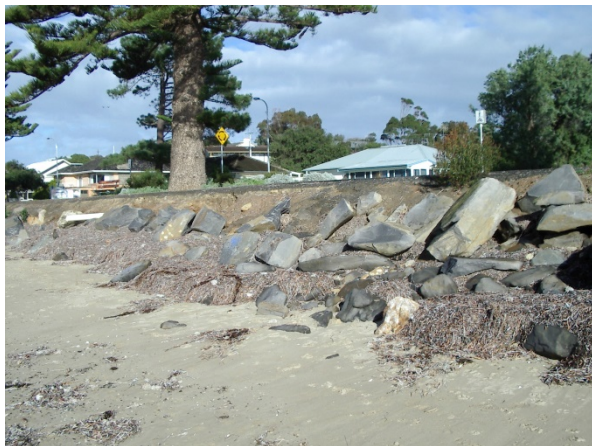
Figure b. Erosion damage near Nevin Ave, 3 August 2004, 1.925 CD (Photograph - Coast Protection Board, 20040810).

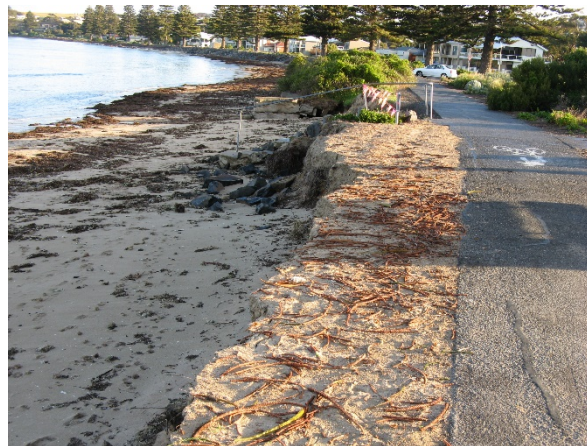
Figure d. Erosion damage between Fell Street and Fountain Ave, June 2011 (Photograph - Coast Protection Board, 20110616).

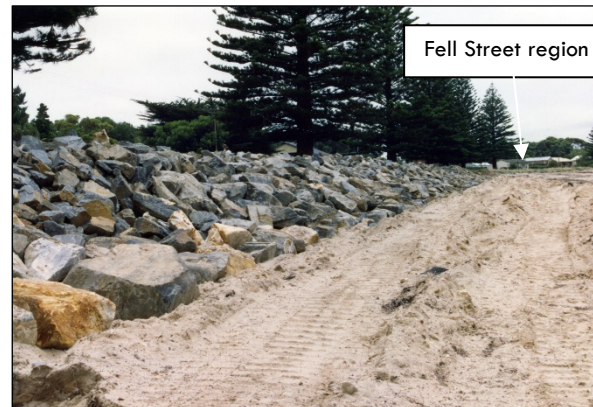
Figure a. Rock revetment extended Jan 2005 (after storms in 2004). (Photograph - Coast Protection Board, 20050101).

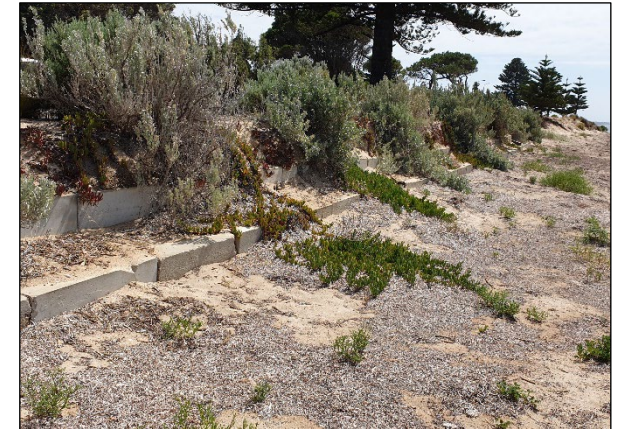
Figure b. Cement blocks 5 tiers high, in vicinity of Fell Street (Photograph – M. Western, 2021).

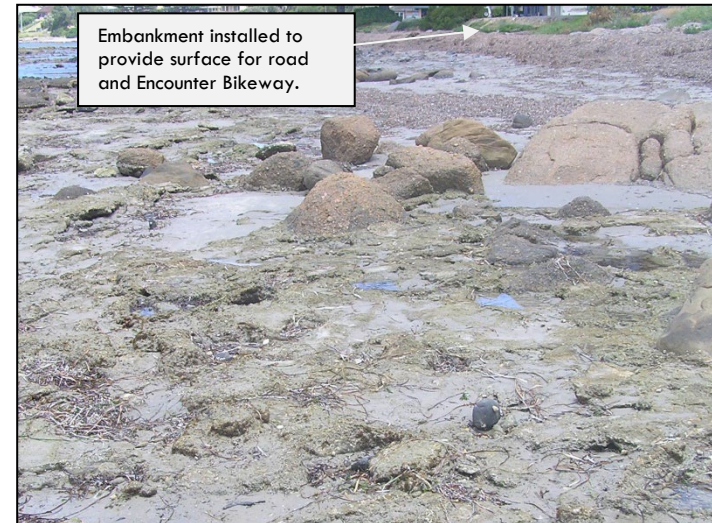
Figure a: Granite boulders incorporated into the last interglacial dune sandstone on the Yilki shore platform.

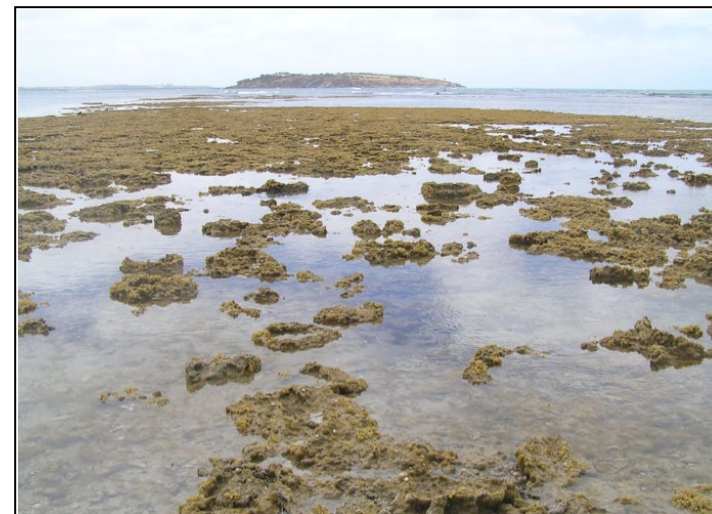
Figure b: View over the calcareous sandstone Yilki shore platform with Granite Island in the background. The reef has formed on last indurated interglacial age calcareous dune sediments.

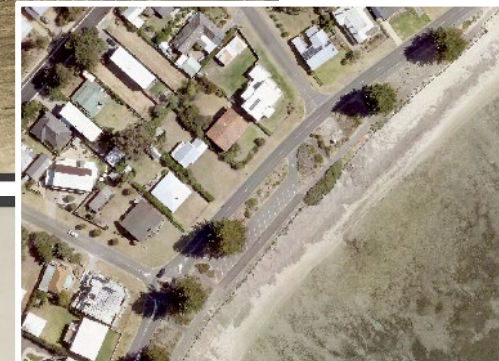
Figure b: View of Encounter Bay (1900), State Library of SA, B-63093. The inset picture shows the position of the current carpark in the vicinity of Fell Street.

1. The road was constructed in 1854 and likely positioned ~30m (100 feet) from the high-water mark. The landward edge of the road surface in 1949 was positioned ~2m further inland than the current road (which is now likely to be the footpath).
2. The beach towards the Bluff appears sandier and the profile of the beach and immediate backshore is lower than current day (note the boats lying on upper beach).
3. To the east, note the larger portion of land left between the road the sea, and the low profile of the shore at what is now current day, Fell Street. This area has now been raised and a carpark and walking trail positioned. It is very likely that periodically higher storms encroached into this area and washed up toward the former road.

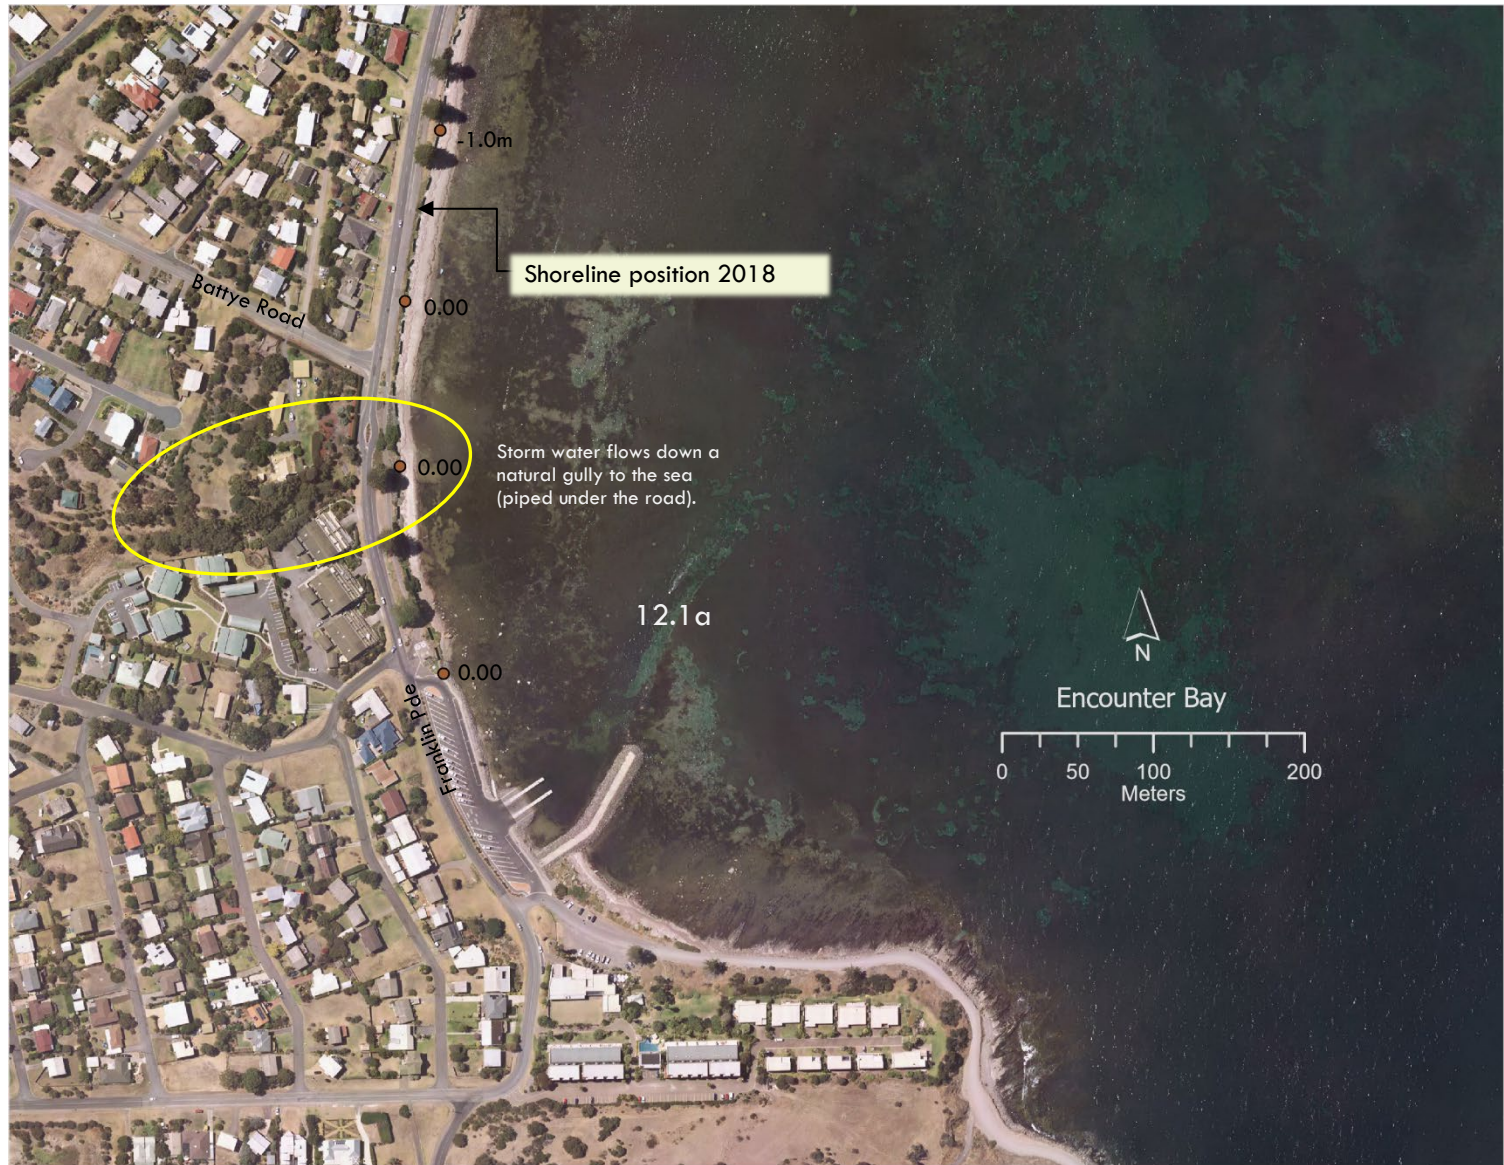
The shoreline in 2016 was in a similar position to current day. However, to create the space for the Encounter Bikeway the slope of the embankment was increased.

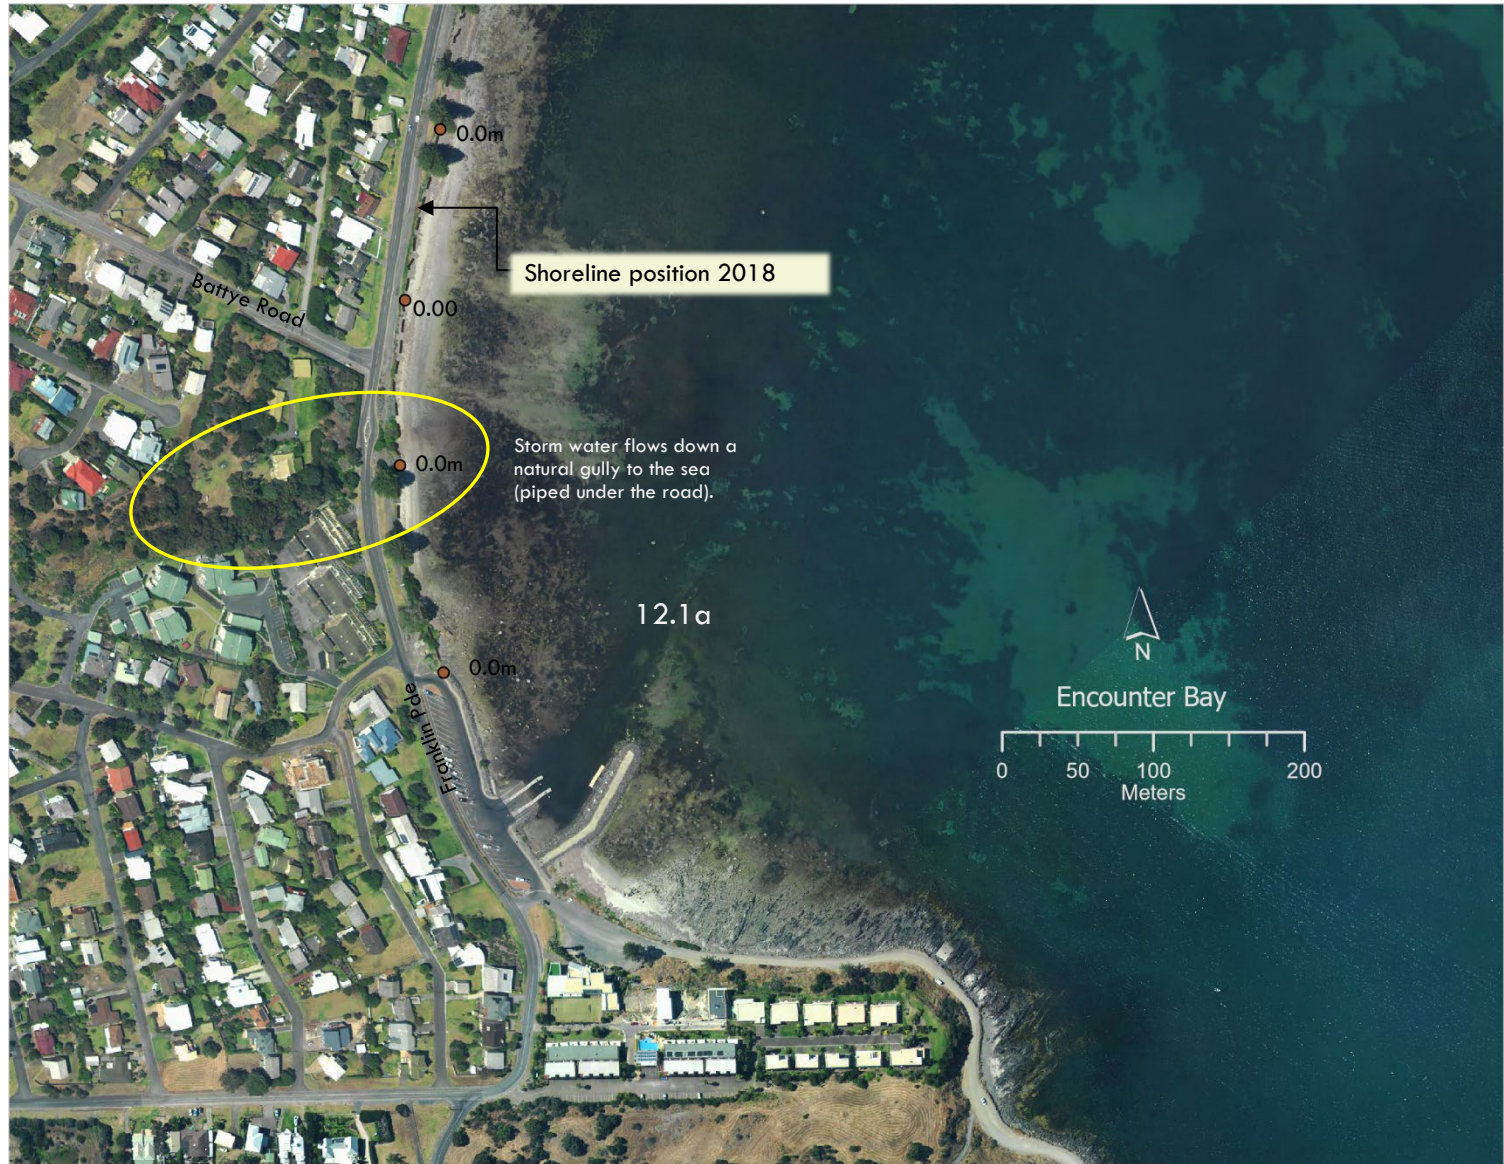
The coast has been stable in this location.

The green section in the south of the photograph is a new carpark installed in the backshore since 2011.

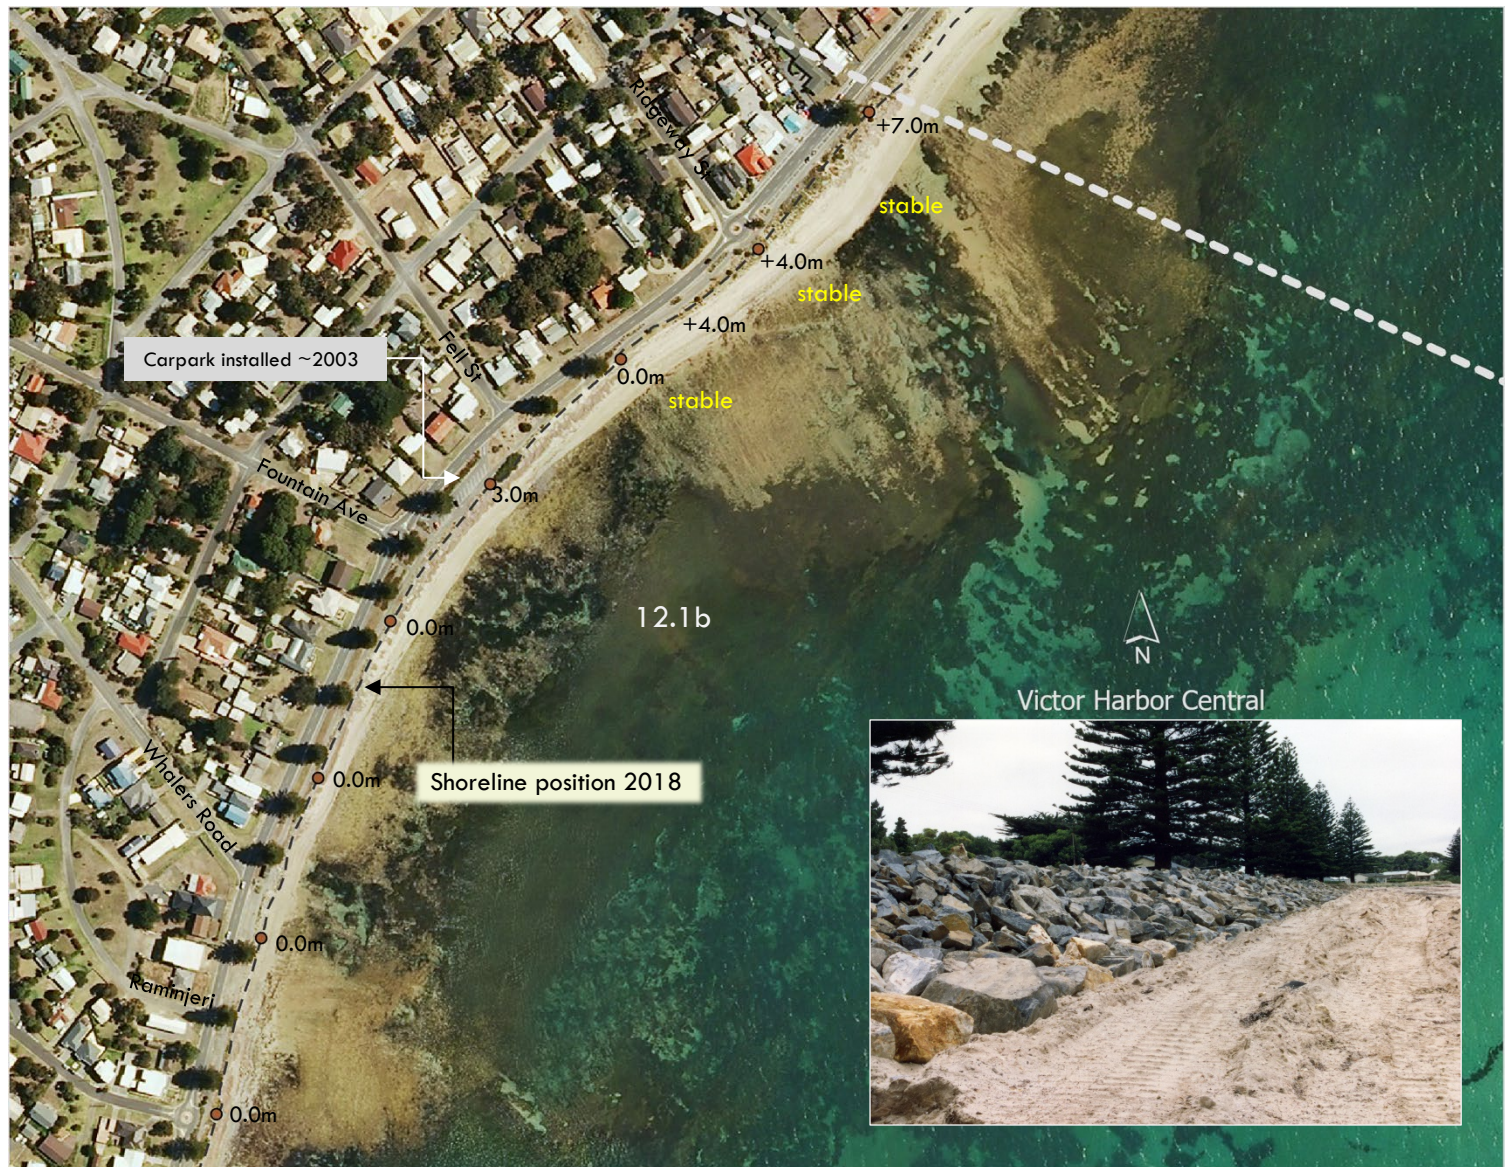
Inset picture: Rock protection installed between Whalers Road and Fell Street carpark.

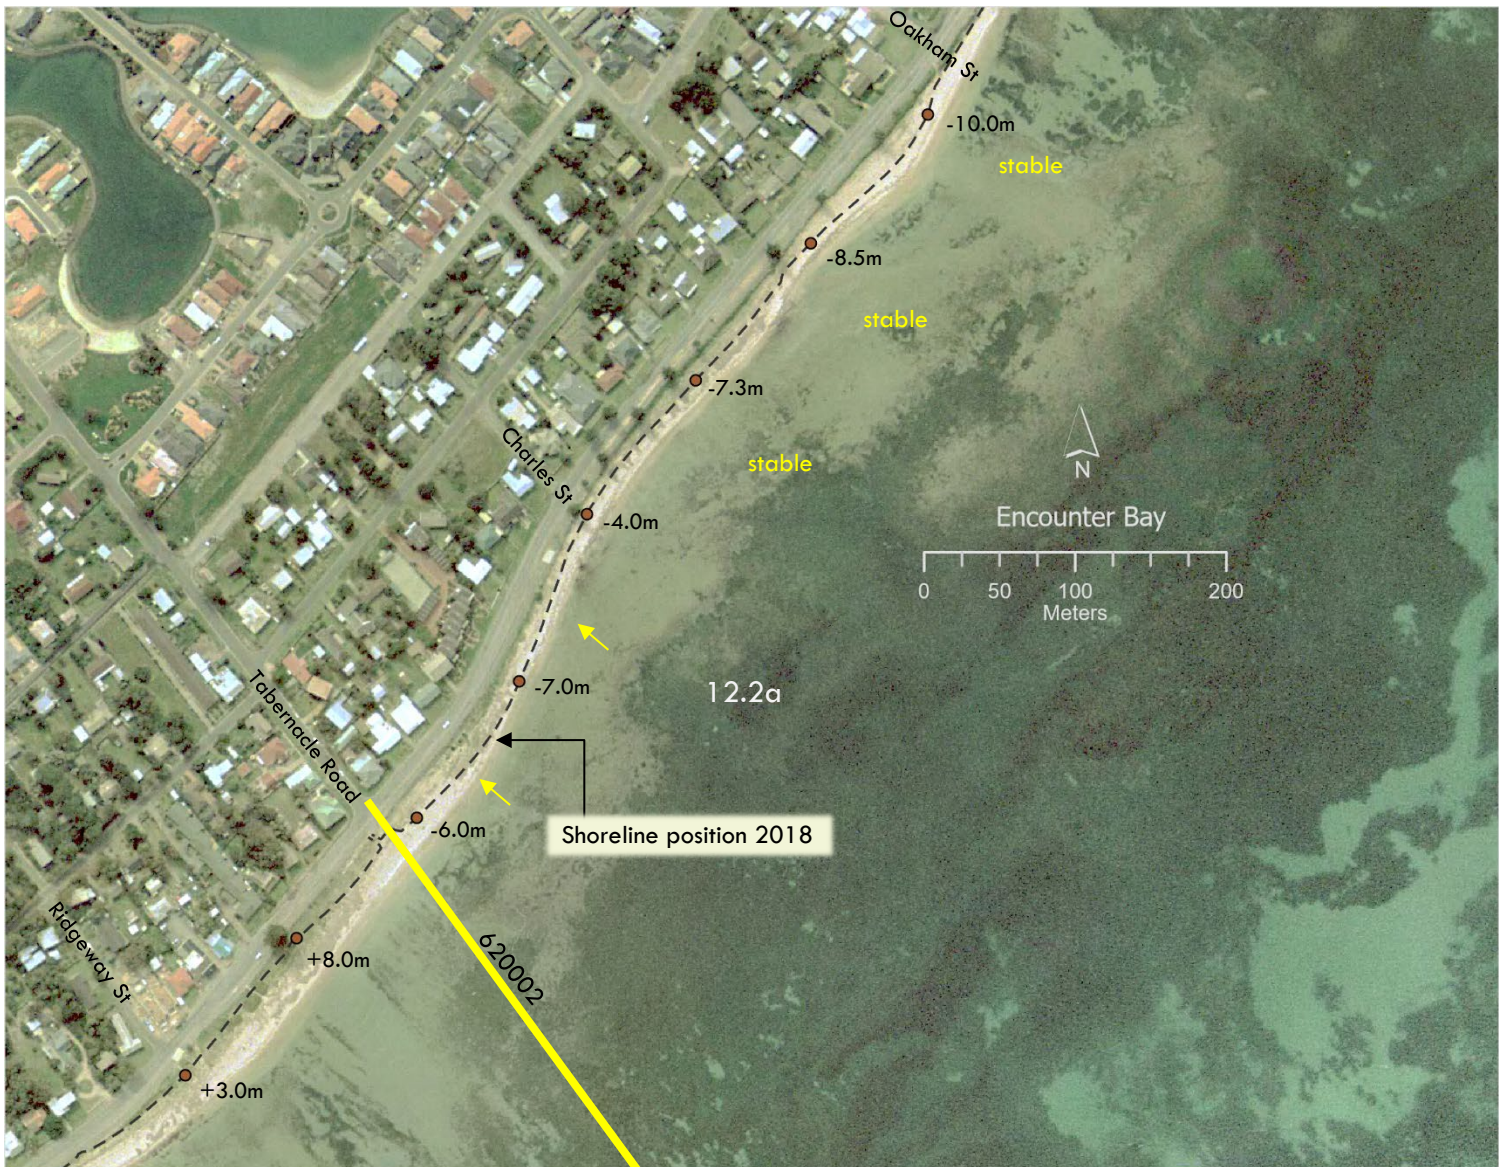
The location of Coast Protection Board profile line 620002 is shown to provide context for later analysis.

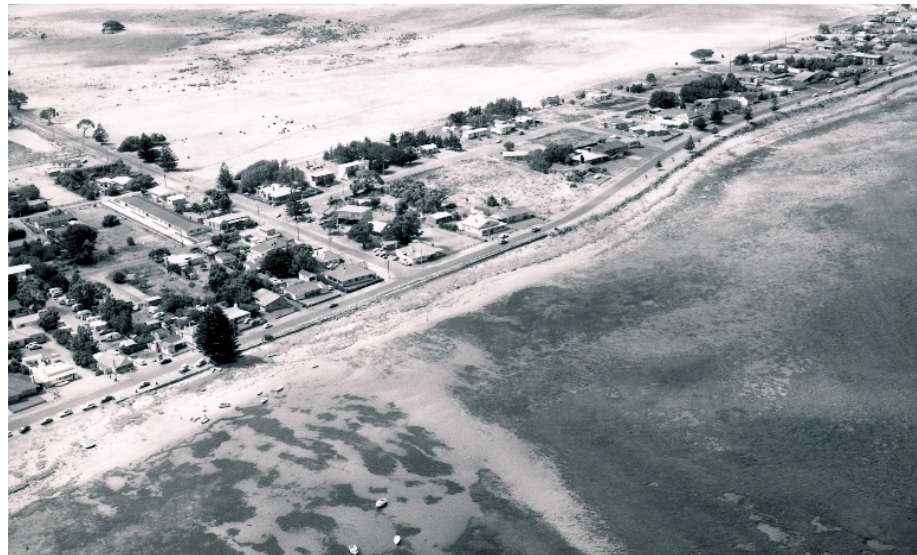
Figure a. The backshore in the vicinity of Yilki and Tabernacle Road was an unvegetated slope back to the road (which appears to have a seawall, most likely constructed in 1950s)

Recent erosion at Yilki over the last few years may indicate a change in actions of the sea. The tidal record from 2004 to 2011 and analysis of other portions of the coast show that this era was a time of increased storminess and elevated sea levels. This may be an indication of the impact of climate change and rising seas. However, it is also relevant to note the characteristics of this location in the 1970s.

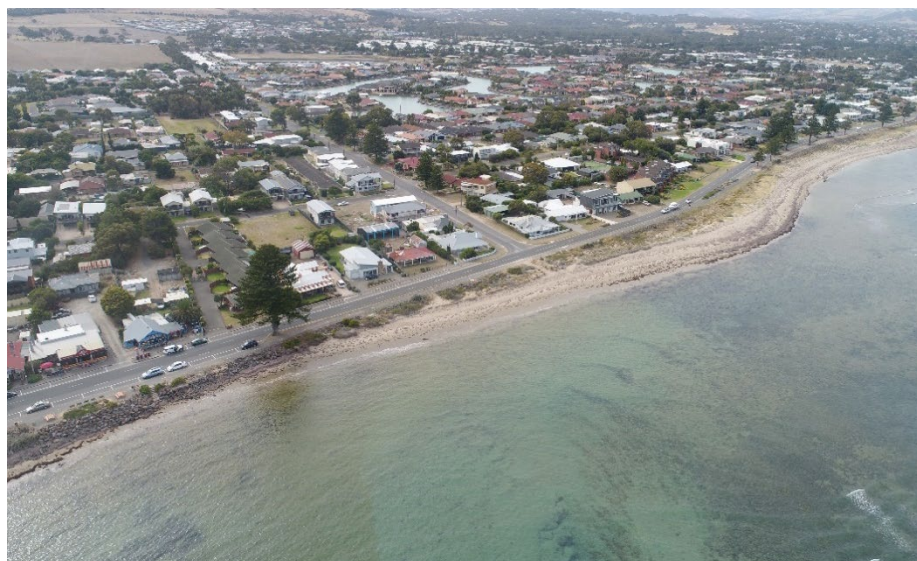
Figure b. The area between Yilki and Tabernacle Road were likely nourished and vegetated by Council in the 1980s. (The only other explanation is that this area accreted and was vegetated but this is unlikely given the timing of the Council's works.)

- It is likely that Council implemented works to install a dune and vegetated backshore in the vicinity of Tabernacle Road (compare pictures to the right).
- Council has an ongoing vegetation and weed control program.
- Controlled access ways exist in the vicinity of Kent Reserve. Access to the beach is more difficult to control south of Tabernacle Road and the impact of informal pedestrian access is observed in some places.
- Sand nourishment was trialled in the vicinity of Fell Street.
- Rock and concrete block protection has been installed from Nevin to Tabernacle, and in some sections east of Tabernacle Road (see pages above).

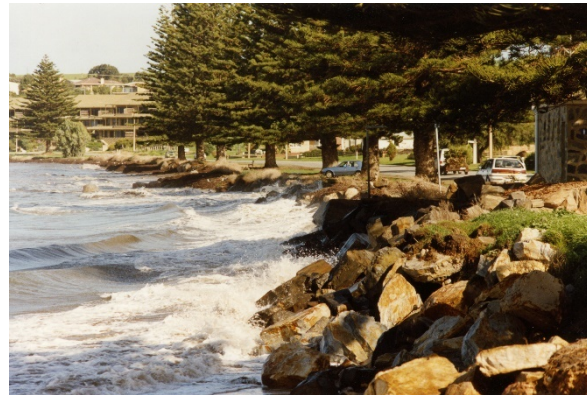
Figure a. Storm in Encounter Bay 1st October 1992 (Photo - Coast Protection Board, 19921001). Does not correlate with high tide.

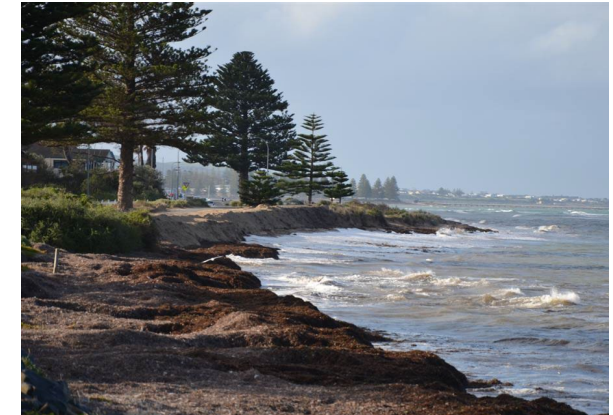
Figure b. Storm impact between Fell Street and Fountain Ave, 4 June 2012 (Photograph - Coast Protection Board, 20120604). Does not correlate with a high tide.

There are very few photographs of storm action into Encounter Bay. The two shown here (Figures a,b) were not accompanied by very high tides but do provide an insight into wave action upon the coast. Figure (c) shows erosion damage after an event that was almost

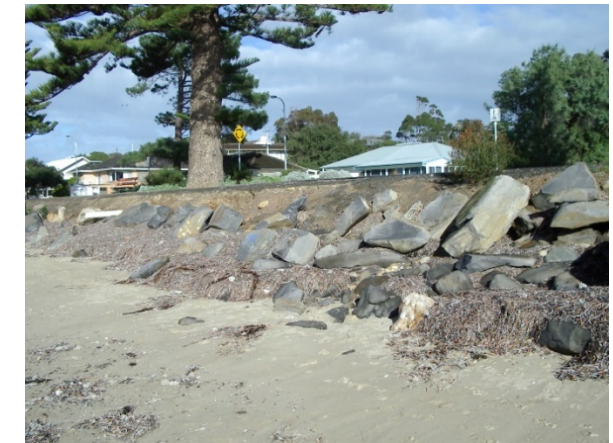
Figure c. Erosion damage near Nevin Ave, 3 August 2004, 1.925 CD (Photograph - Coast Protection Board, 20040810).

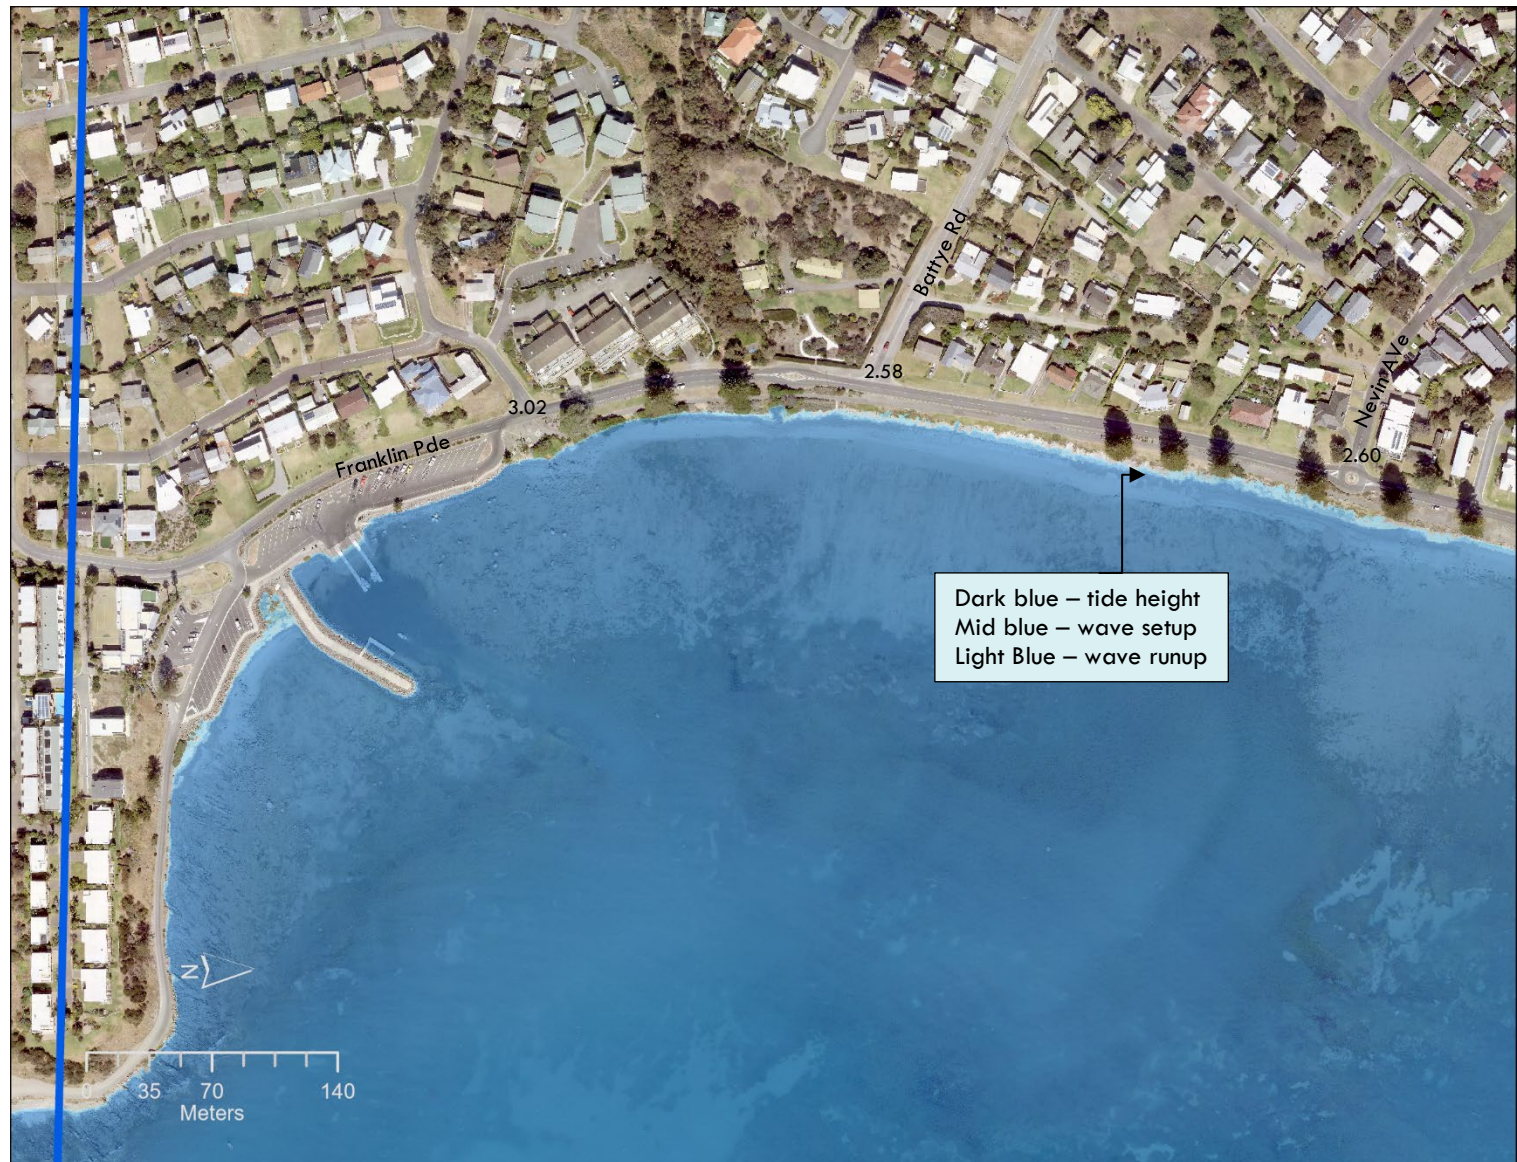
5. Coastal exposure – routine high water (2020)

Assessment: The modelling is congruent with observations and the current impact on beach and backshore is low.

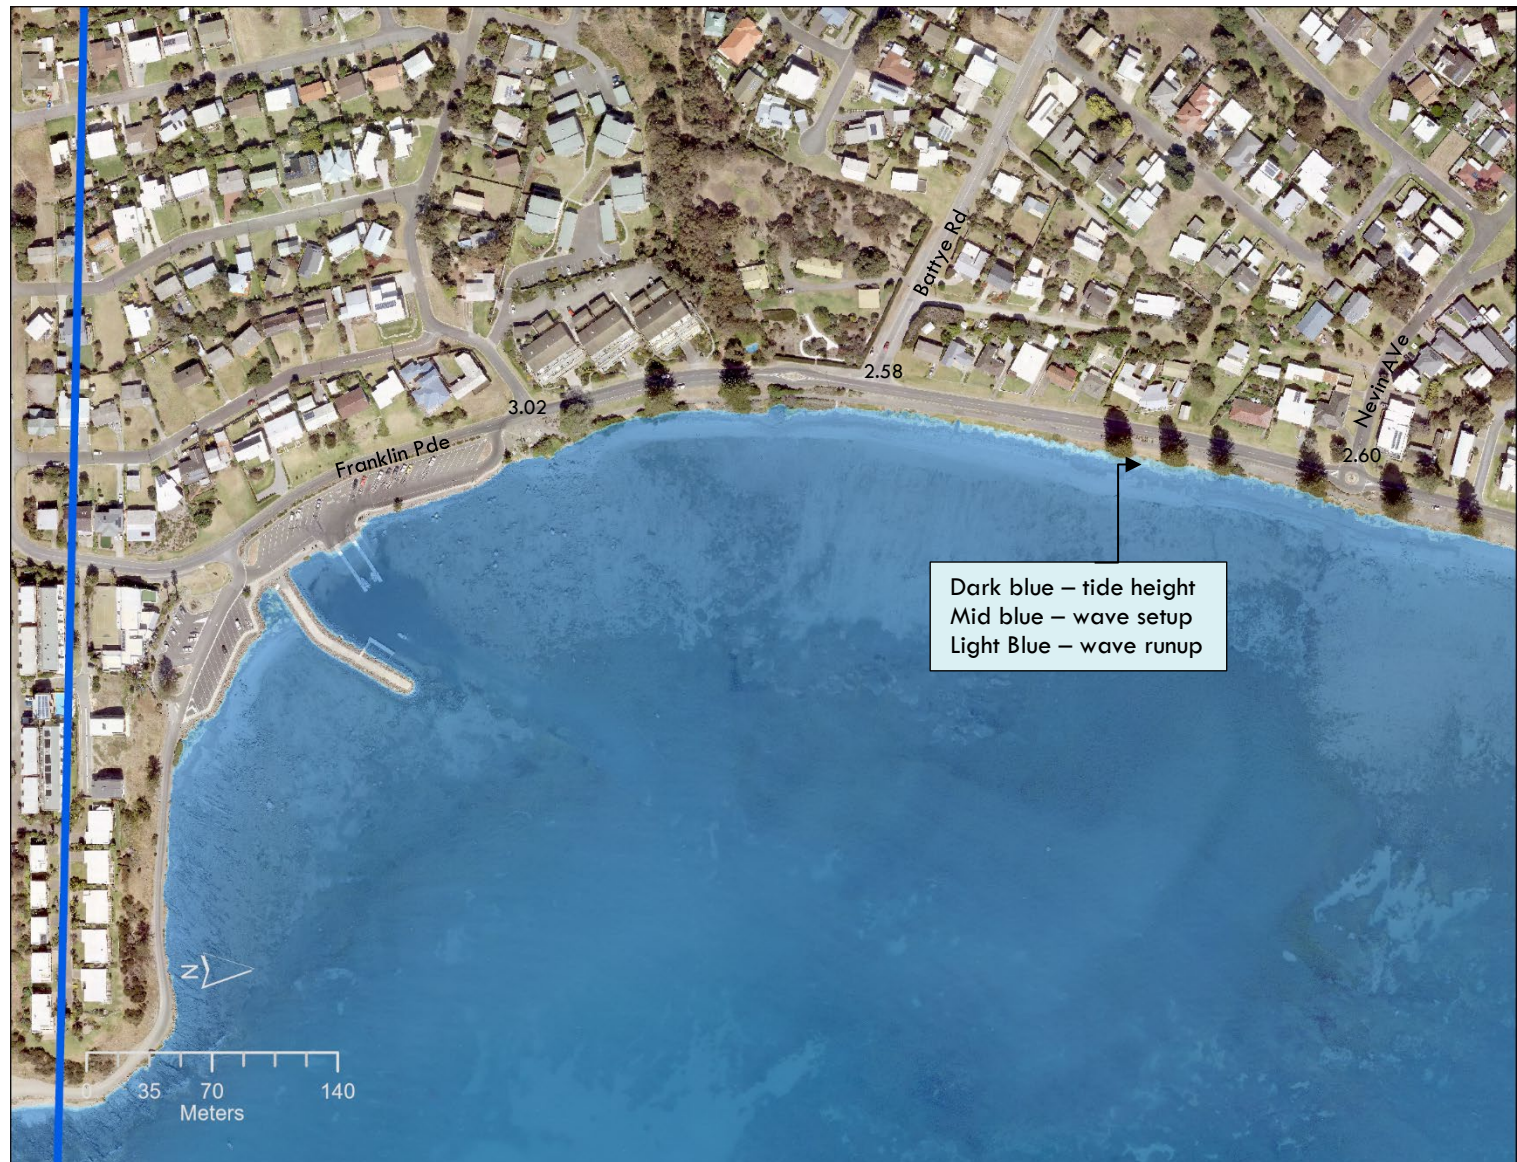
5. Coastal exposure – routine high water (2050)

Routine highwater events at 0.30m higher than present are likely to erode and scour the bank under the road (minor overtopping likely)

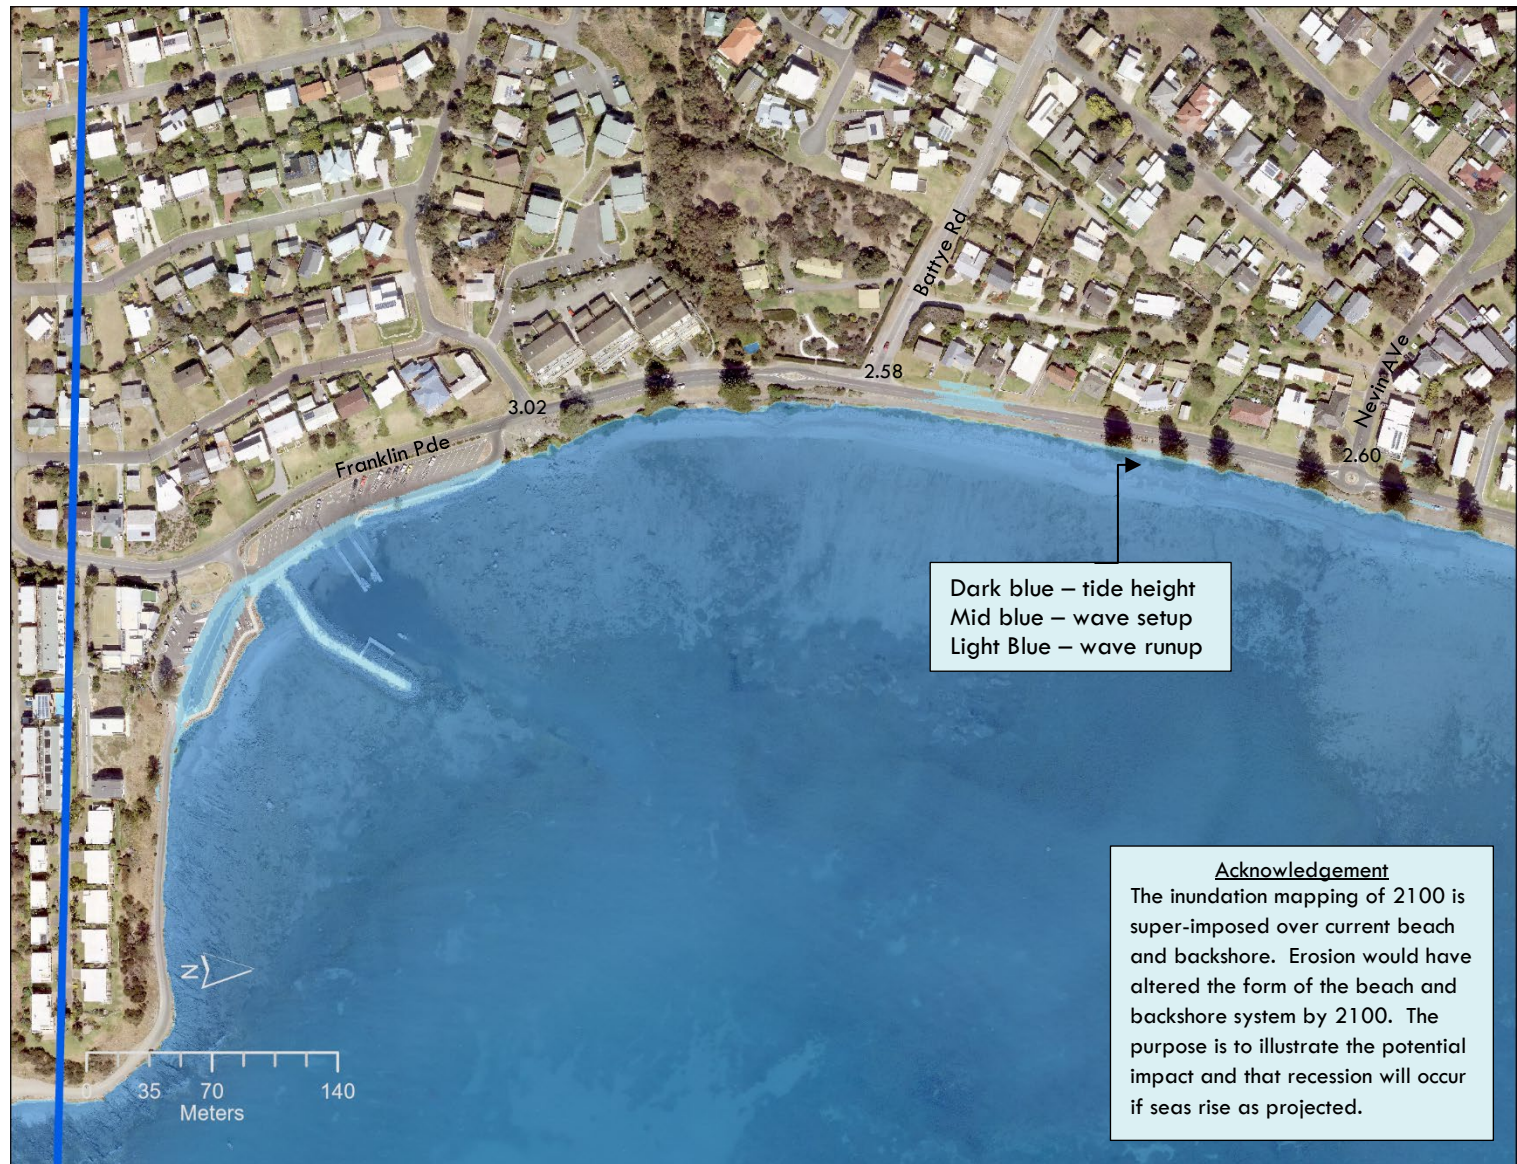
5. Coastal exposure – routine high water (2100)

Dr Bourman notes that the surface upon which the road is situated was likely formed 4-5000 years ago when seas were 1m higher. Routine highwater events at 1.0m higher would cause significant erosion of the road and routine overtopping (not fully depicted here as waves interacting with vertical surfaces produce higher wave action).

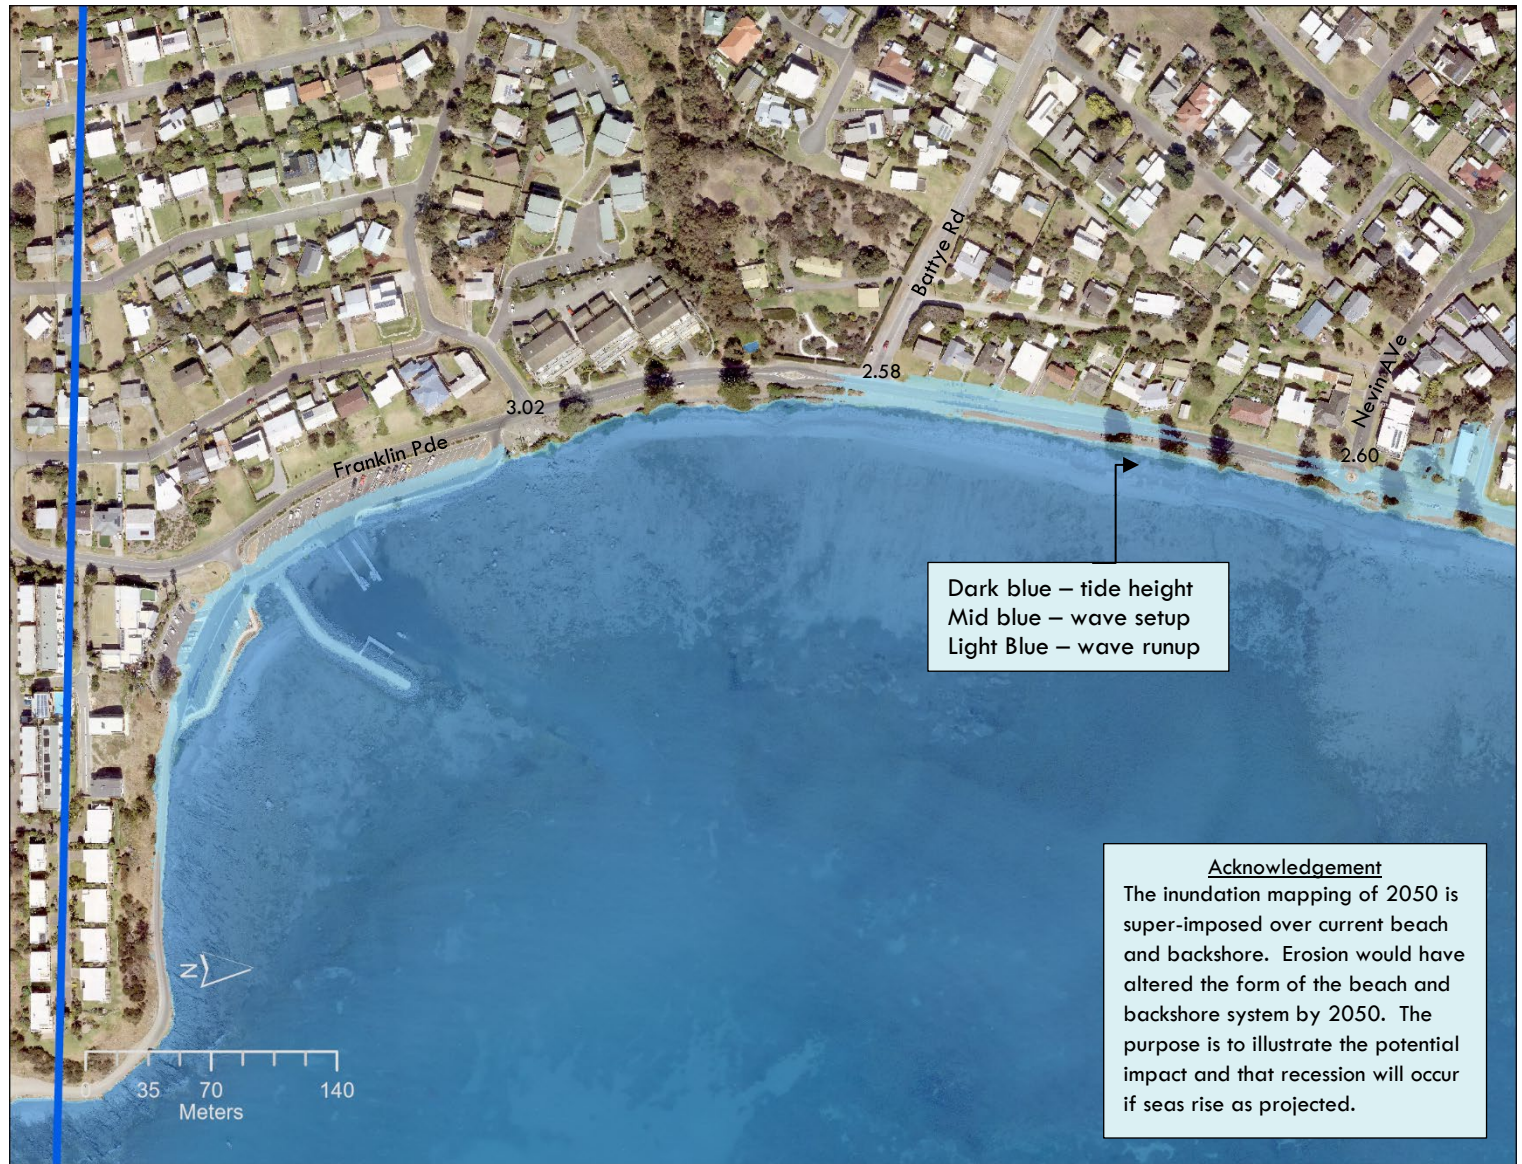
5. Coastal exposure – storm surge (2050)

Assessment.
 The lighter blue is wave runup which indicates that overtopping of the embankment would be significant where indicated. Also note that wave setup would be directly impacting the embankment (some protected) and undermining and damage is likely.
