Coastal Adaptation Study &
Coastal Adaptation Strategy

ENCOUNTER BAY

Cell
Fleurieu 12

For City of
Victor Harbor

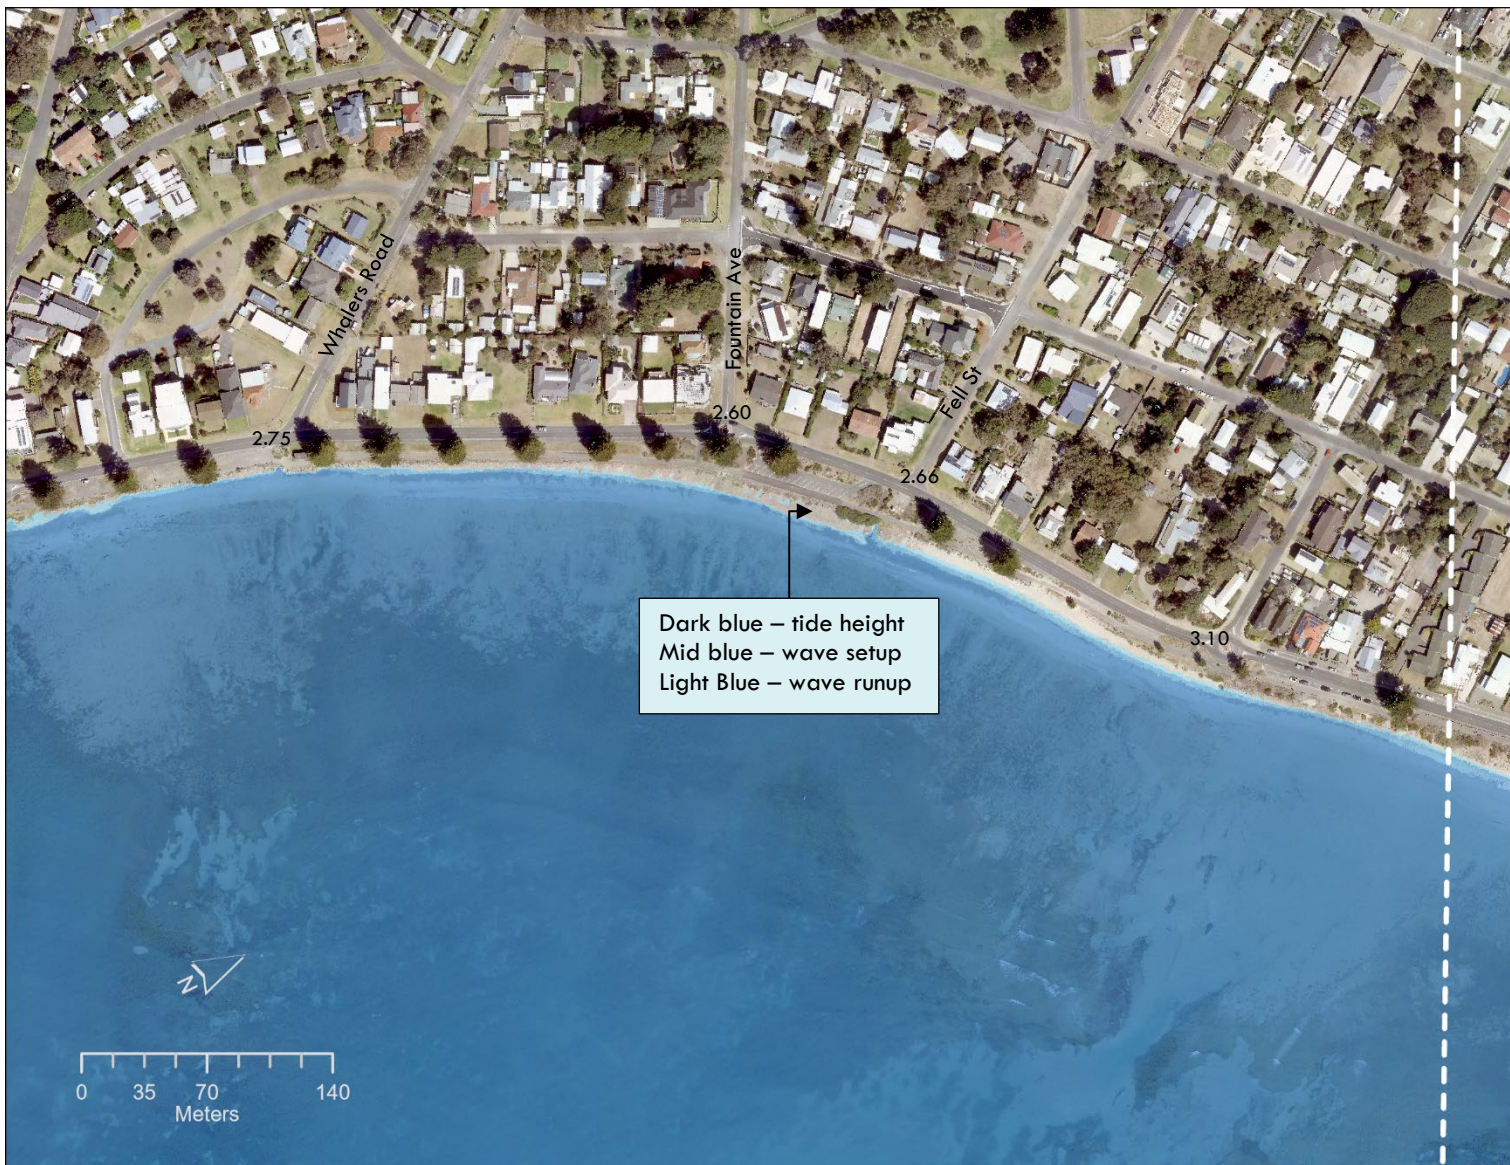
5. Coastal exposure – routine high water (2020)

Assessment: The modelling is congruent with observations and the current impact on beach and backshore is low (higher impact Yilki).

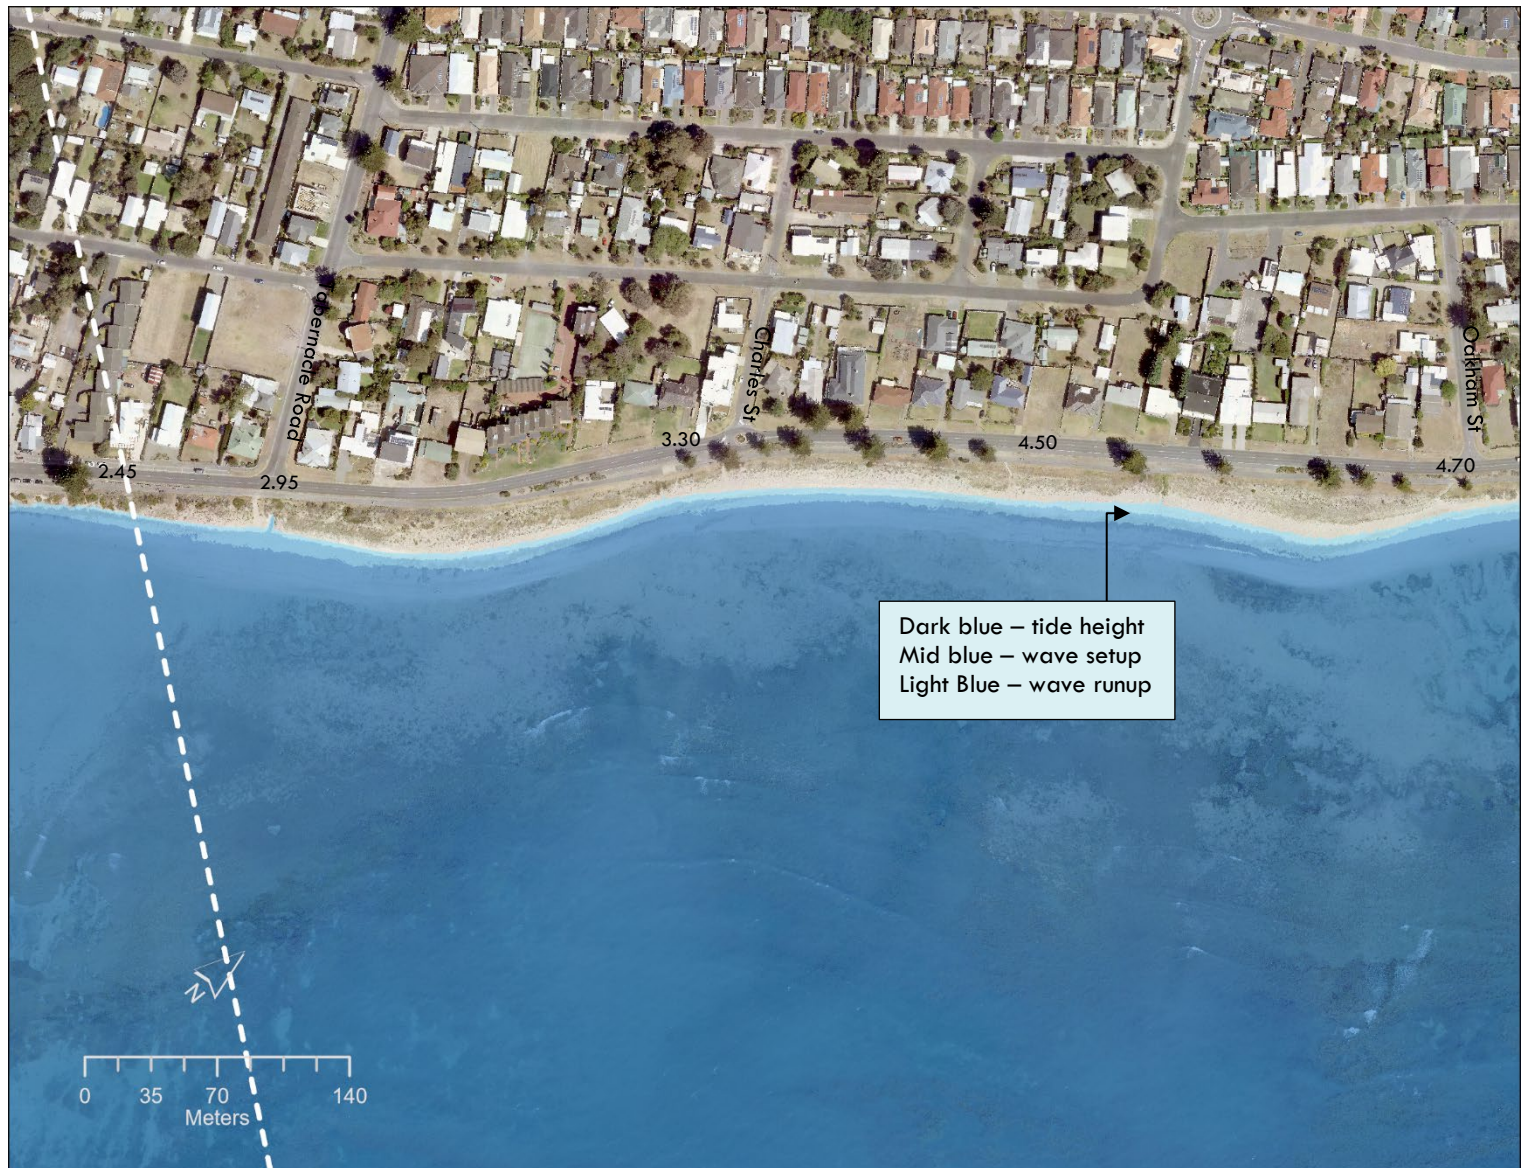
5. Current exposure – routine high water (2020)

Assessment: The modelling is congruent with observations and the current impact on beach and backshore is low.

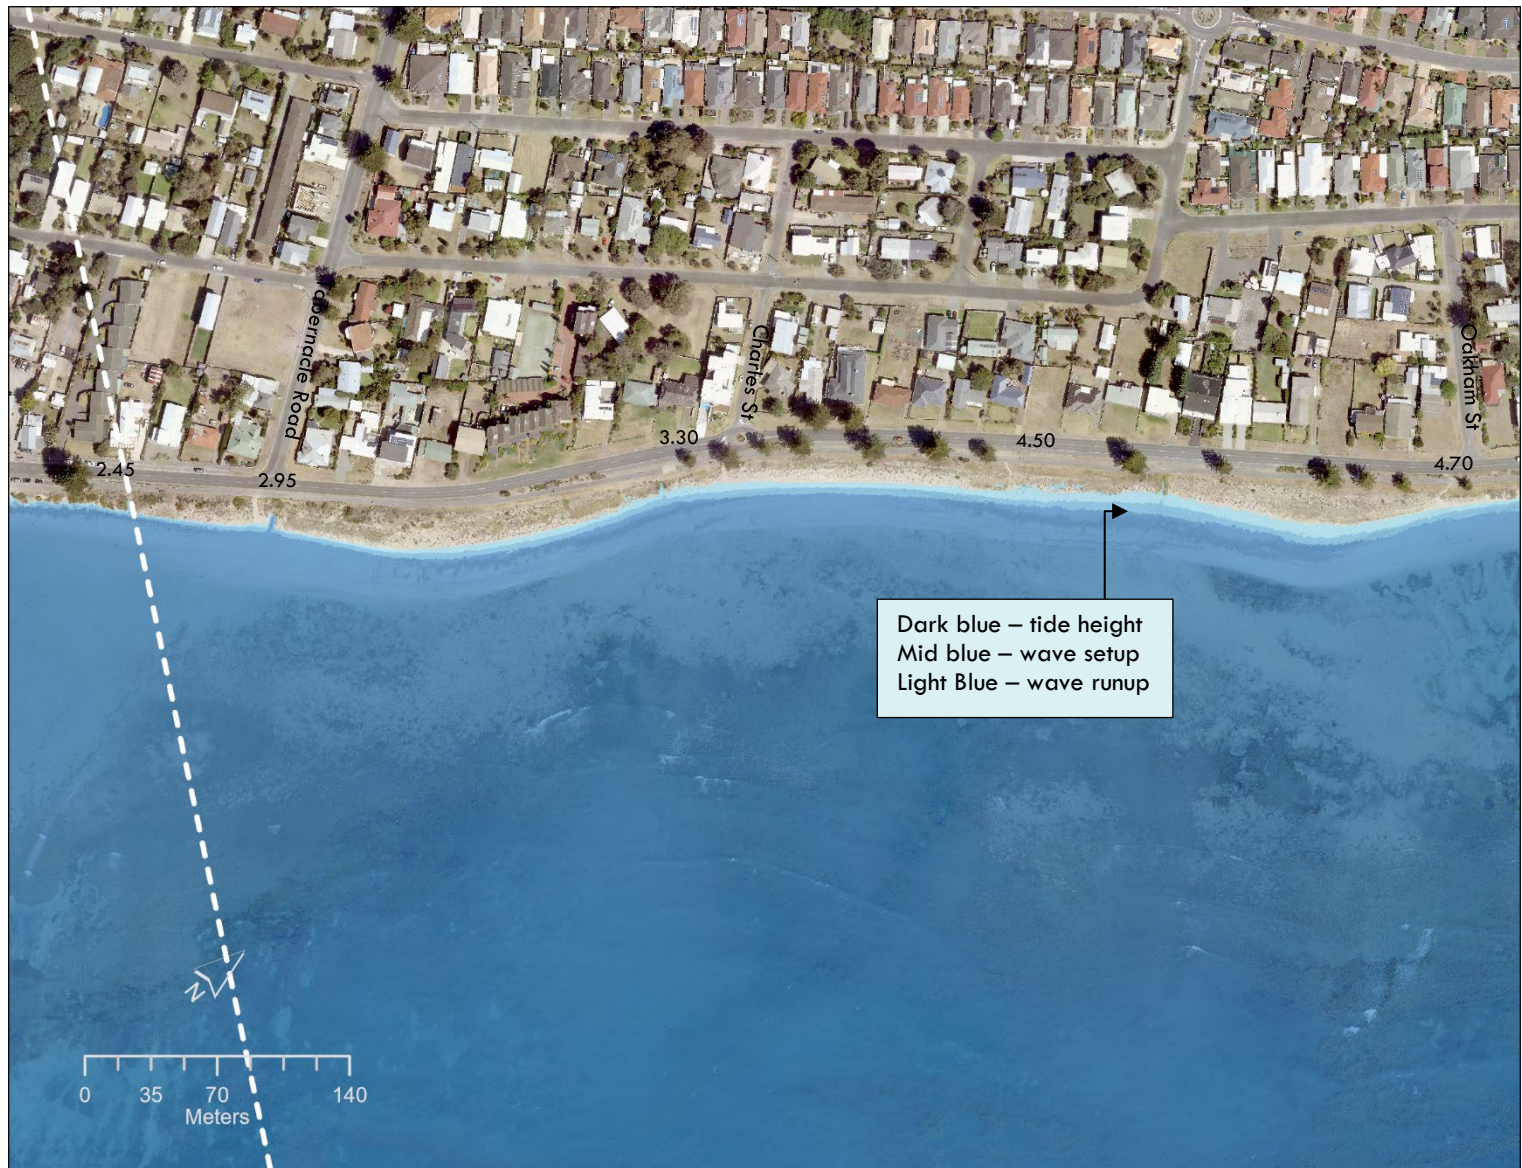
5. Coastal exposure – routine high water (2050)

Routine highwater events at 0.30m higher than present are likely to cause some recession to the shoreline (measured in metres) which in some places would undermine the embankment under the road and sand levels lowered on the beach.

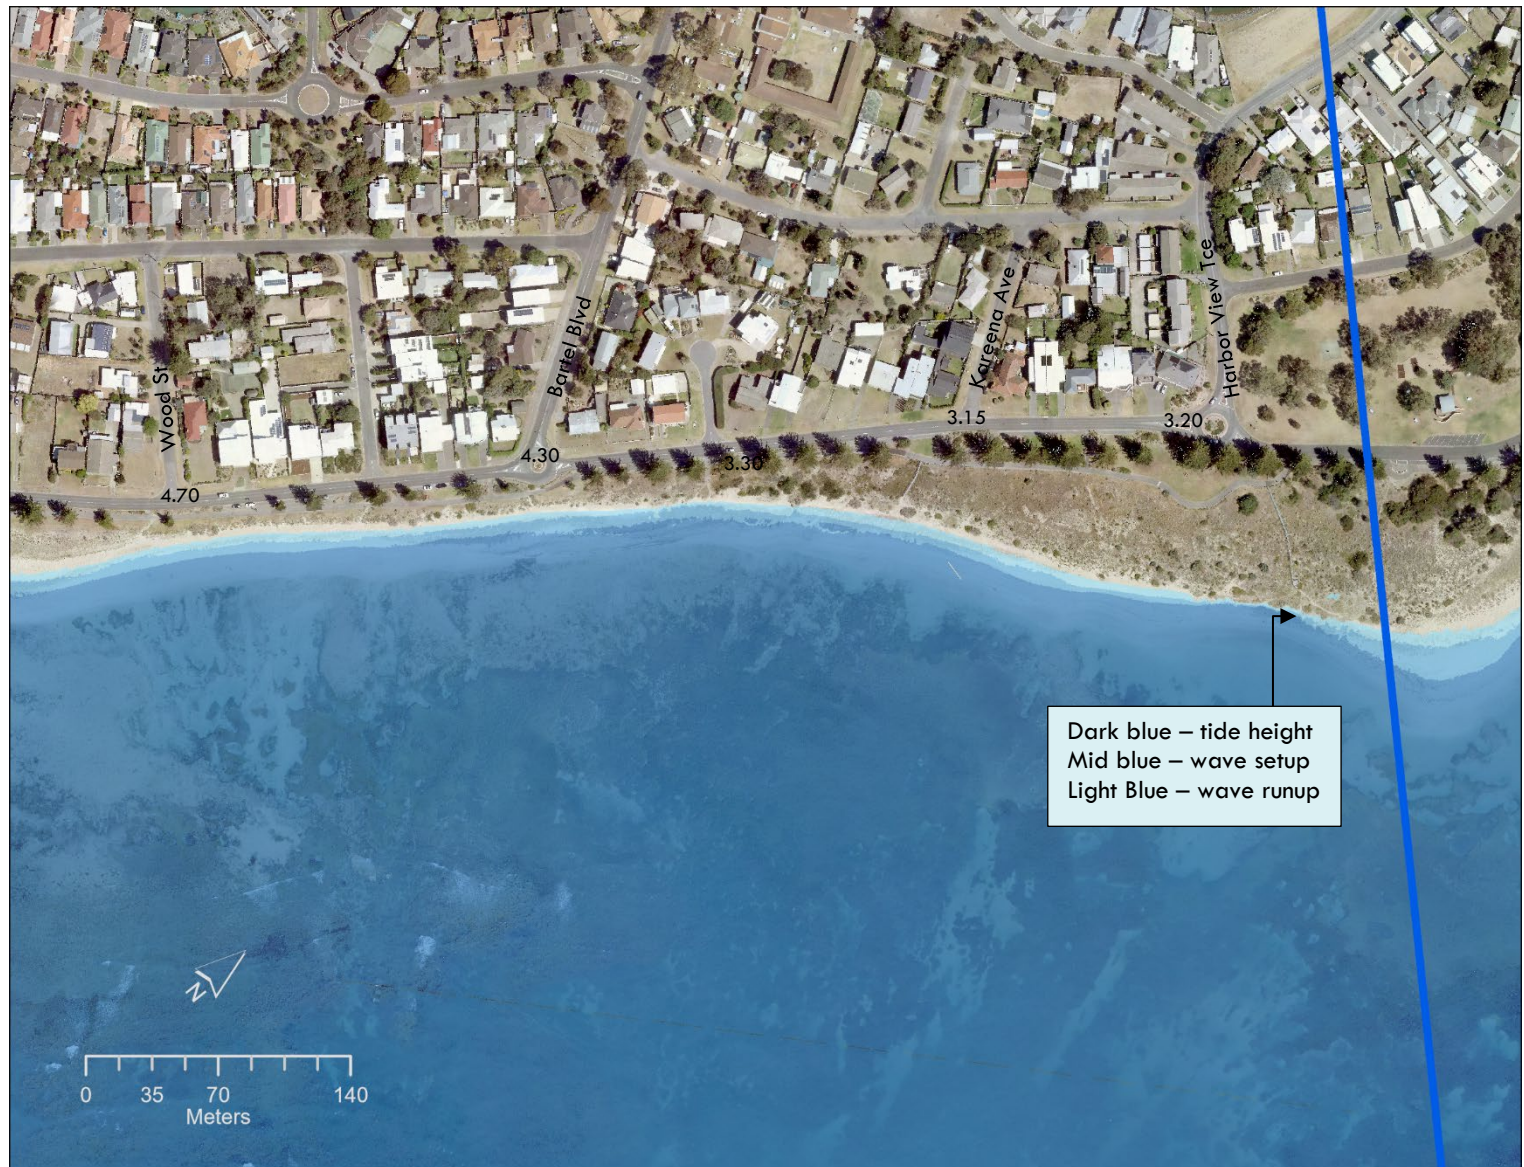
5. Coastal exposure – routine high water (2020)

Assessment: The modelling is congruent with observations and the current impact on beach and backshore is low.

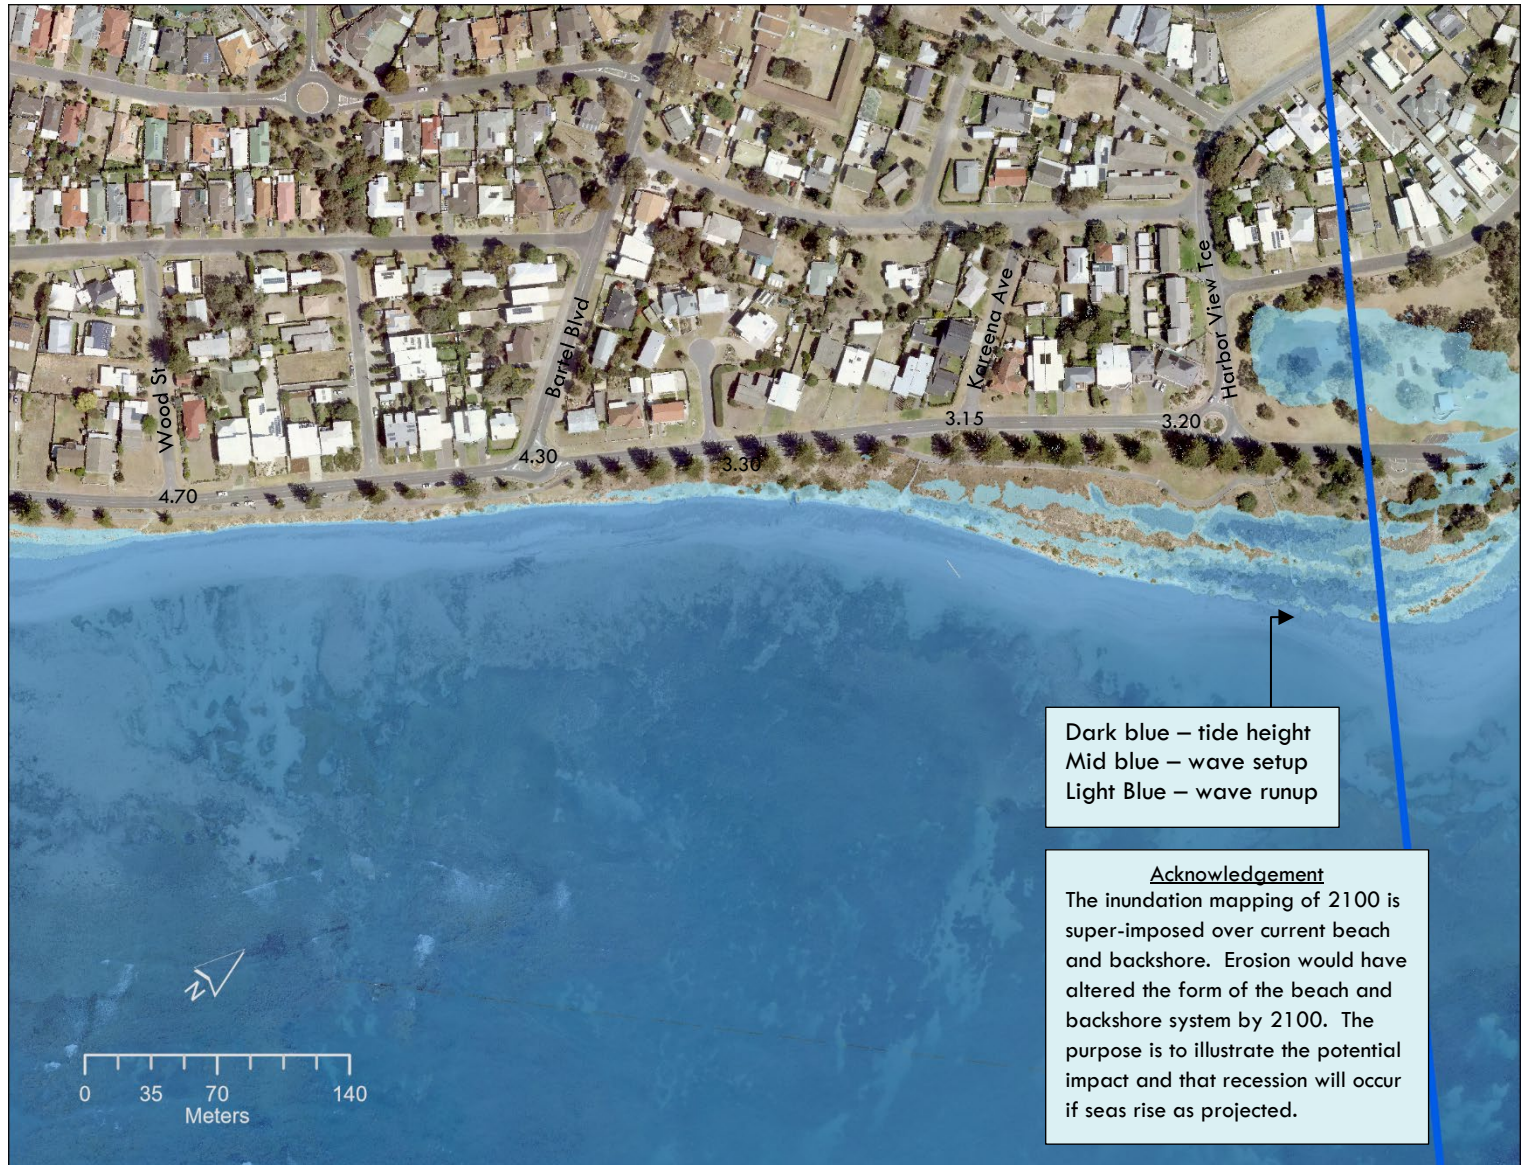
5. Coastal exposure – routine high water (2100)

The road and residential area is more elevated in this location but routine high water events projected for 2100 would cause significant erosion of the coastline, likely to undermine the embankment under the road reserve.

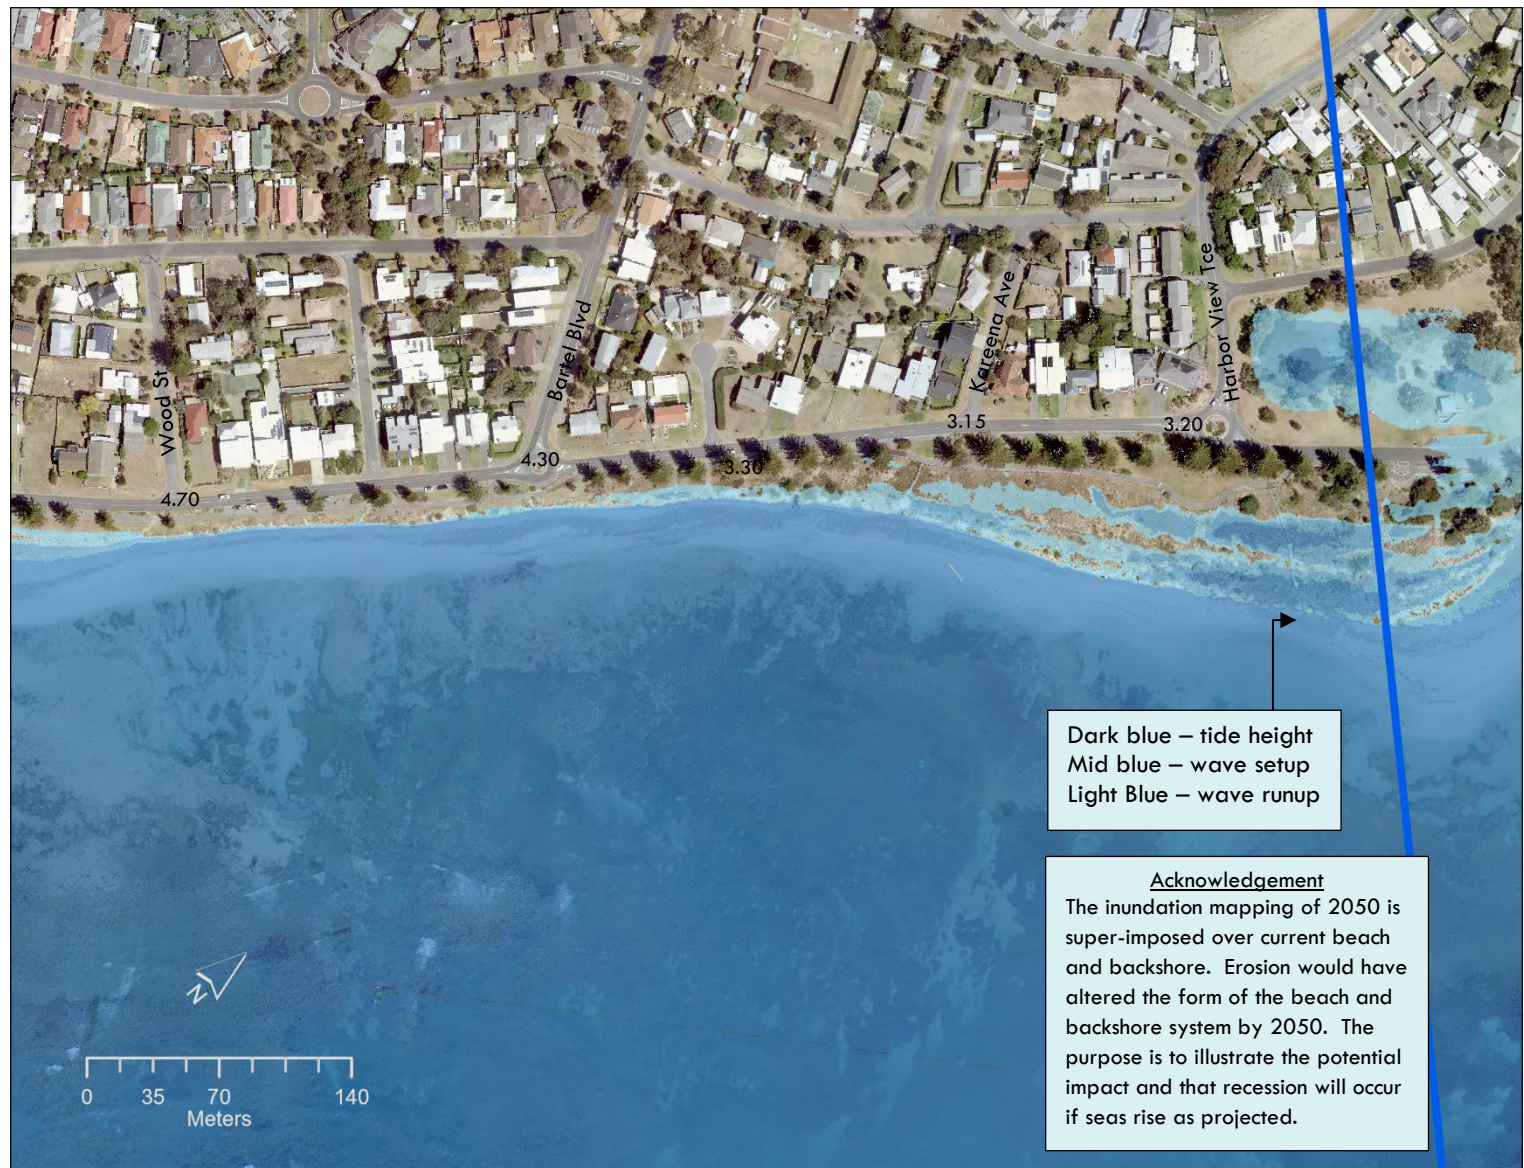
Dark blue – tide height
 Mid blue – wave setup
 Light Blue – wave runup

Acknowledgement
 The inundation mapping of 2050 is super-imposed over current beach and backshore. Erosion would have altered the form of the beach and backshore system by 2050. The purpose is to illustrate the potential impact and that recession will occur if seas rise as projected.

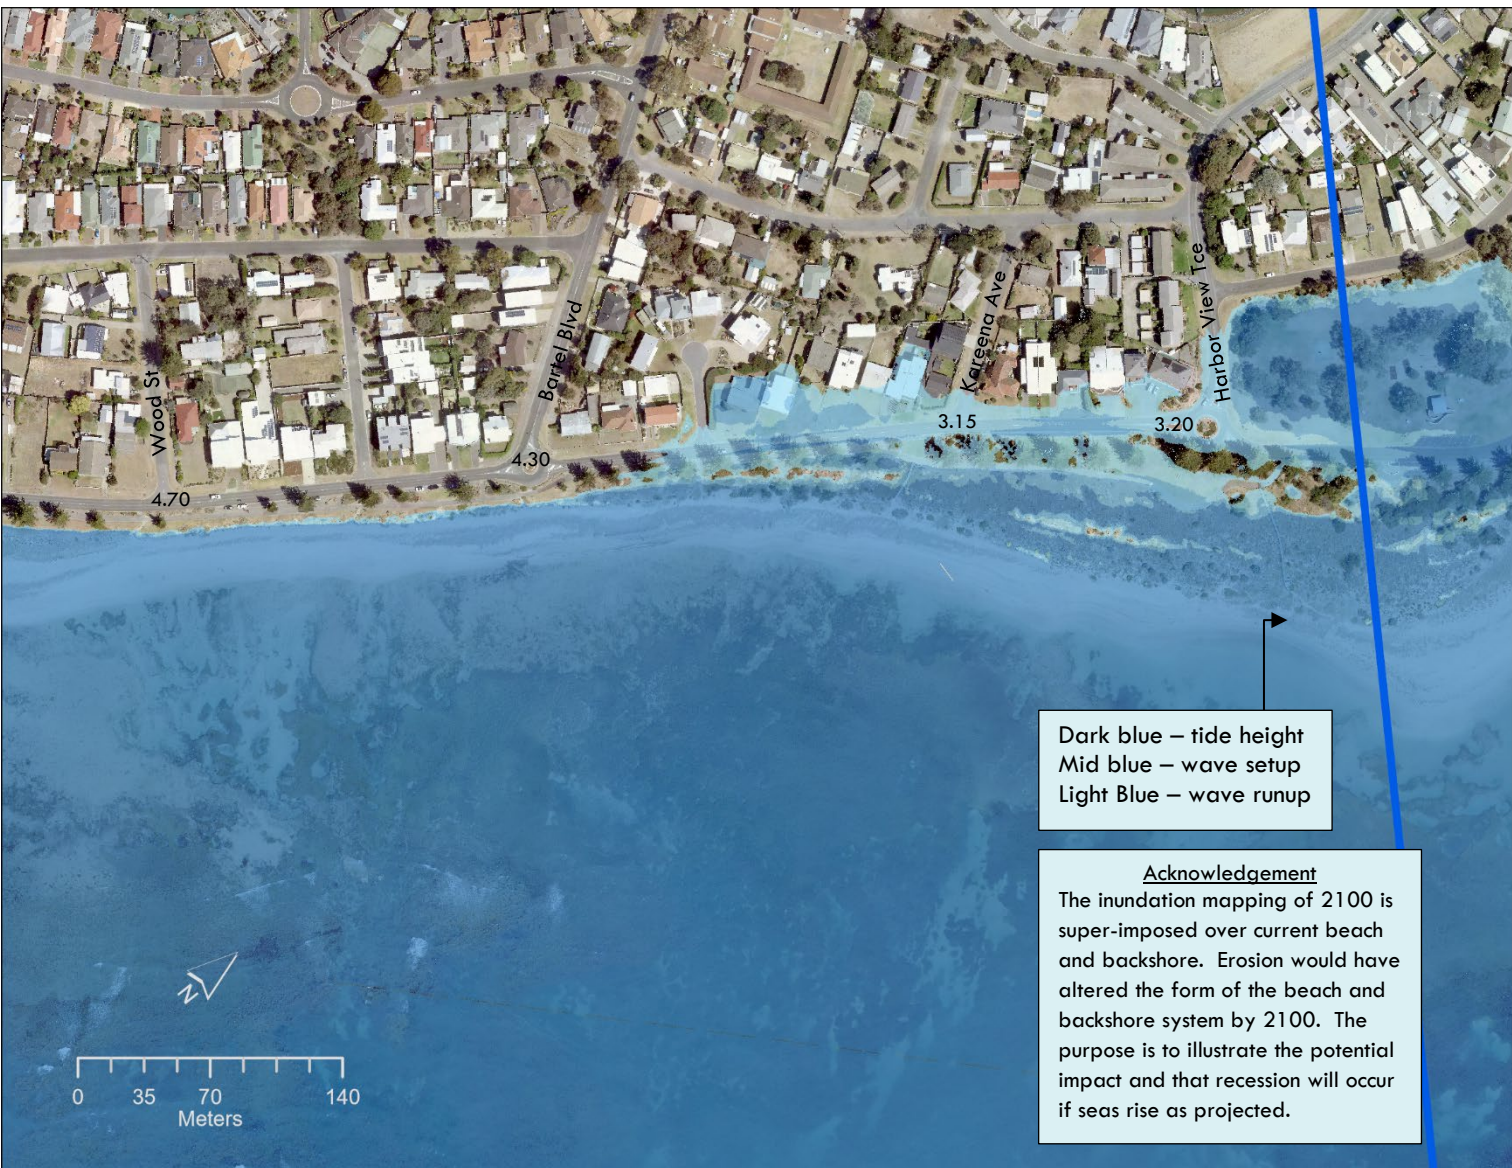
Dark blue – tide height
 Mid blue – wave setup
 Light Blue – wave runup

Acknowledgement
 The inundation mapping of 2100 is super-imposed over current beach and backshore. Erosion would have altered the form of the beach and backshore system by 2100. The purpose is to illustrate the potential impact and that recession will occur if seas rise as projected.

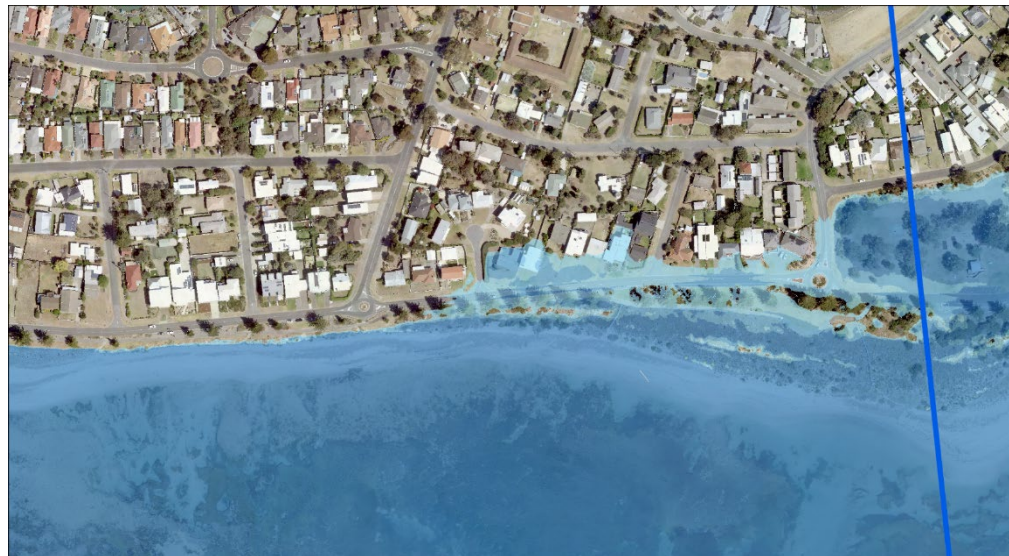
Figure b. Depicts the likely location of the shoreline in the Kent Reserve region when sea levels were ~1m higher 4-5000 years ago. Residential settlement has been established upon a former sand dune that was formed in the Holocene period. This sand dune now separates the coast from the lowland behind which is now occupied by Encounter Lakes.

Dr. Robert Bourman notes in Section 3 that behind Franklin Parade from Tabernacle Road to Kent Reserve is a coastal sand dune that was formed in the Holocene period. Behind the sand dune which is now known as Encounter Lakes was formerly a poorly drained coastal lowland. The approximate location of the former shoreline when seas were ~1m higher than present can be observed in the Kent Reserve area, but it is not possible to identify this elsewhere along the coast.

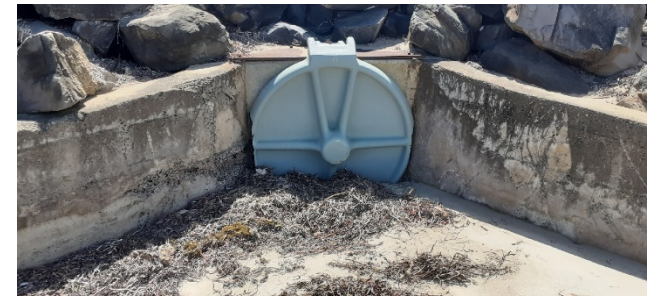
Figure a. Headwall tends to prevent undermining from actions of the sea.

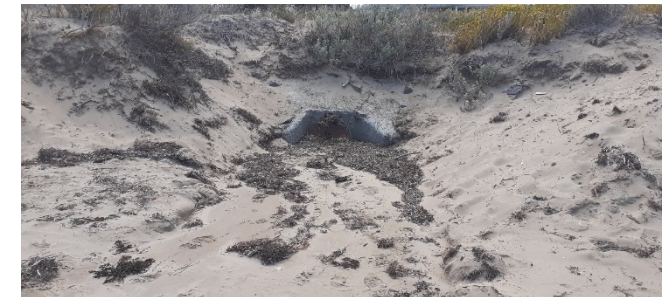
Figure b. Some outlets require maintenance (not the focus of this assessment)

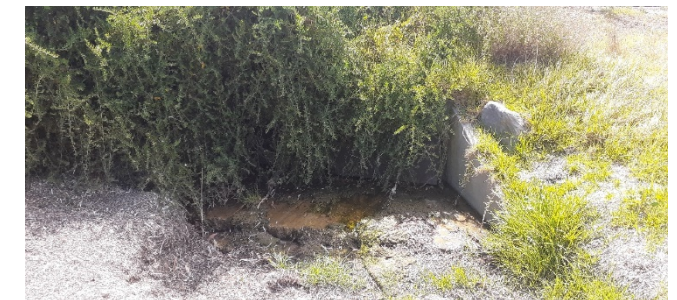
Figure d. Fell Street outlet. Same location as Figure (a). The headwall tends to prevent undermining from actions of the sea.

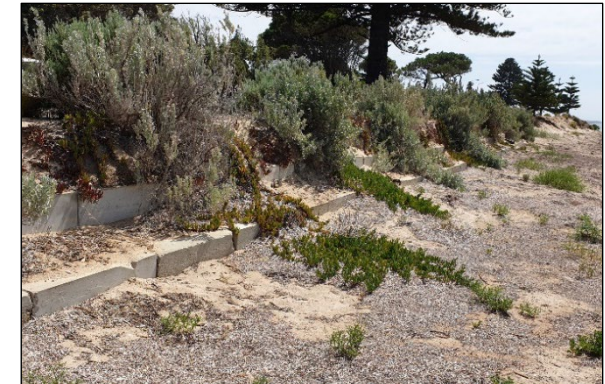
Figure c: Concrete block seawall installed as a trial 5 tiers high, covered with sand and vegetated in the region of Fell Street.

'Where wave effects are higher, the rock revetment wall is the preferred protection solution. Randomly stacked rock armour is more effective to dissipate wave energy and has been utilised in other nearby locations. The concrete block wall option may be suitable in sheltered areas with minimal wave action. A more detailed wave analysis is required during the design phase, to confirm viability. The intent is for sand to be backfilled over the concrete blocks, establishing a more natural beach/dune. However, if wave action erodes the sand, the concrete block may be exposed to wave action. Waves tend to reflect off vertical faces such as this, which may lead to further erosion'.

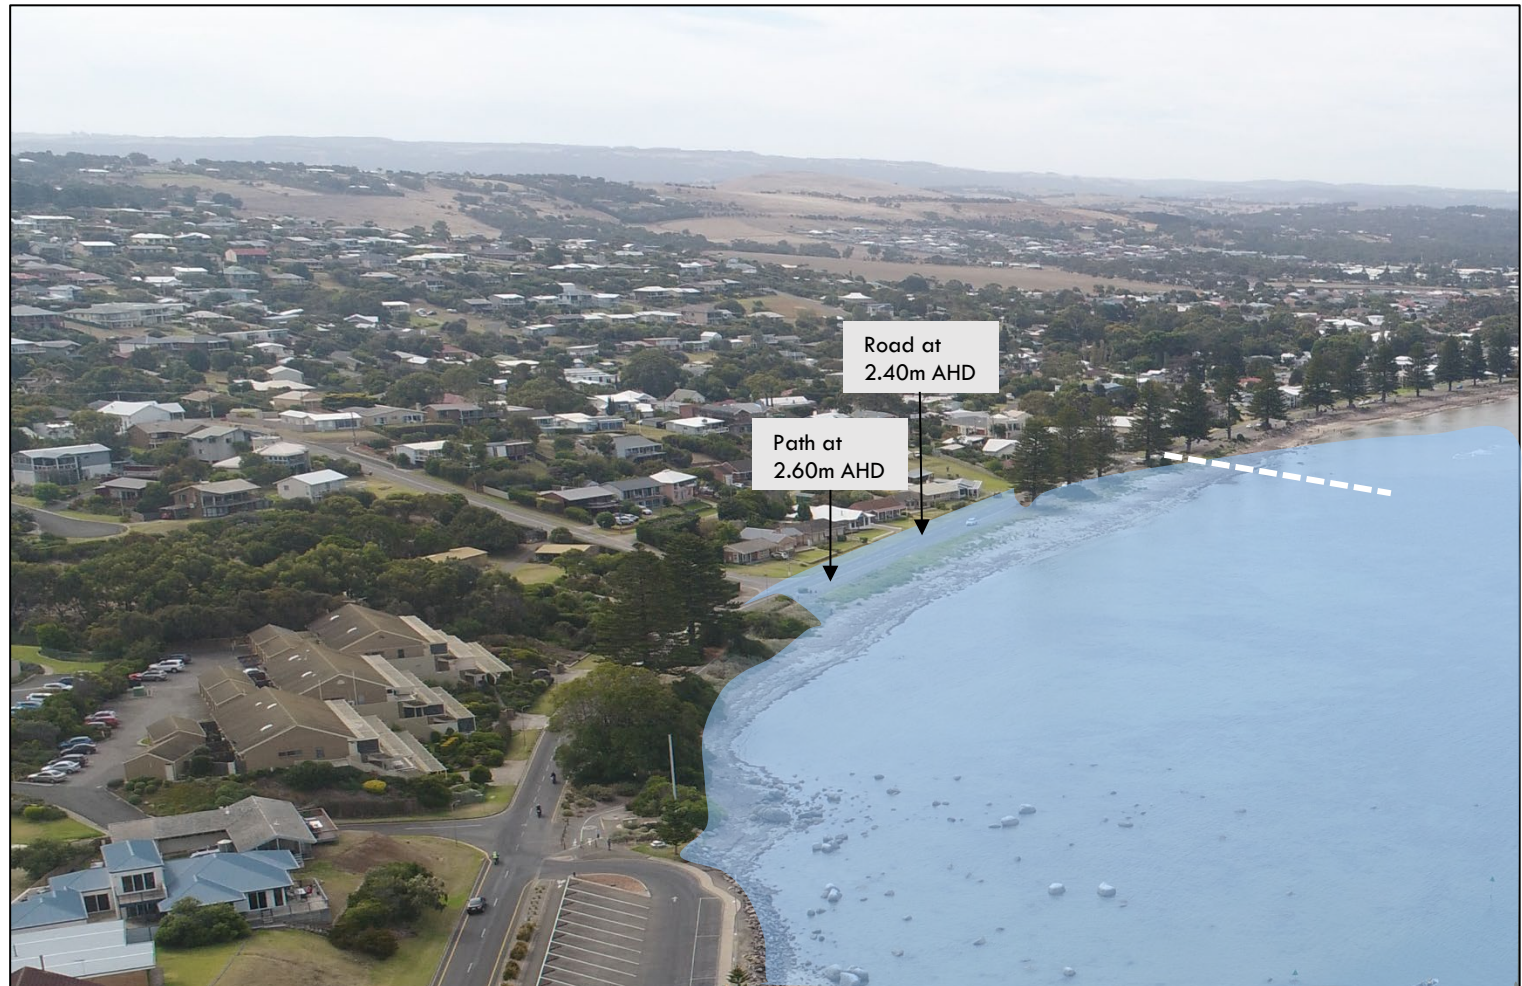
The modelling indicates approximate pattern of sea-flood projected for 2050 and illustrates that wave runup would overtop the backshore and flood the road at low depth. The road is at 2.40m AHD.

*It is recommended that wave and tidal studies be carried out within Encounter Bay to enable more site-specific allowances for wave setup, wave runup and wave overtopping to be allocated. For example, it is likely that wave impacts and the potential for overtopping is less in this section of the bay than further to the east due to the sheltering effect of The Bluff.

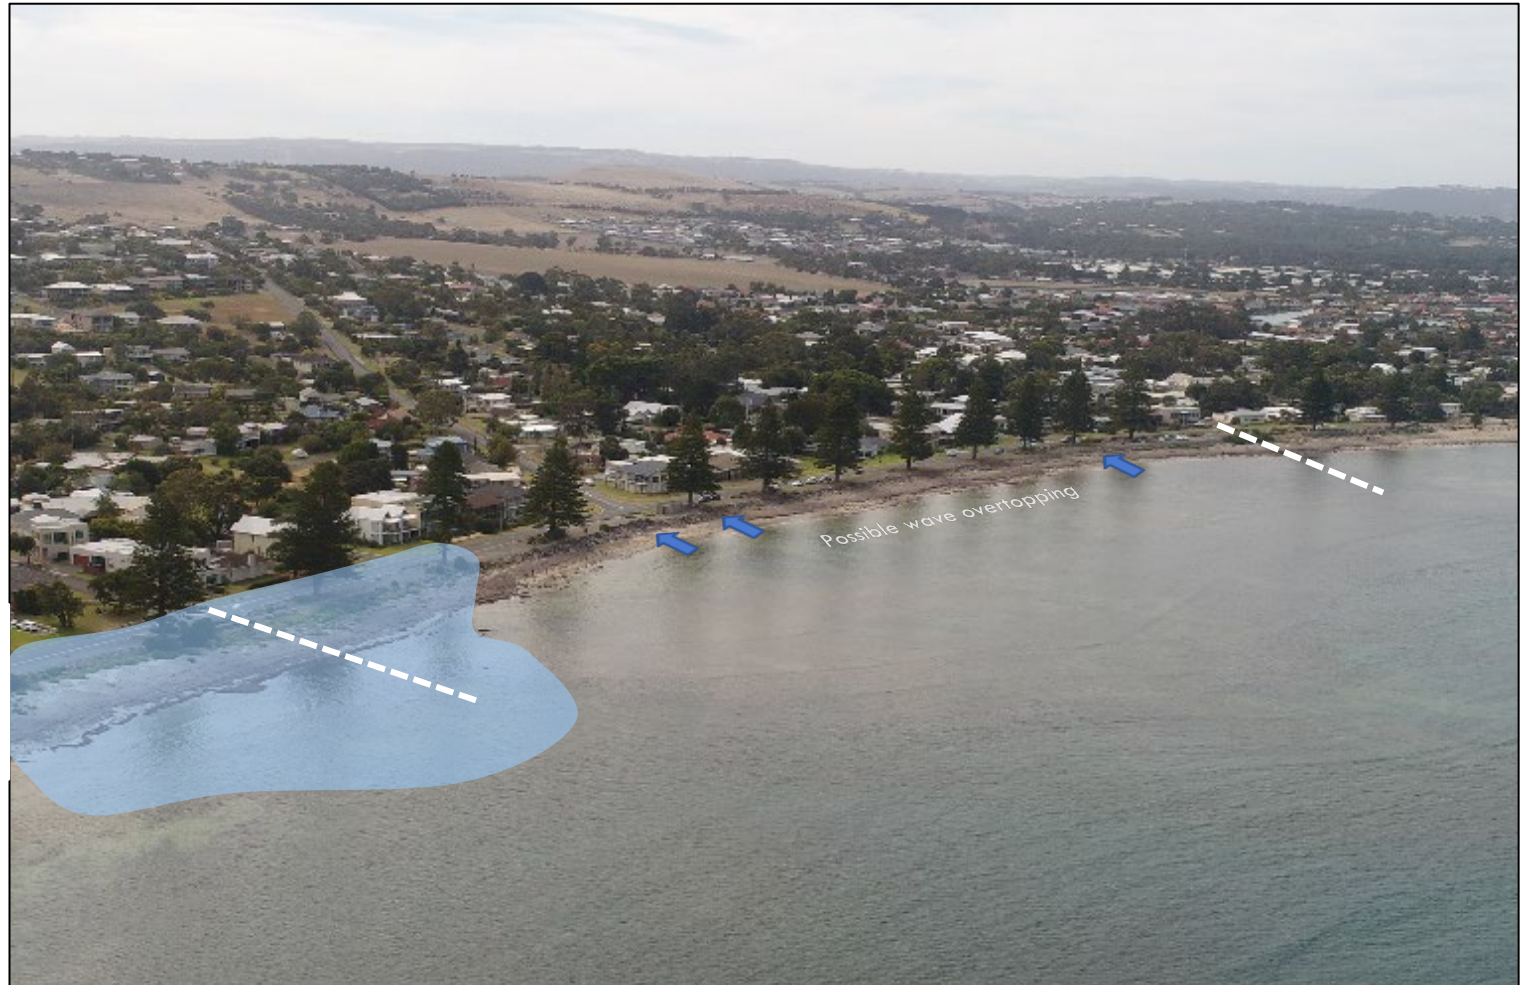
The modelling indicates some overtopping near Nevin Street. Residents report overtopping at the Whalers Road toilets. The modelling indicates wave overtopping at Fell Street possible.

*It is recommended that wave and tidal studies be carried out within Encounter Bay to enable more site-specific allowances for wave setup, wave runup and wave overtopping to be allocated. For example, it is likely that wave impacts and the potential for overtopping is less in this section of the bay than further to the east due to the sheltering effect of The Bluff.

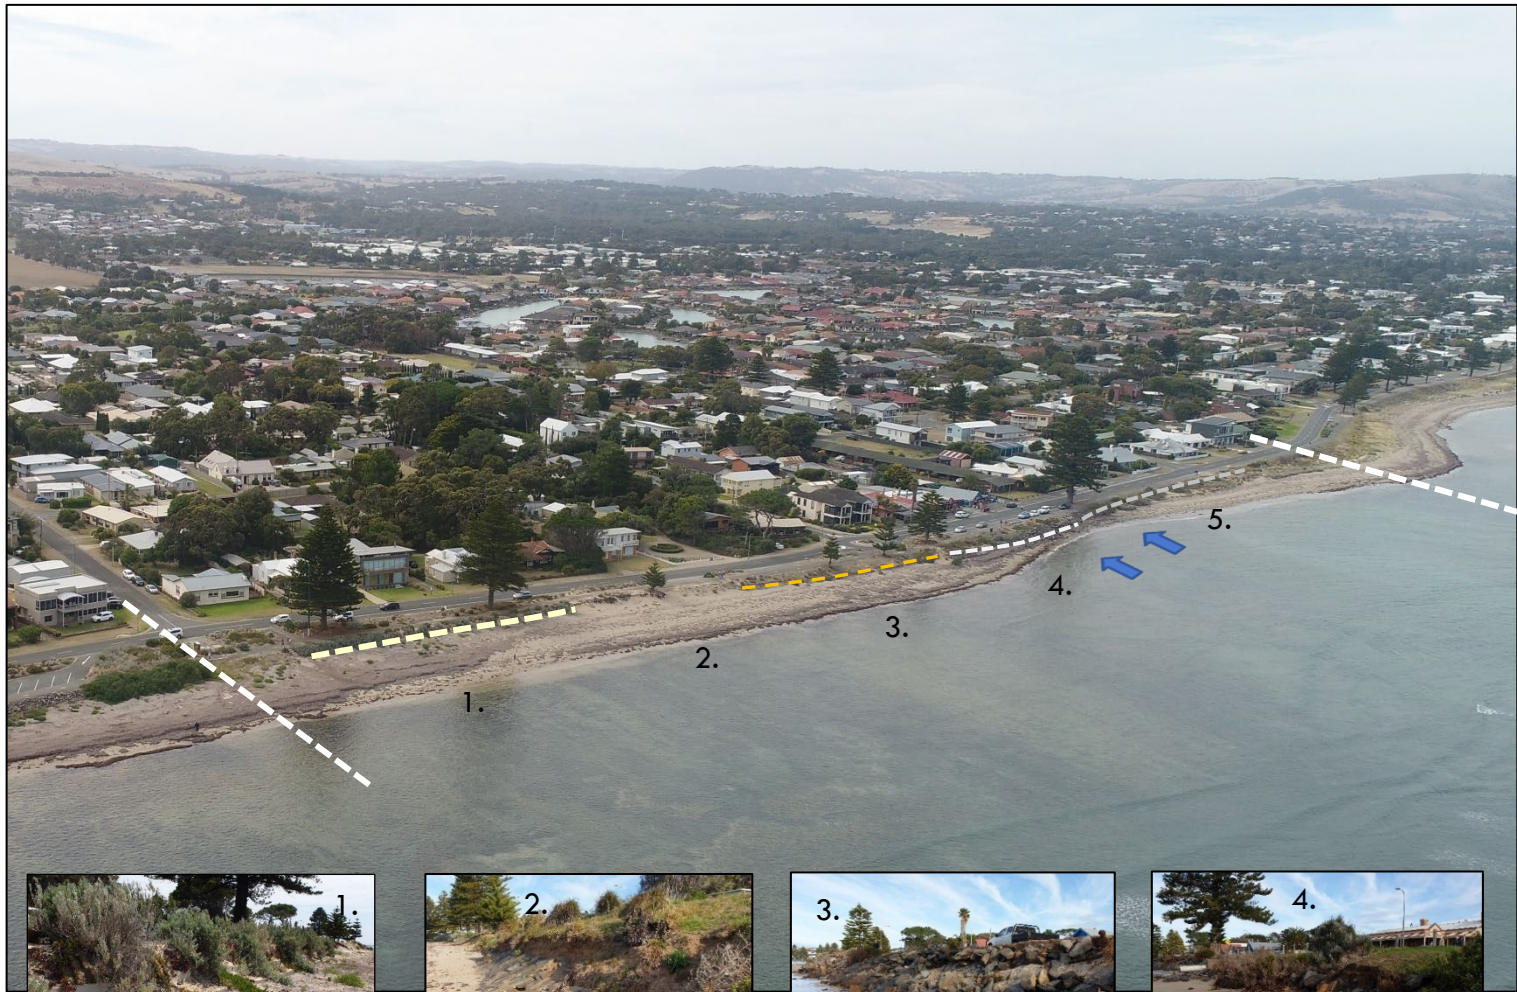
1. Concrete block (Fell Street)
2. No protection
3. Concrete rock wall (1950s)
4. Rock revetment (poor condition)
5. Rock walling (behind bank/dune).

Exposure
 The sea-flood risk projected for 2050 is 2.65 (including wave runup). In the Yilki region, moderate events overtop the rock revetment (see following page).

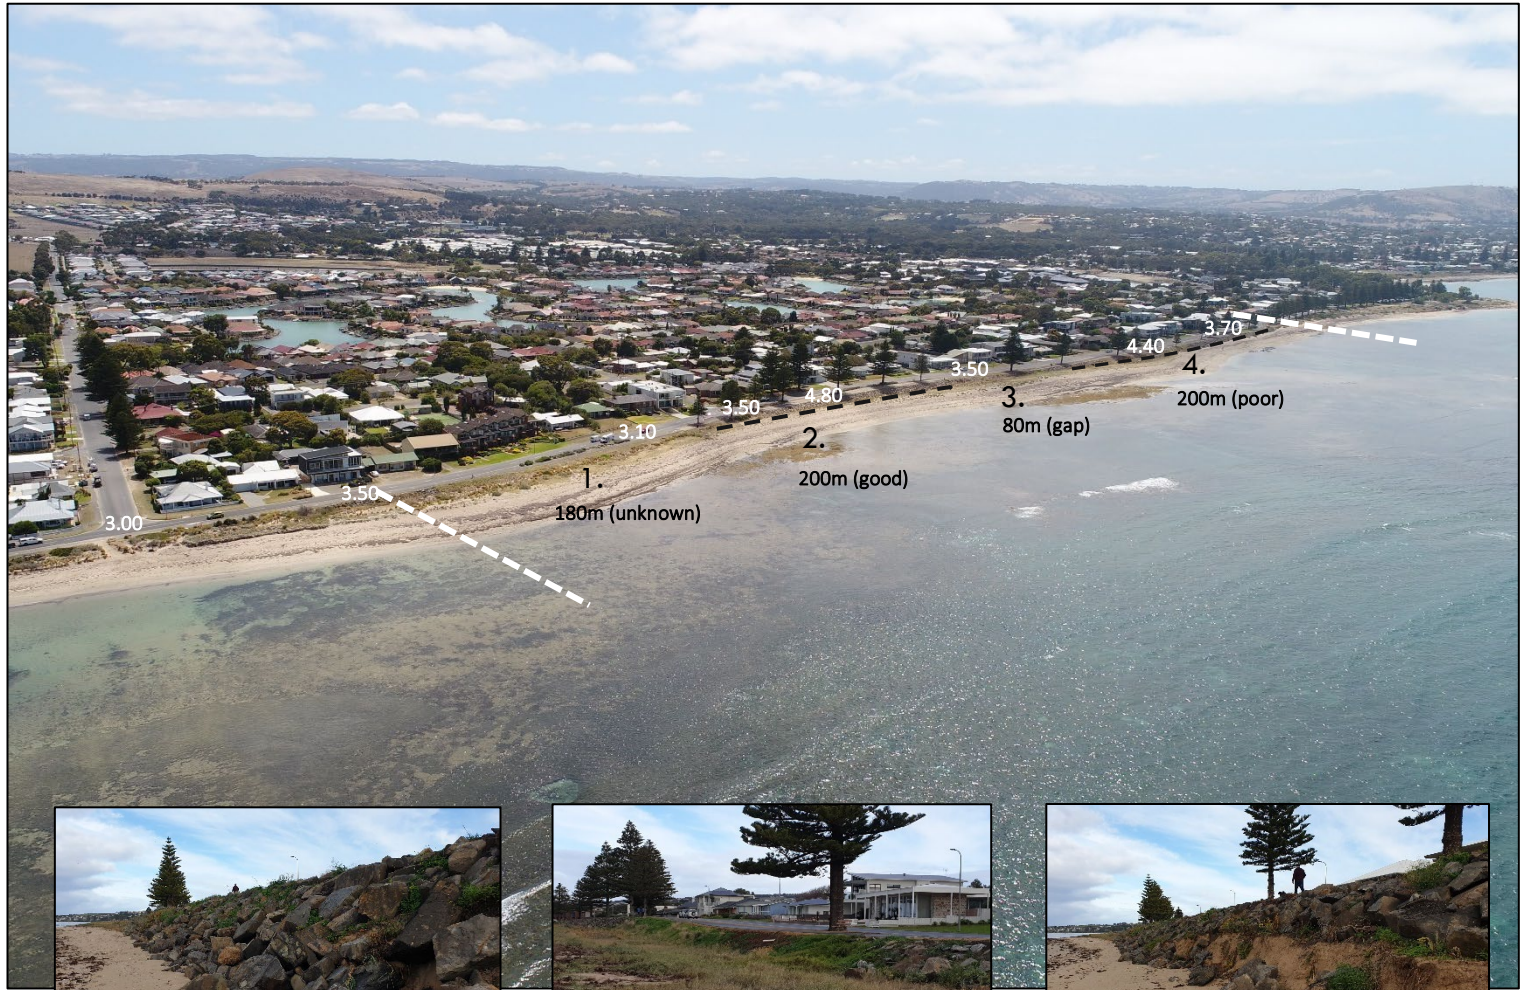
1. Rock walling behind embankment installed in 1970s (?) (not pictured)
2. Rock revetment in sound condition
3. Gap in protection works
4. Rock revetment – recent erosion, rocks sliding on to the beach.

Exposure
 The sea-flood risk projected for 2050 is 2.65 (including wave runup). This area is elevated above inundation, but subject to erosion.

- Conduct an inspection of section (1) to ascertain the nature of the protection structures that appear buried under the embankment.
- Design and install rock revetment to section (3). Low priority.
- Conduct an inspection of the recently damaged section (4) and repair or replace rock revetment.

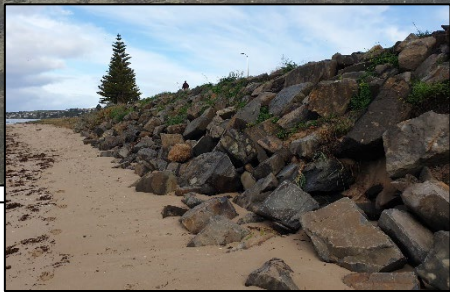
2. Rock revetment – well constructed and in sound condition

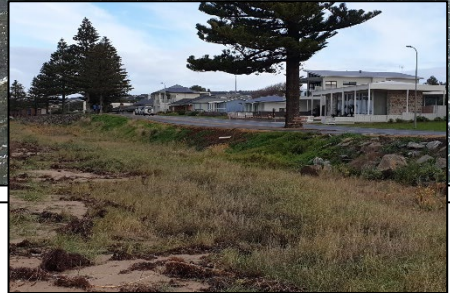
3. A gap in the protection works – but not under immediate threat.

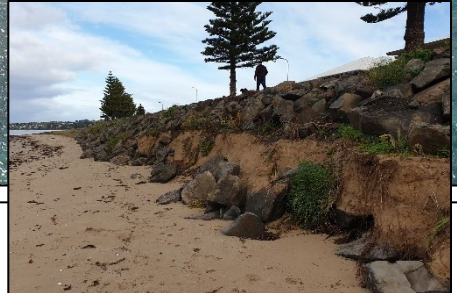
4. Rock revetment – recently eroded so that rocks are sliding on to the beach.
