Coastal Adaptation Study &
Coastal Adaptation Strategy

ENCOUNTER BAY

Cell
Fleurieu 12

For City of
Victor Harbor

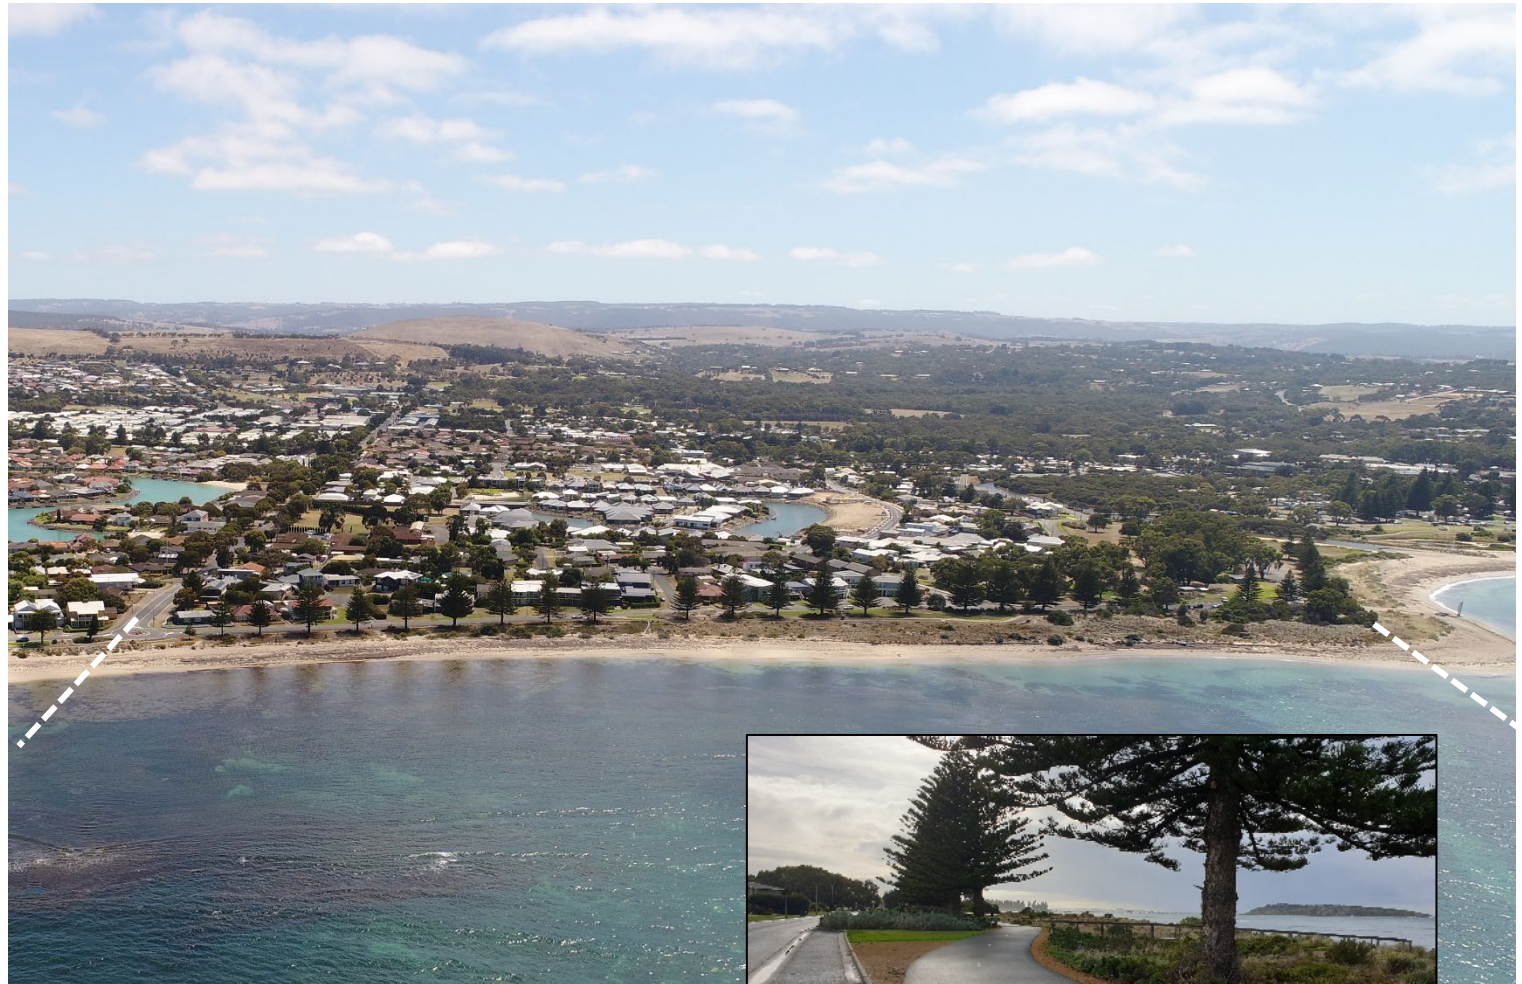
The bikeway/ path has recently been upgraded in this location and is constructed at height 3.10m AHD and runs along the road on the left of the photograph and on the seaward side of the Norfolk Pines on the right side (see inset photograph).
