City of Victor Harbor

Victor Harbor Coastal Management Study

FINAL REPORT

December 2013

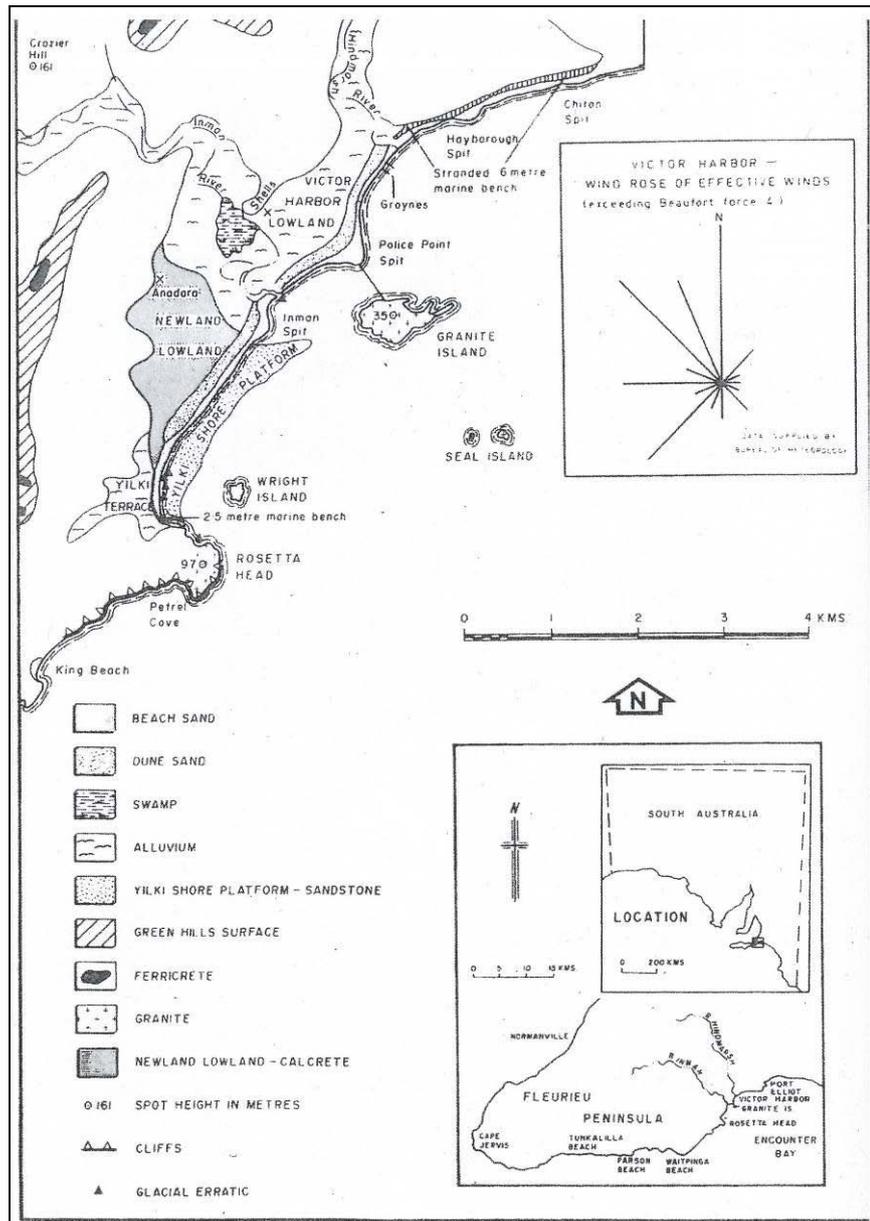
FIGURE 2-1 SURFACE GEOLOGY OF ENCOUNTER BAY AND VICTOR HARBOR

Source: Bourman 1989

shelf at the base of the cliffs to the west. The Inman River valley is also of glacial origin, carved out by an ice sheet moving westward and evident some 30 km up the valley at Normanville. The valley formed was some 16 km wide and it was within this broad valley that glacial features were first identified on the Australian mainland in 1859. The glacial deposits in this valley have been subsequently reworked, resulting in the rolling upper catchment landscape and infilled lower valley and low lying areas between the Inman and Hindmarsh Rivers that exists today.

The lack of detailed subsurface geology, particularly landward of the existing shoreline is an impediment to the accurate prediction of the likely rate of recession of the shoreline into the future, particularly given the scenario of a rising sea level. The presence of any resistive substrate will exert control on the shoreline movement, halting recession at some locations and possibly accelerating it at others. In the absence of this information, determination of future hazard zones landward of the beach must be considered carefully. For particular future projects and locations, detailed geotechnical/geological investigations may be warranted.

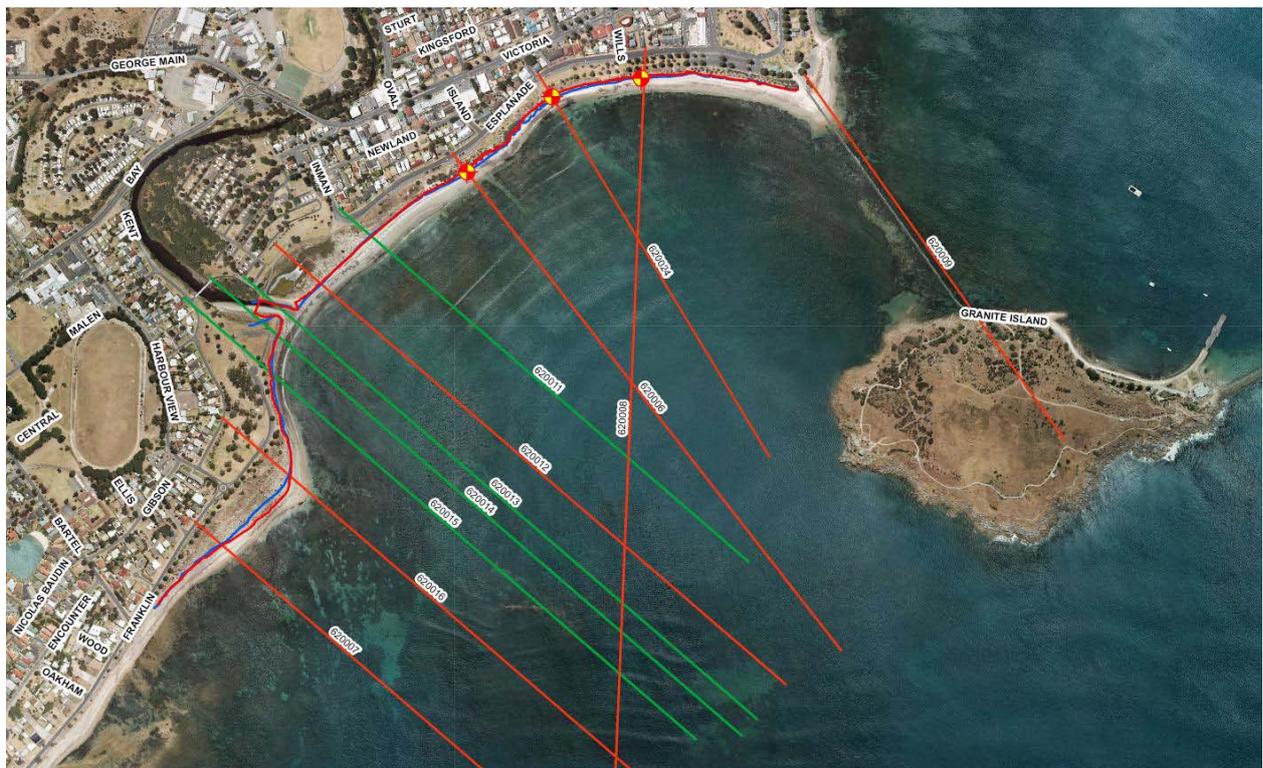
FIGURE 2-2 SURVEY PROFILE LOCATIONS WEST OF POLICE POINT

Profiles have been collected at selected locations along the beach using a combination of ground and bathymetric survey, providing a continuous profile from a base location approximately 80 m to 100 m landward of the intertidal zone, to a depth around -7 m Australian Height Datum (AHD) approximately 500 m from the base line. The length and final depth of each profile varies.

The locations of the profiles are shown below whilst approximate location and dates included for each survey profile are as shown in the following table.

Profile Number	Location	Survey Dates
620004	South of Coral Street, aligned to shore normal to east	
620009	Police Point Causeway	
620008	North of Wills St, aligned to south angled across embayment	2003, 2006, 2009, 2011, 2012
620024	King St, shore normal	
620006	South of Island St, shore normal	1987, 1989, 2003, 2006, 2009, 2011, 2012
620011	Inman St, shore normal	
620012	Centre of Caravan park, shore normal	
620013	North side Inman River entrance, shore normal	
620014	South side Inman River entrance, shore normal	
620015	Kent Reserve, north end Franklin Parade, shore normal	
620016	Seaward tip Kent Reserve, shore normal along rock reef	
620007	Kent Reserve at Kareena Avenue, shore normal	1987, 1989, 2006, 2009, 2011, 2012

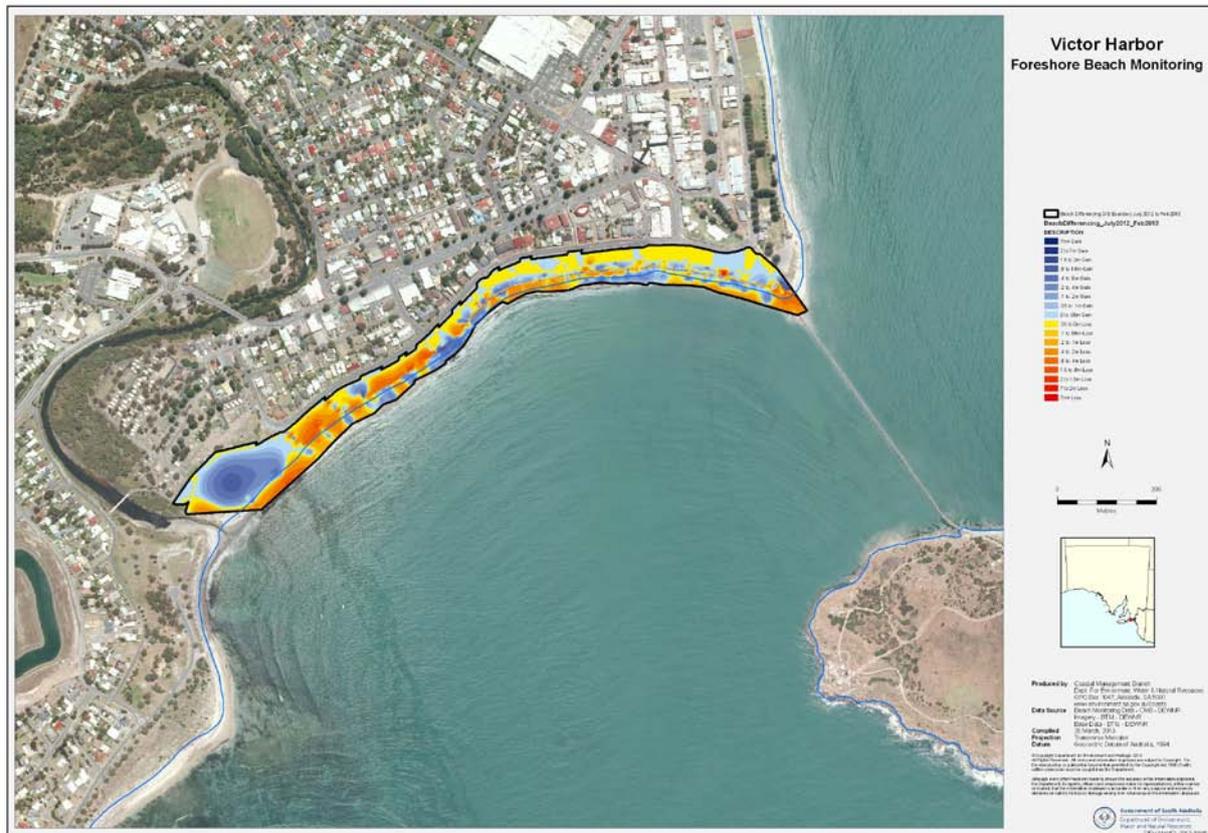
FIGURE 2-3 SURVEY ISOPACHS - INMAN RIVER ENTRANCE TO POLICE POINT, JULY 2012 TO FEBRUARY 2013

This base survey has been supplemented by ground survey of the area between the Inman River entrance and the Police Point, undertaken by DEWNR in July 2012 and repeated in February 2013 and also by Council for a 300 m section of the beach west of Police Point. The ground survey has not been overlain against the LIDAR data which was only recently obtained. DEWNR has undertaken a preliminary isopach analysis of the two ground survey dates as shown below in the figure below. The results of this analysis shows areas of accretion (blue tones) and areas of erosion (orange tones) along the beachfront over the intervening 6 month period covered by the surveys. No clear trend is evident from this short data as yet but this analysis will become increasingly valuable over time, highlighting those sections of the beach under erosion threat and allowing a comparison of the overall beach sand volumes over time.

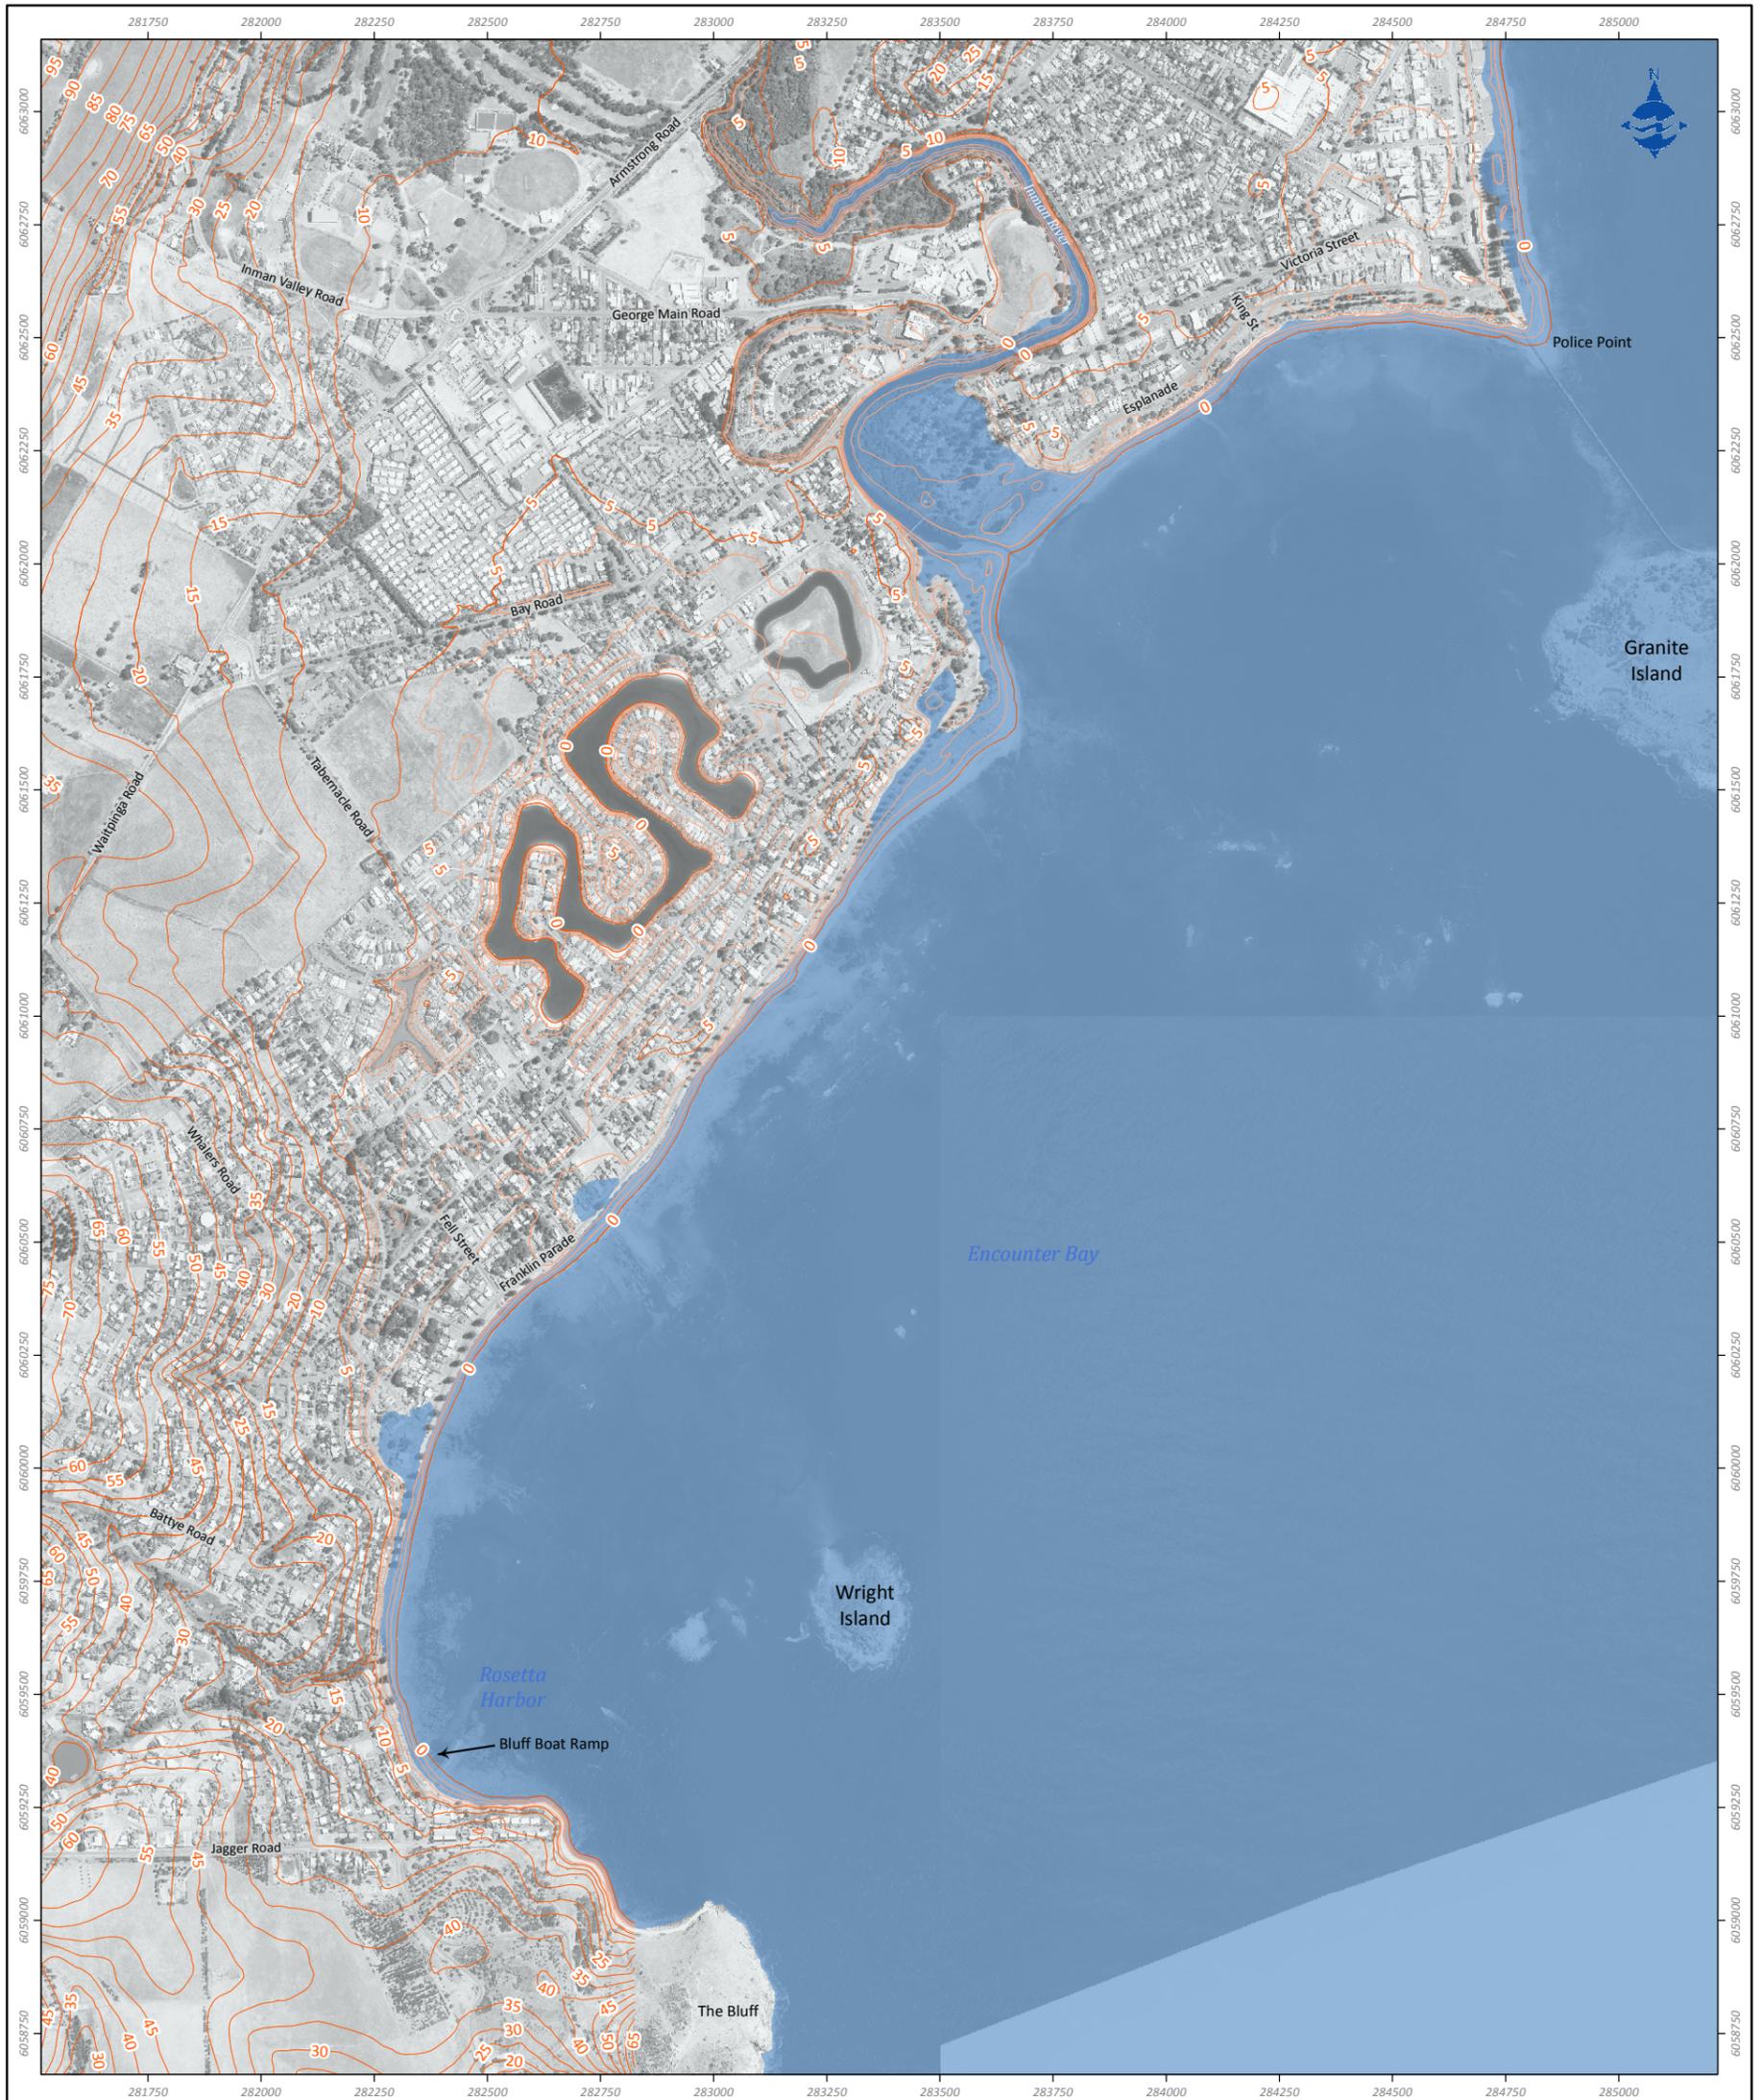
- Index Contour (5m interval)
- Intermediate Contour (1m interval, 1-4m AHD only)
- Area Below 2.65 m AHD 2050

Sea Level Rise, Wave Set Up, Wave Run Up and 1 in 100 year Storm Surge Level 2050

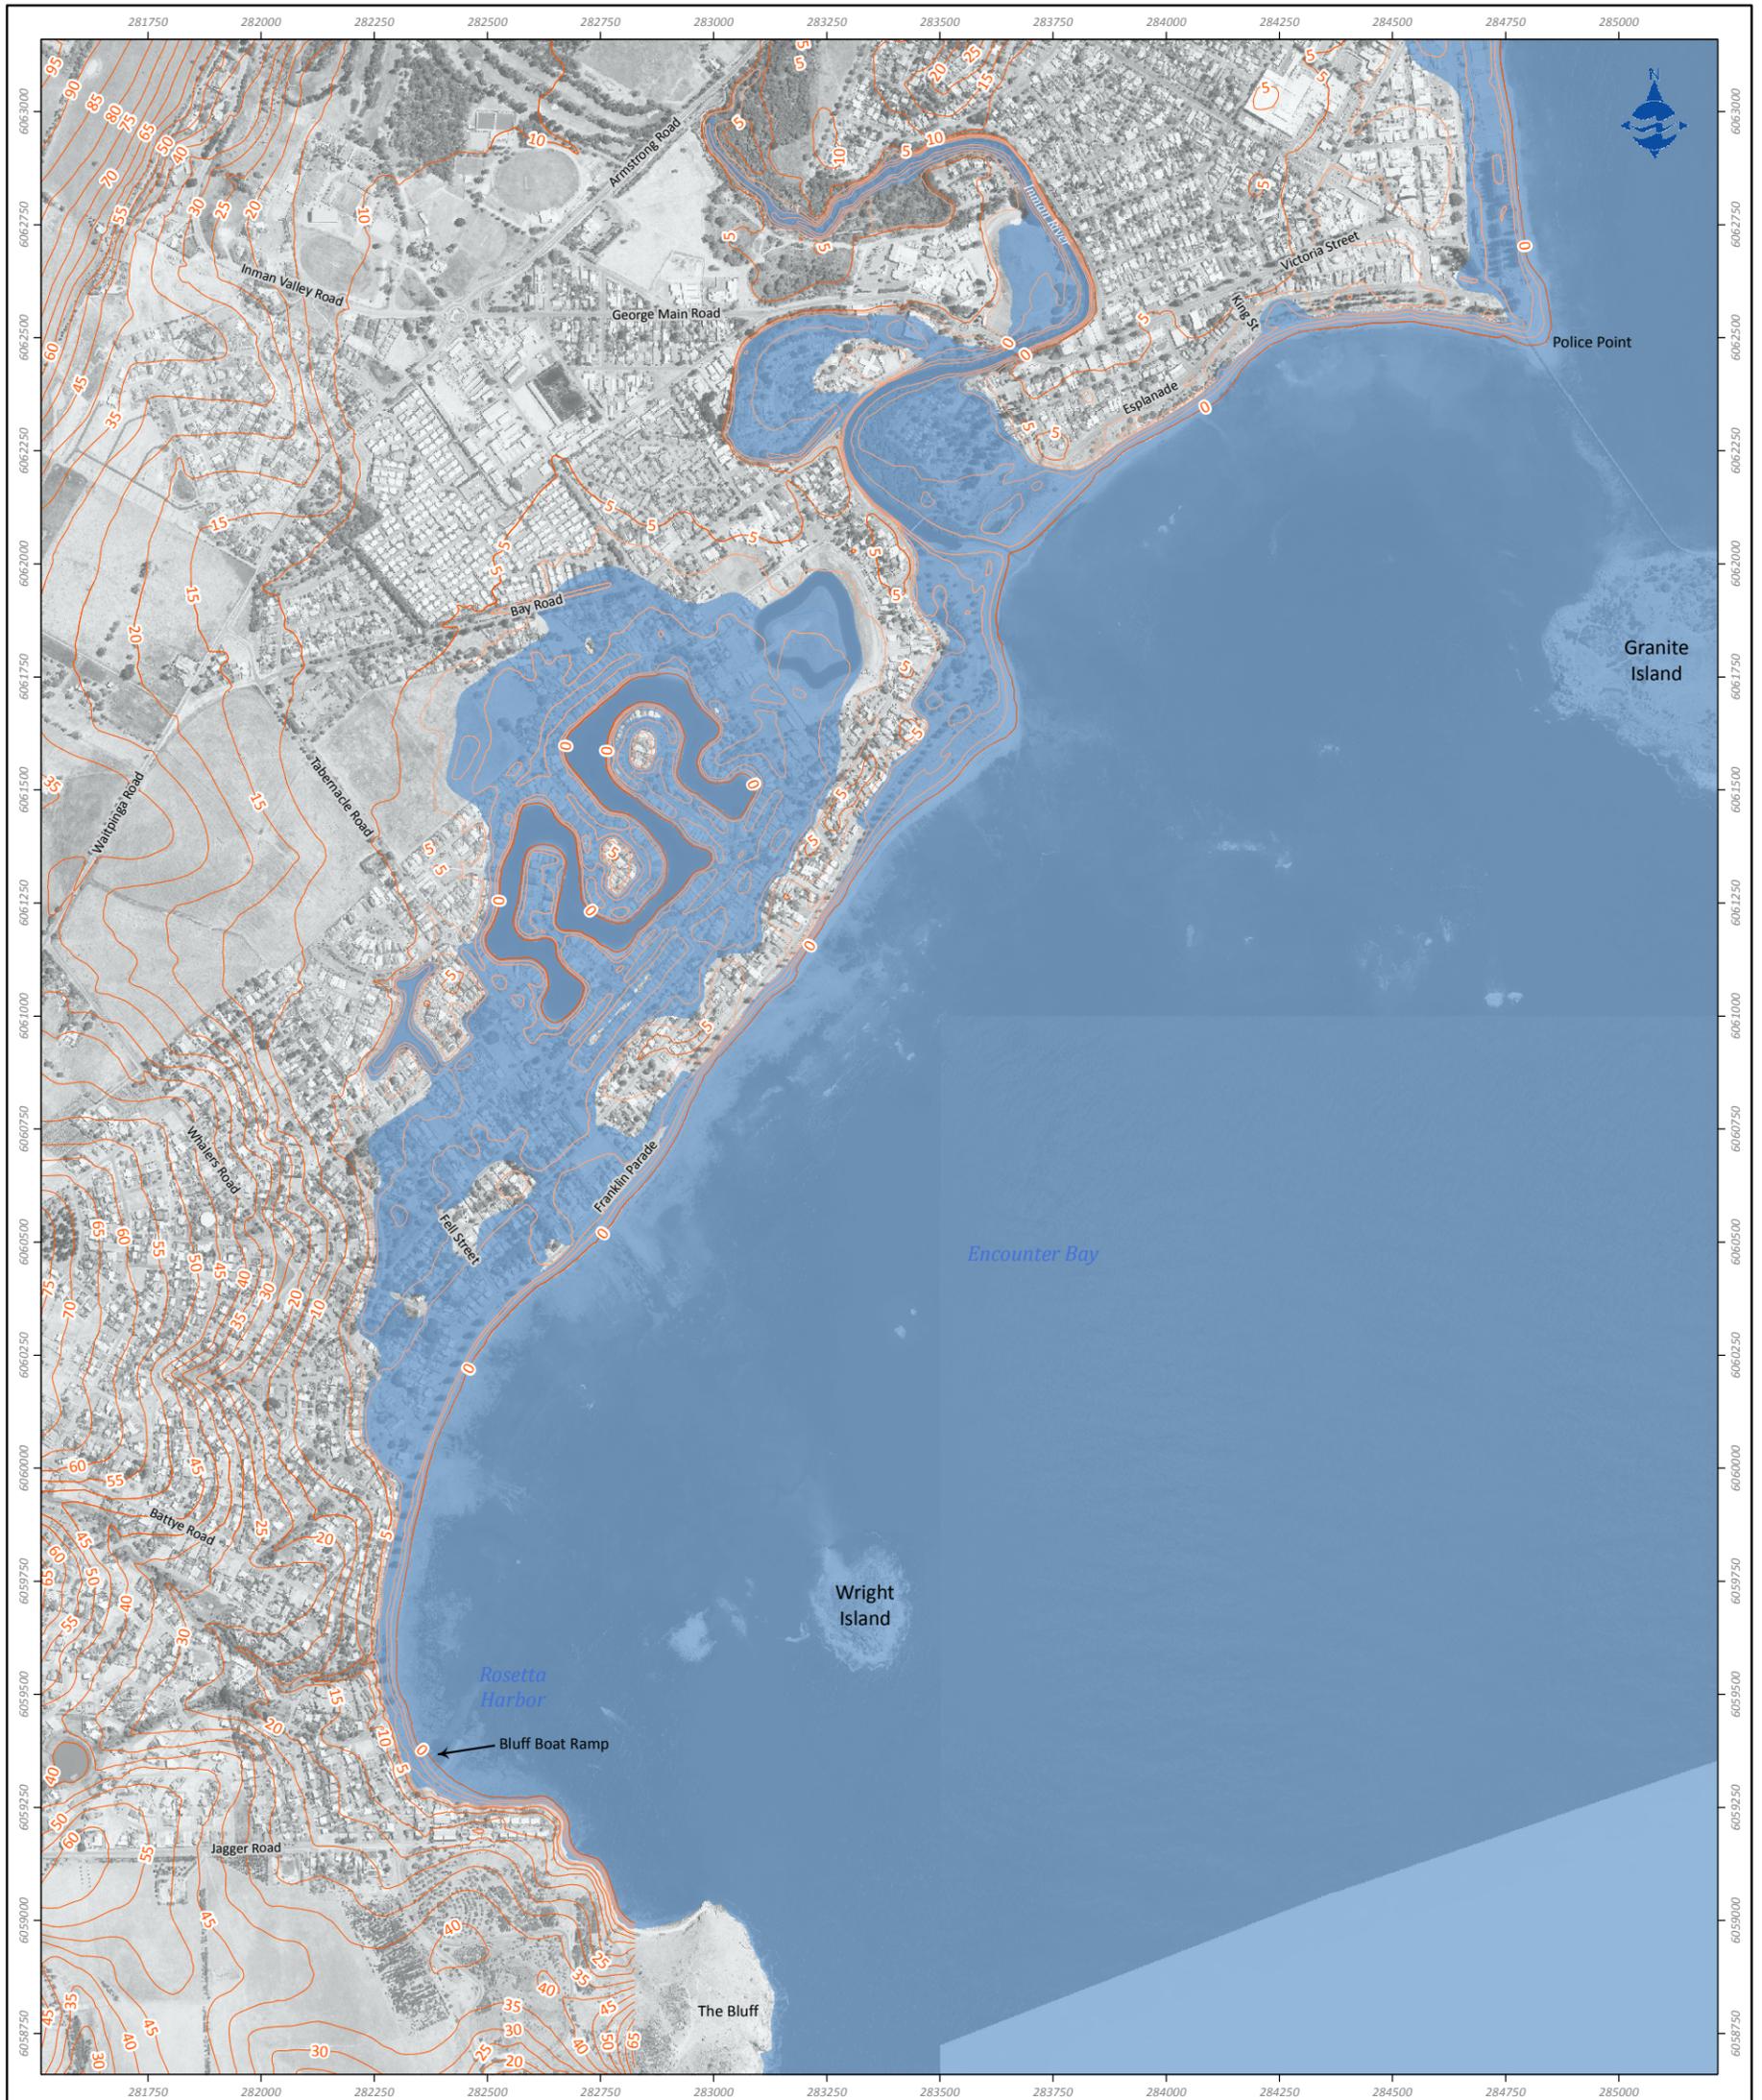
- Index Contour (5m interval)
- Intermediate Contour (1m interval, 1-4m AHD only)
- Area Below 3.35 m AHD 2100

Sea Level Rise, Wave Set Up, Wave Run Up and 1 in 100 year Storm Surge Level 2100

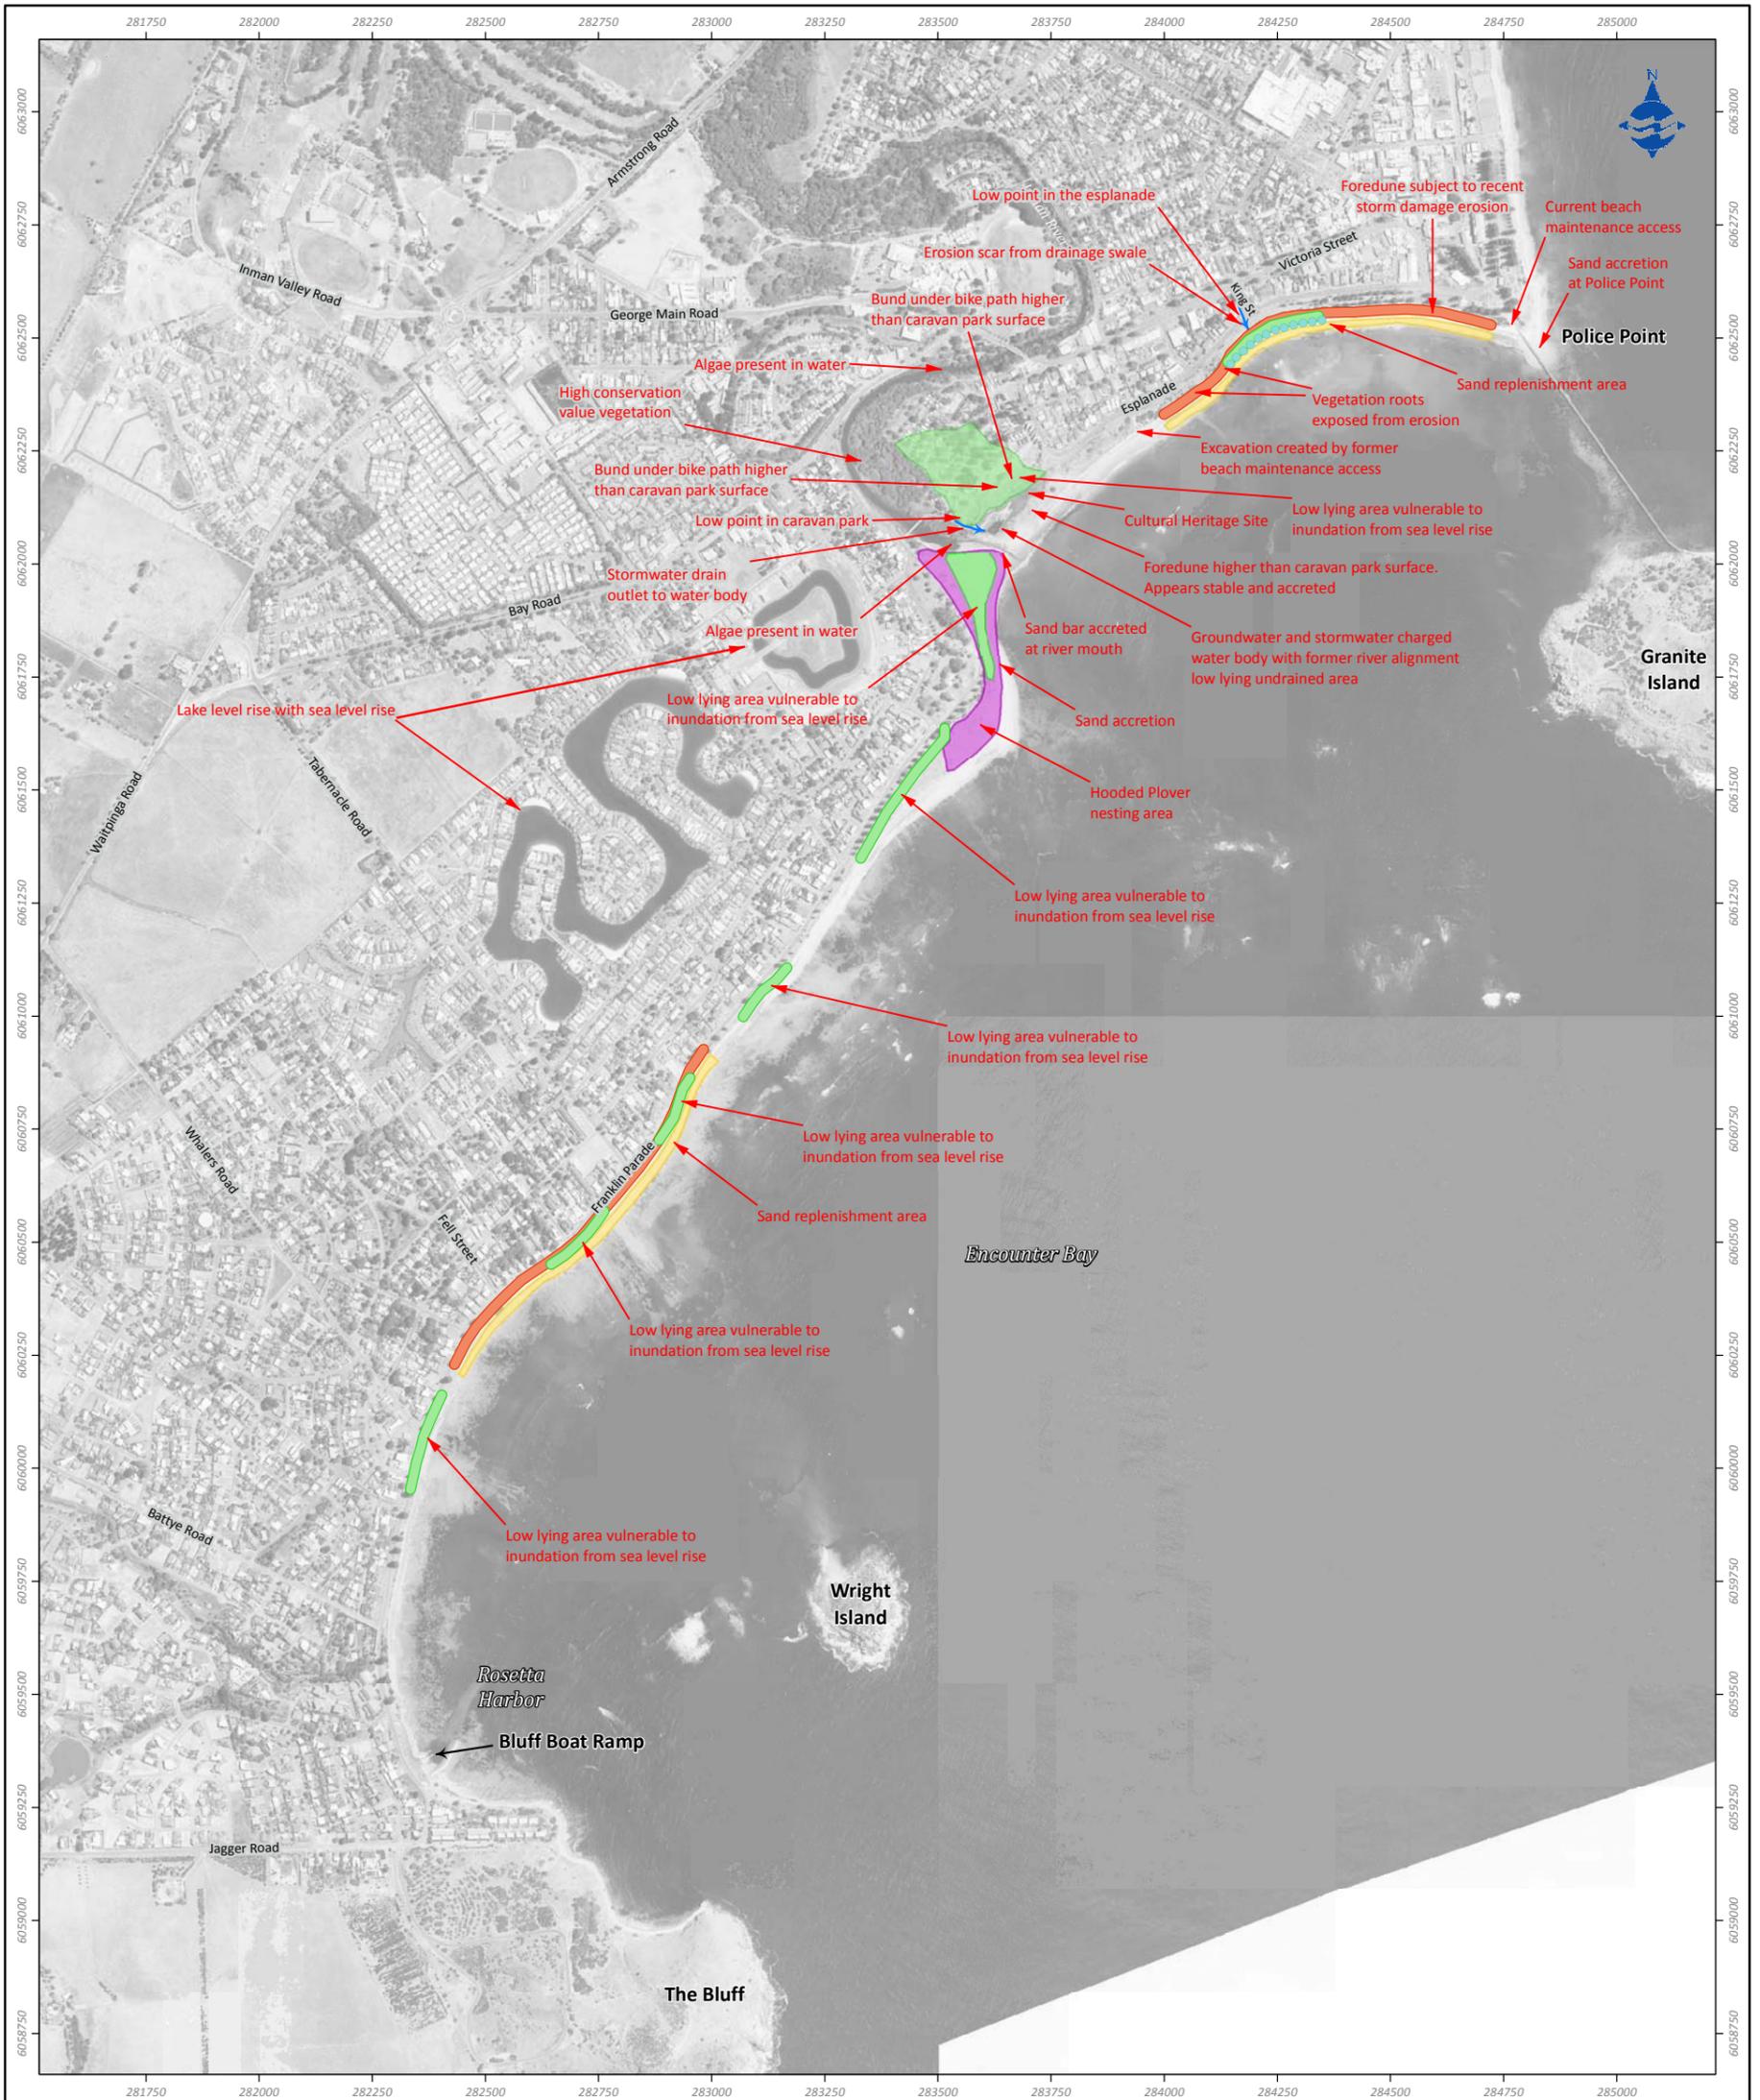
Victor Harbor Coastal Management Study
Issues and Assets

- LEGEND**
- Stormwater
 - Sand Sausage
 - Erosion
 - Low Lying Area Vulnerable to Inundation
 - Extended Low Lying Area Vulnerable to Inundation
 - Hooded Plover Nesting Area
 - Sand Replenishment Area

Data Source:
Contours and Aerial Imagery (2010) supplied by the City of Victor Harbor, Existing issues data created by Australian Water Environments.
