Coastal Adaptation Study &
Coastal Adaptation Strategy

VICTOR HARBOR CENTRAL

Cell
Fleurieu 11

For City of
Victor Harbor

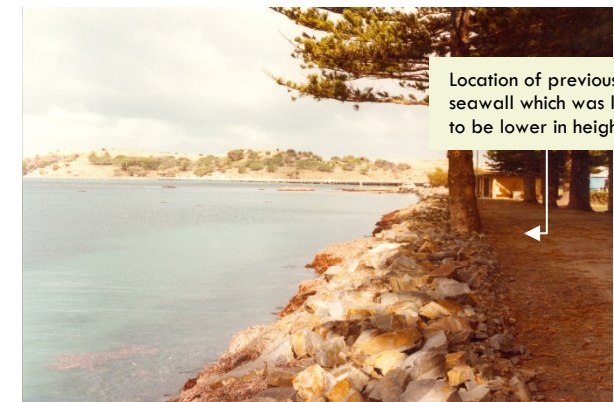
Figure d: Completed wall with line depicting the approximate location of the top of the previous seawall (Photograph: Coast Protection Board, 14 May 1987).

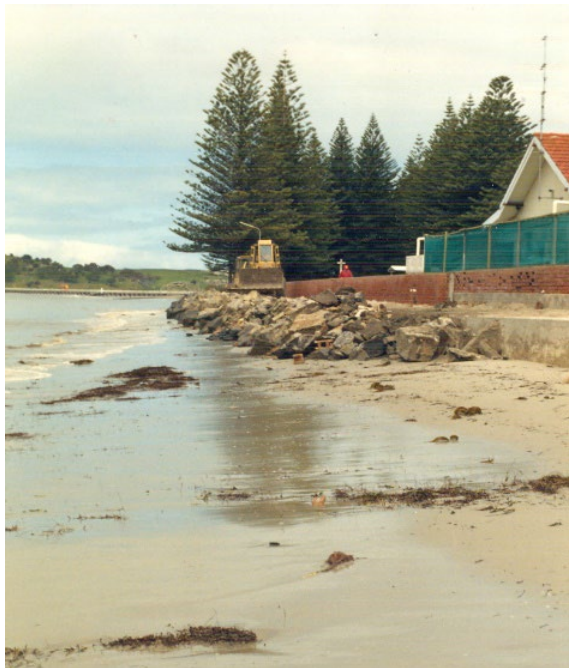
Figure a: Rock protection installed as emergency works after storms of 10-11 September 1989 (19890912, CPB).

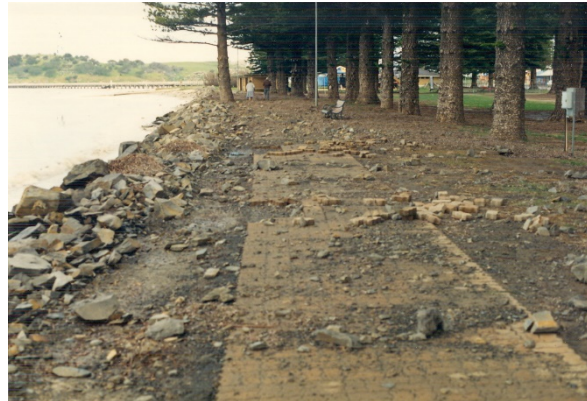
Figure b: Wave over-topping at Soldiers Memorial Gardens (Photograph: Coast Protection Board, 12 September 1989).

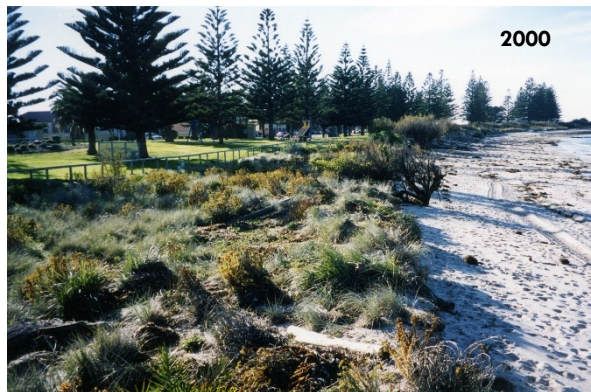
The era from 2004 to 2012 was dominated by concerns of erosion to The Esplanade beach between Inman River and the causeway. Residents and Council report that increases in erosion occurred from about 2000²⁶, especially in the vicinity of King Street.

Figure a: Foreshore in vicinity of King Street in 2000. (CPB, 20000101).

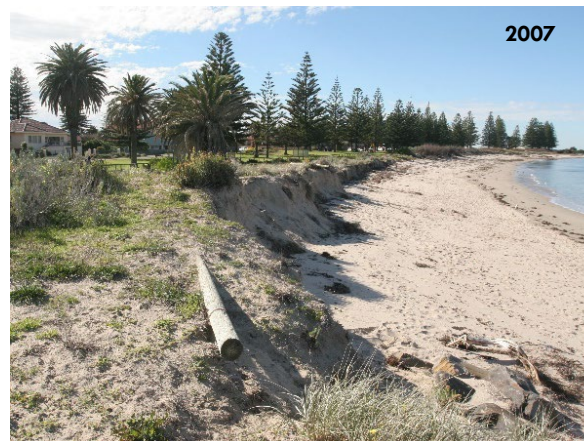
Figure c: Foreshore in vicinity of King Street in 2007 (CPB, 20070724).

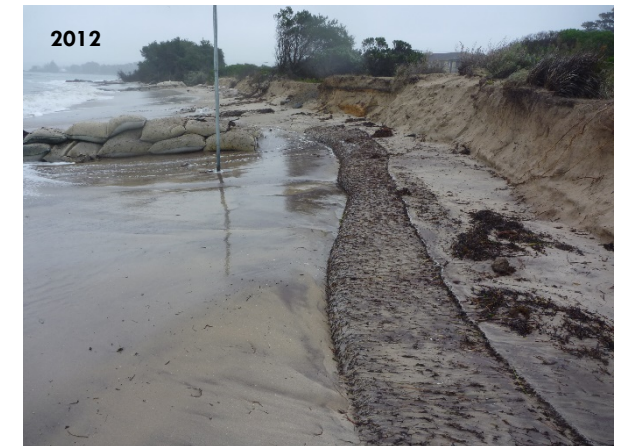
Tide heights for pictured events 4 June 2012 was 1.353m CD and 30 April 2014 was 1.458m CD. The likely cause of erosion was increased storminess in this time period. (See also exposure section for analysis).

Figure d: Foreshore in vicinity of King Street in 2012, reverse angle from 2004, 2007 (CPB, 20120604).

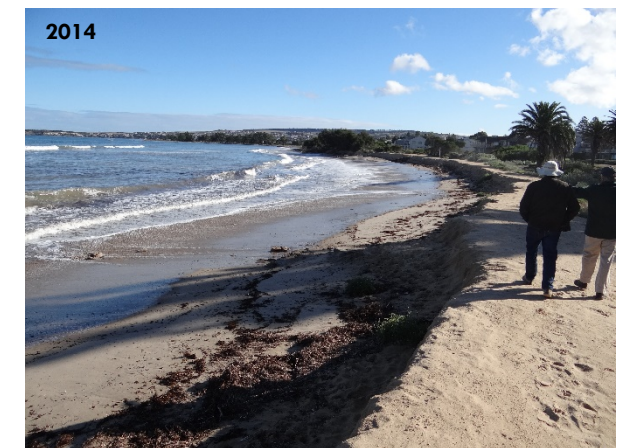
Figure d: Foreshore in vicinity of King Street in 2012, after sand nourishment (see next pages) (CPB, 20140430).

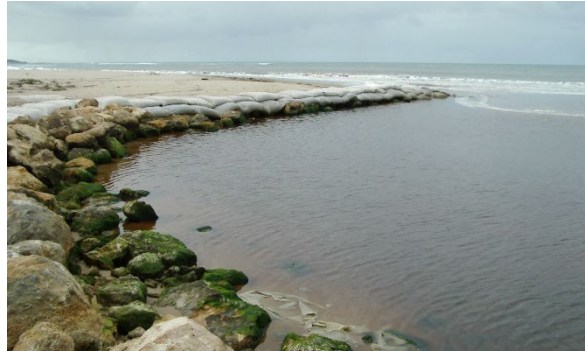
Figure a: Hindmarsh River – training groyne (CPB, 20040810).

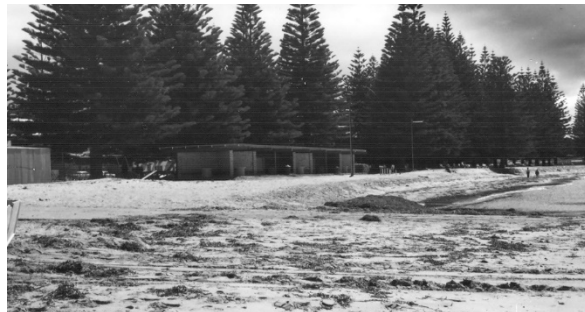
Figure b: Sand nourishment (CPB, 19760301).

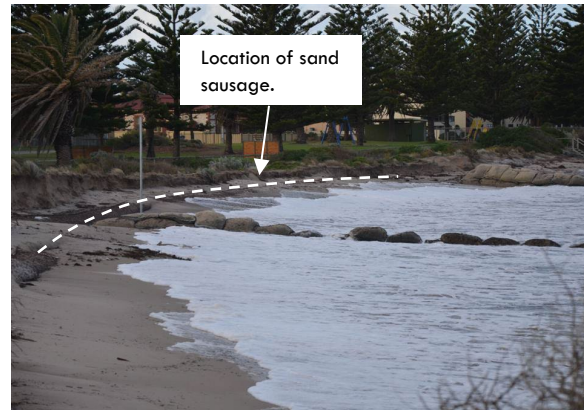
Figure a: Sand sausage installed along the beach near King Street; sandbag groynes installed perpendicular to the beach (CPB, 20120604).

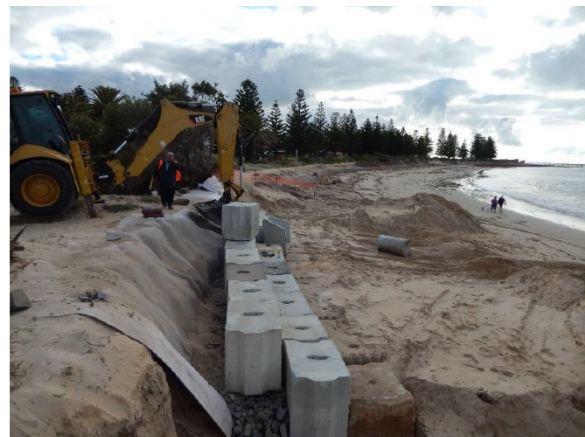
Figure b: Concrete blocks installed in backshore near King Street, covered with sand and vegetated (Email_CMB_20210217).

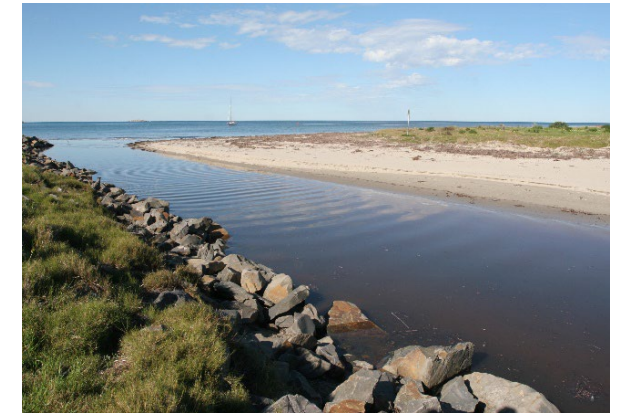
Figure c: Mouth of Inman River realigned, and rock training wall added in 1997. (CPB, 20070724).

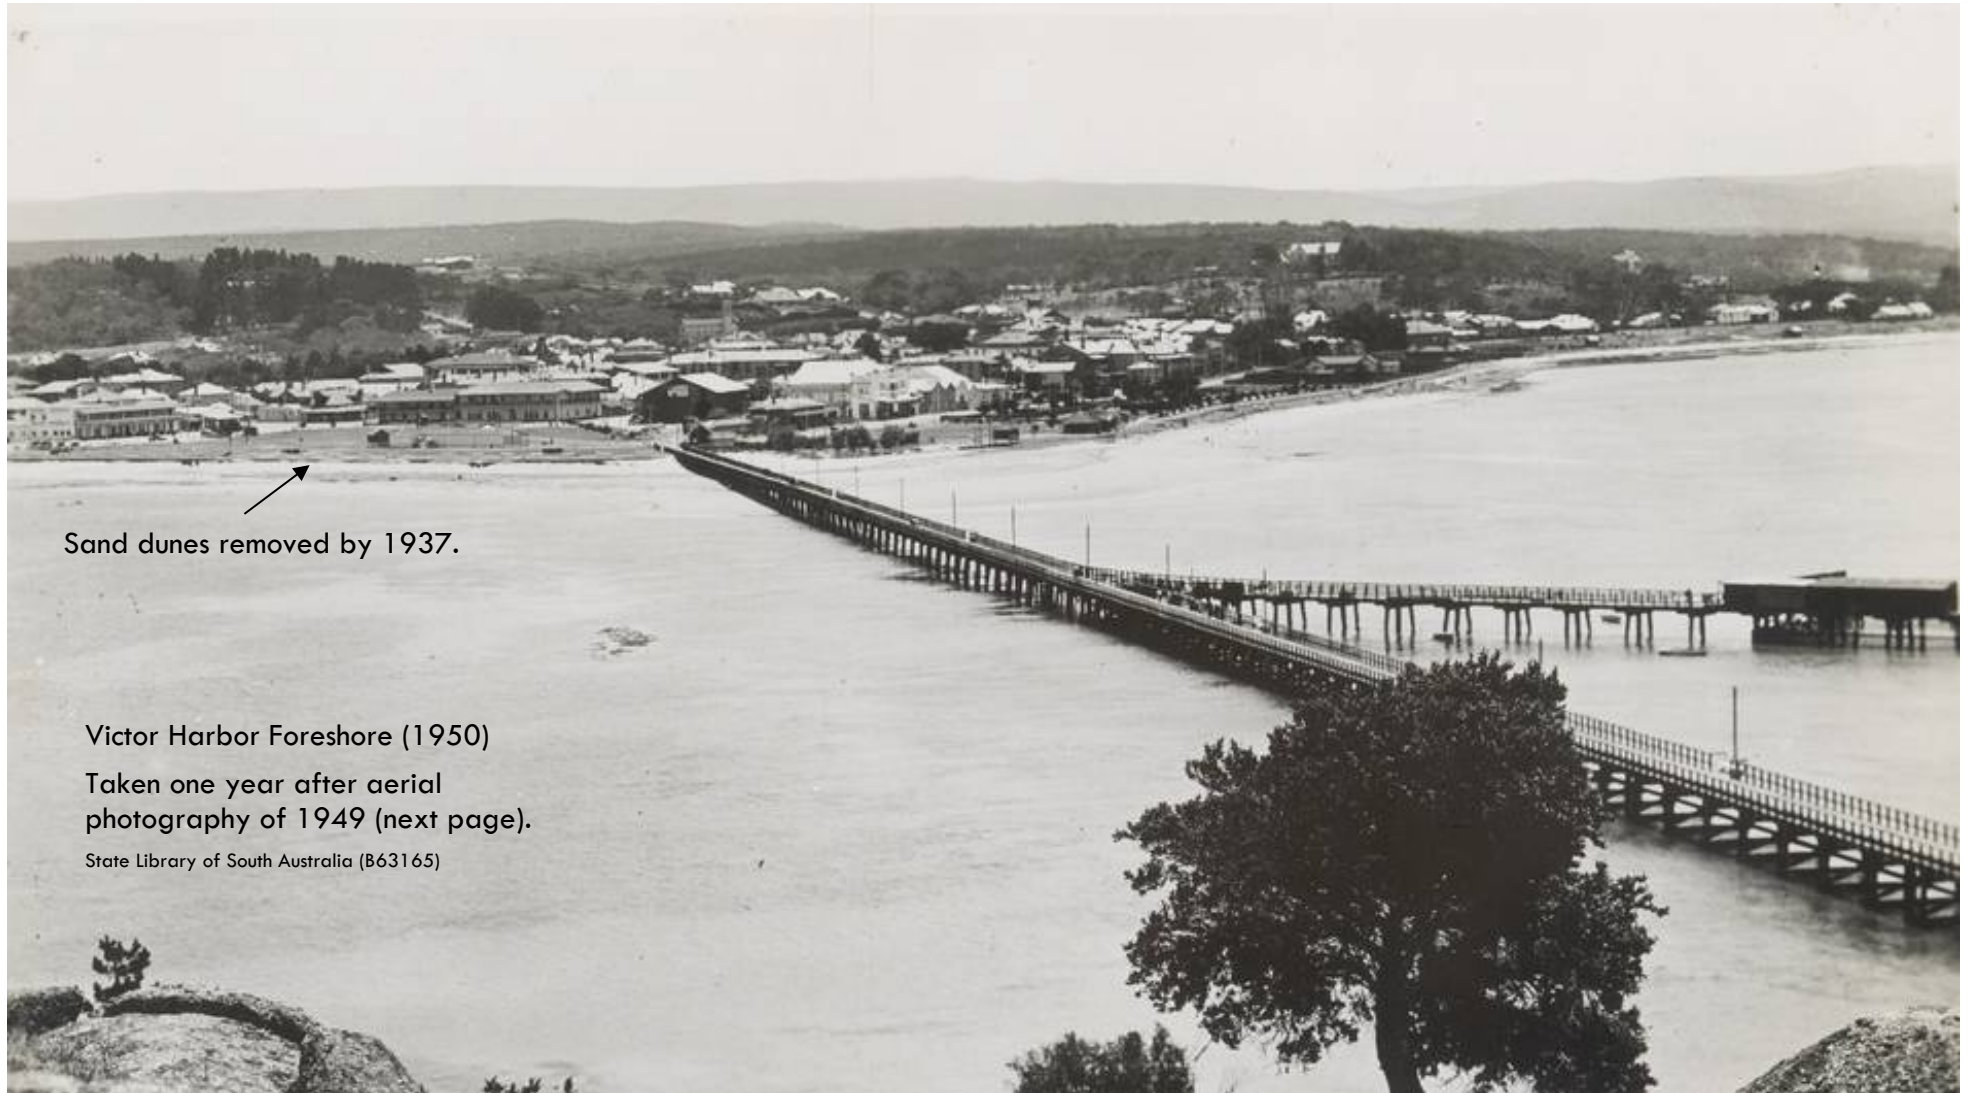
Victor Harbor Foreshore (1950)

Sand dunes removed by 1937.

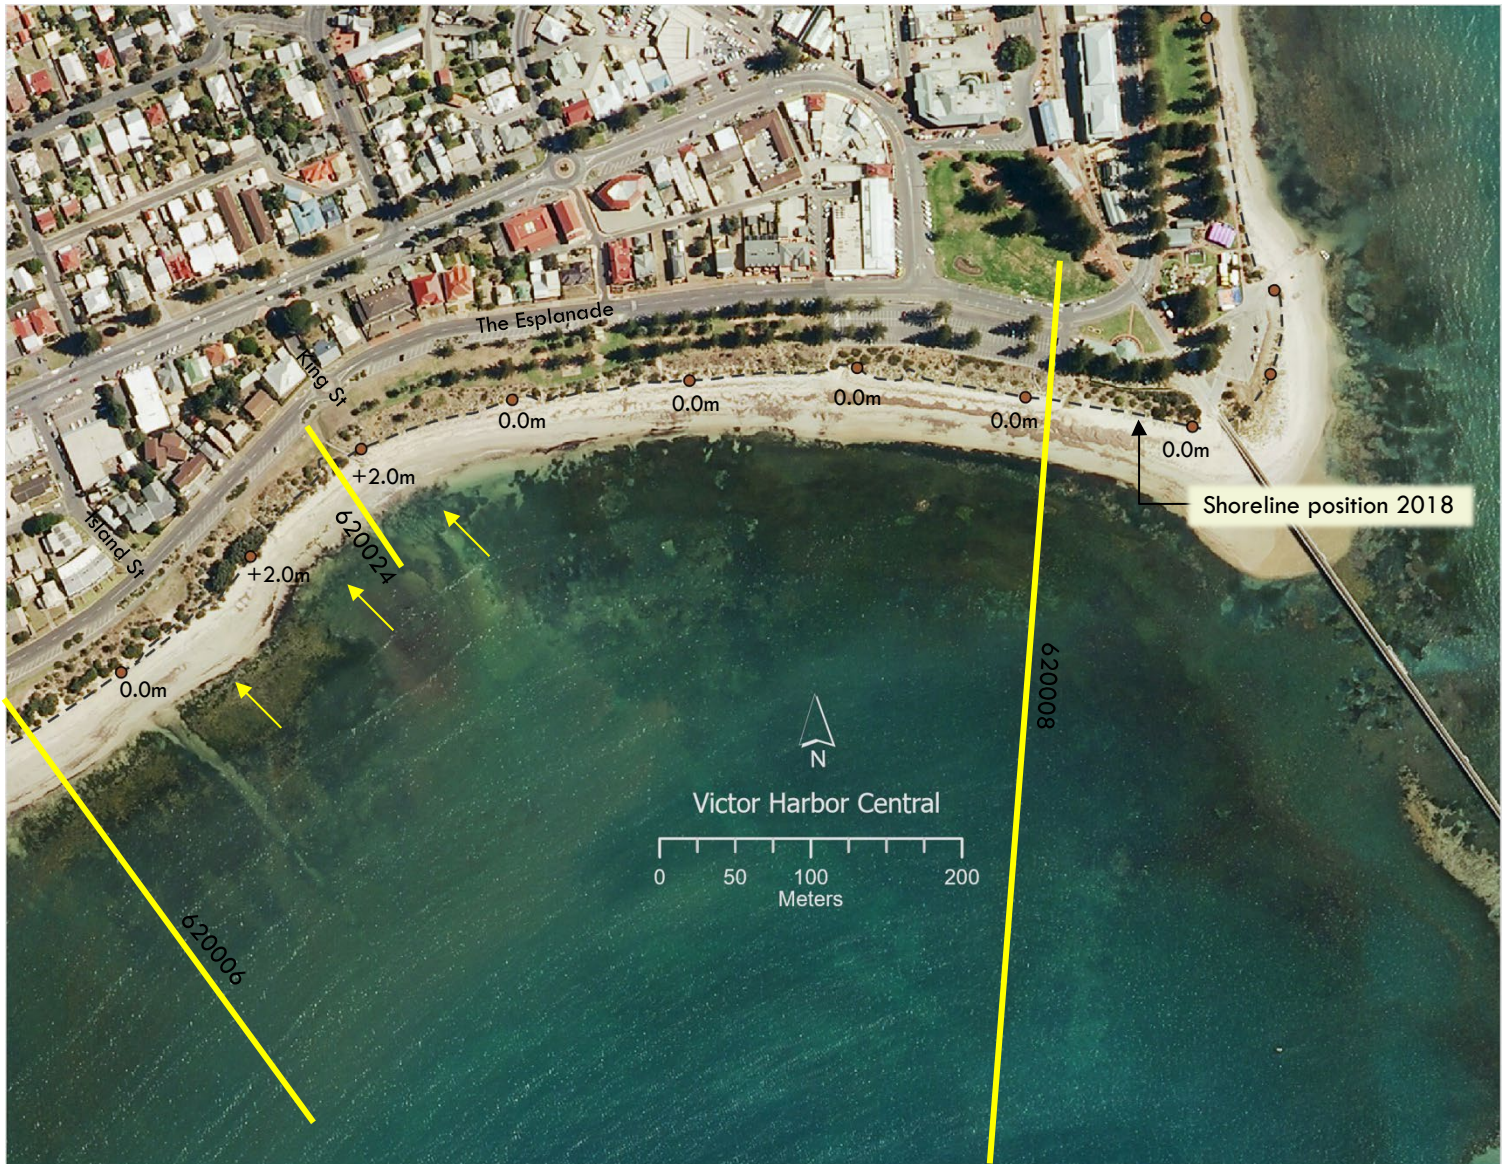
The shoreline in vicinity of King Street a total of 11 m since 2004 and increased erosion occurred near the causeway. Sand nourishment was carried out in the King Street area in 2012.

The curve in the bay at King Street was likely formed partly due to the nature of the wave action in this area combined with a gap between the reef (see 1949). The higher consistent storm action 2004 to 2011 had the greatest impact here. These factors also noted by Richard House (Victor Harbor Coastcare) in 2012.

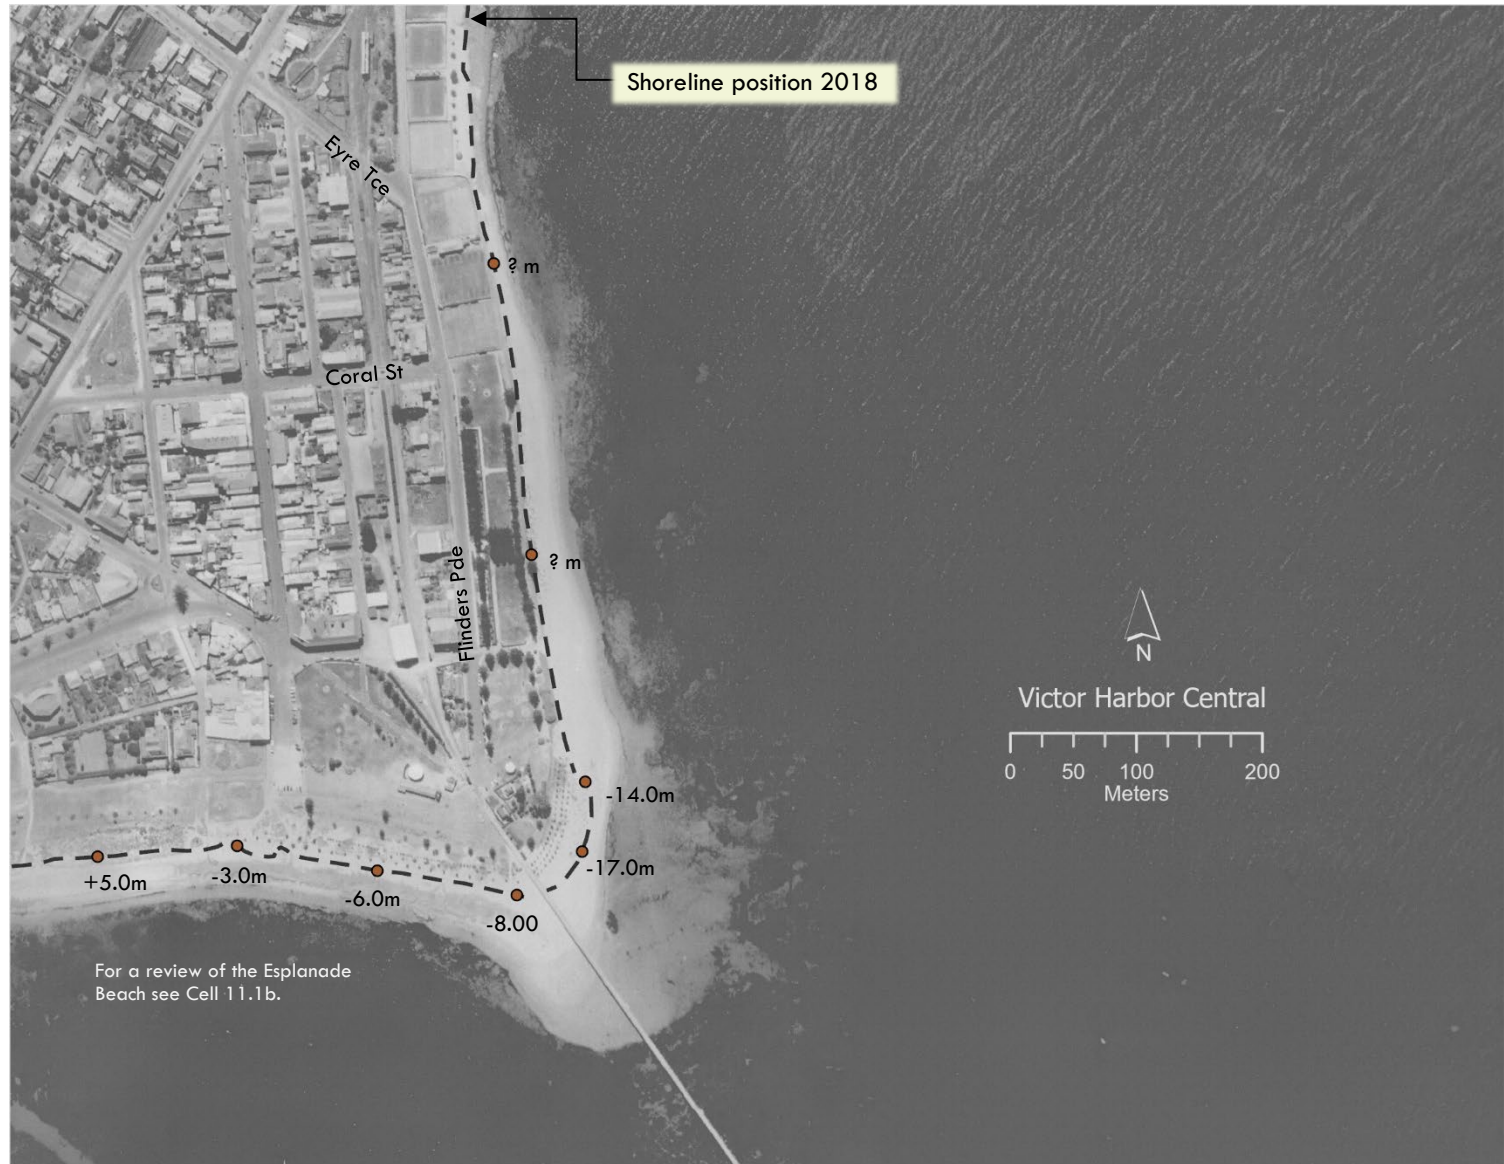
The boat ramp was installed in the 1970s (?) and acts as a groyne preventing sand from moving northward. A car park was constructed in the former dune to the east of the causeway. (This was likely used as a 'dirt' car park for some time before construction). These two factors are likely reasons for loss of sand on the beach to the north.

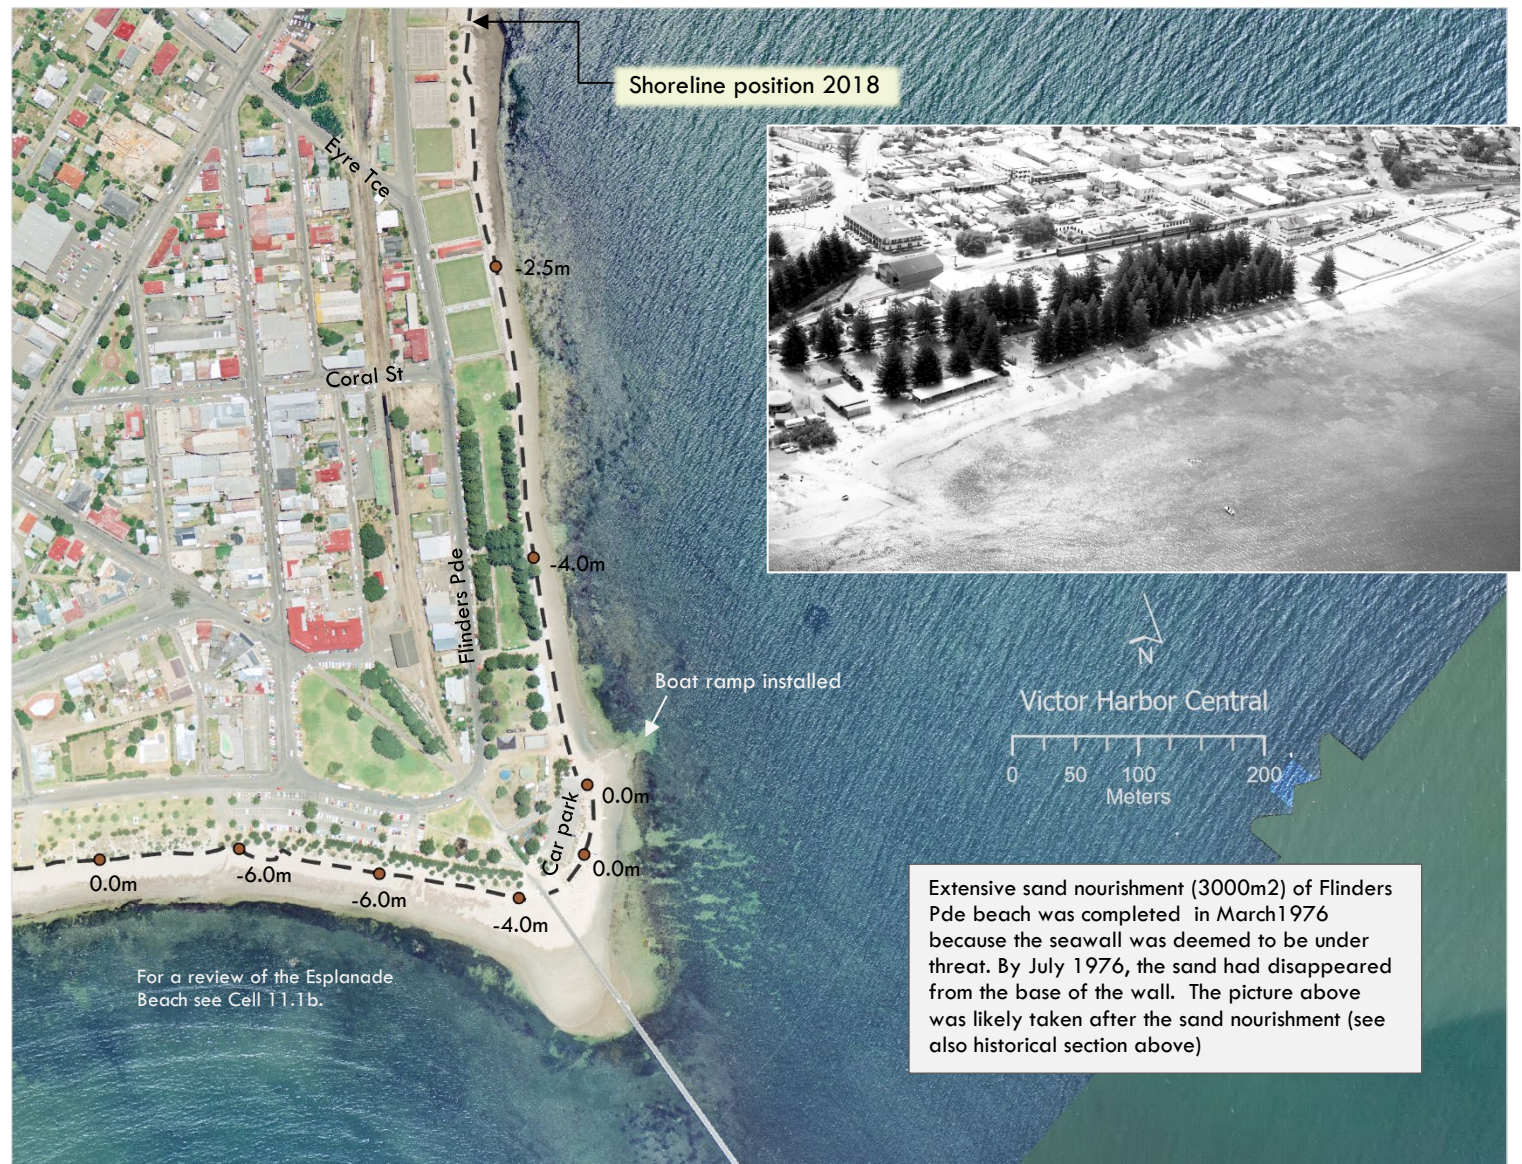
Note the lack of sand along Flinders Parade beach (but also take into account that the tide is higher in this picture).

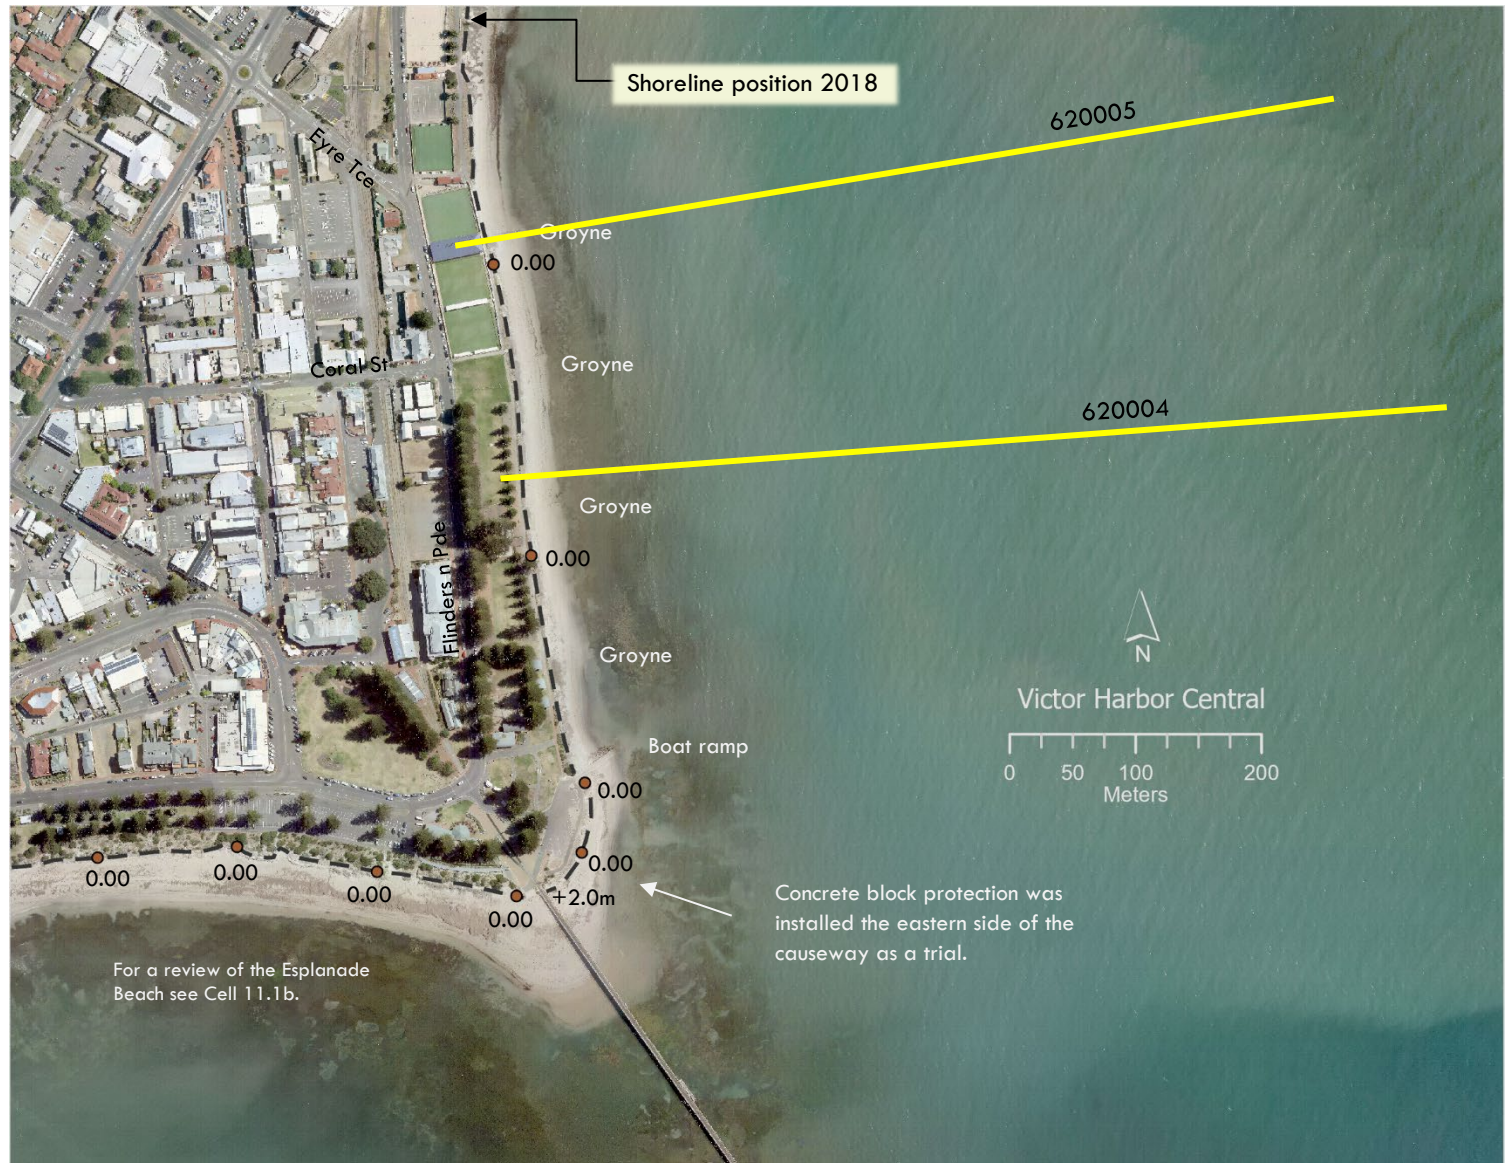
Sandbag groynes were introduced in 2008 which seem to have increased the volume of sand. The node of sand to the east of the causeway receded and concrete block protection was installed.

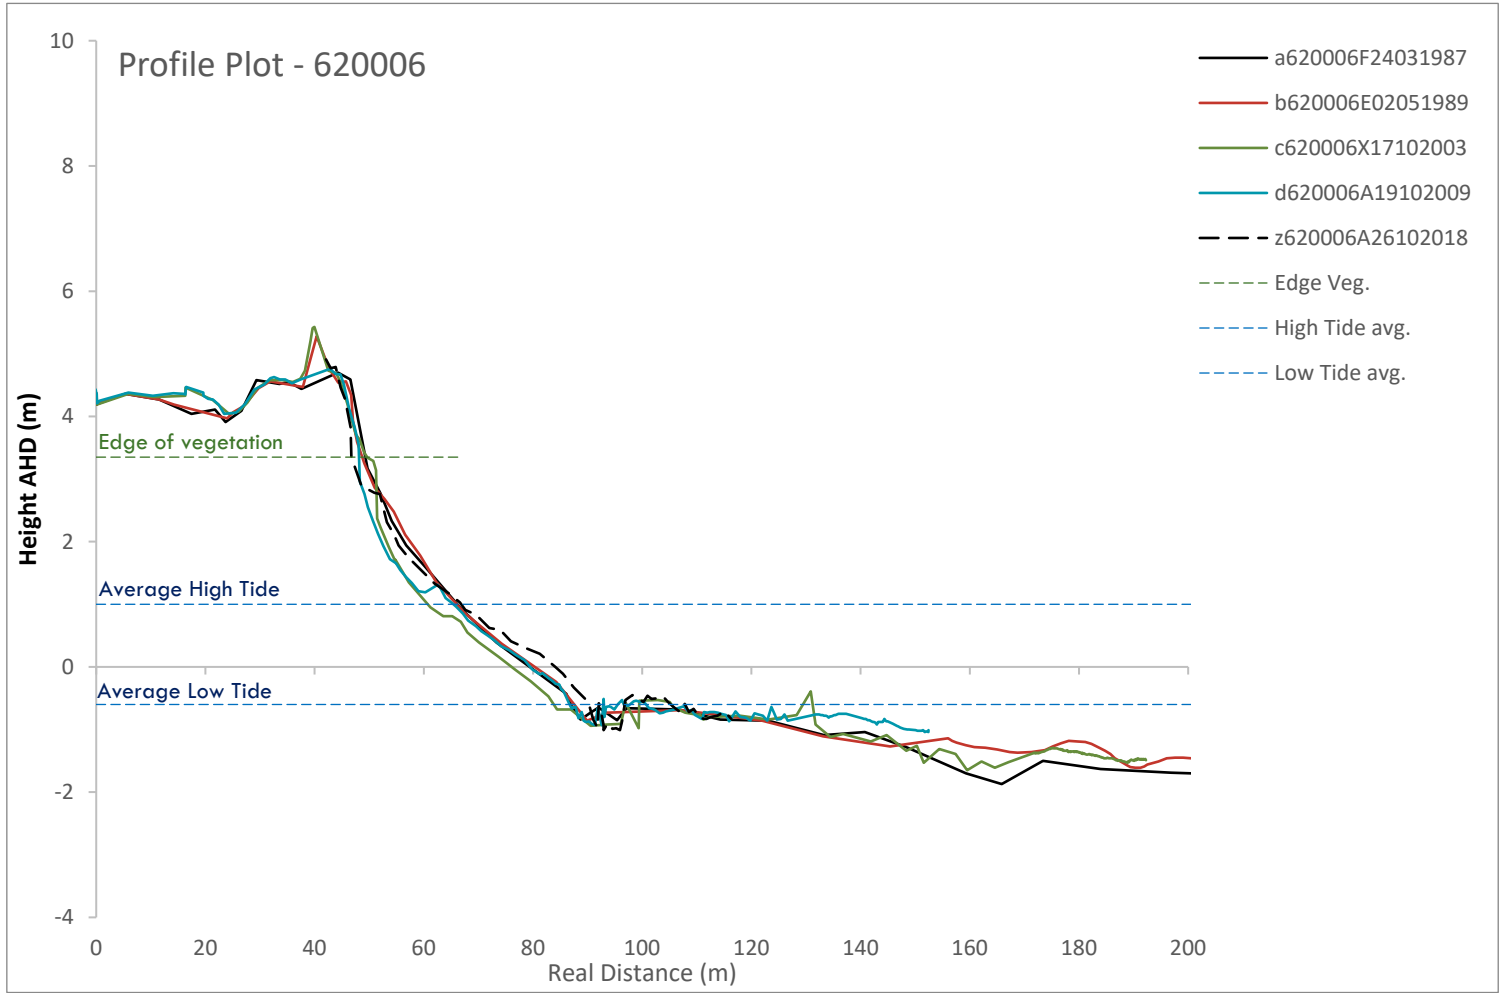
The escarpment between +4.5m and +2.7m elevation has generally undergone minor erosion and has translated landward between 1987 and 2018 by a total distance of ~1m.

Sand levels in 2018 in the intertidal zone were higher than at any other historical profile.

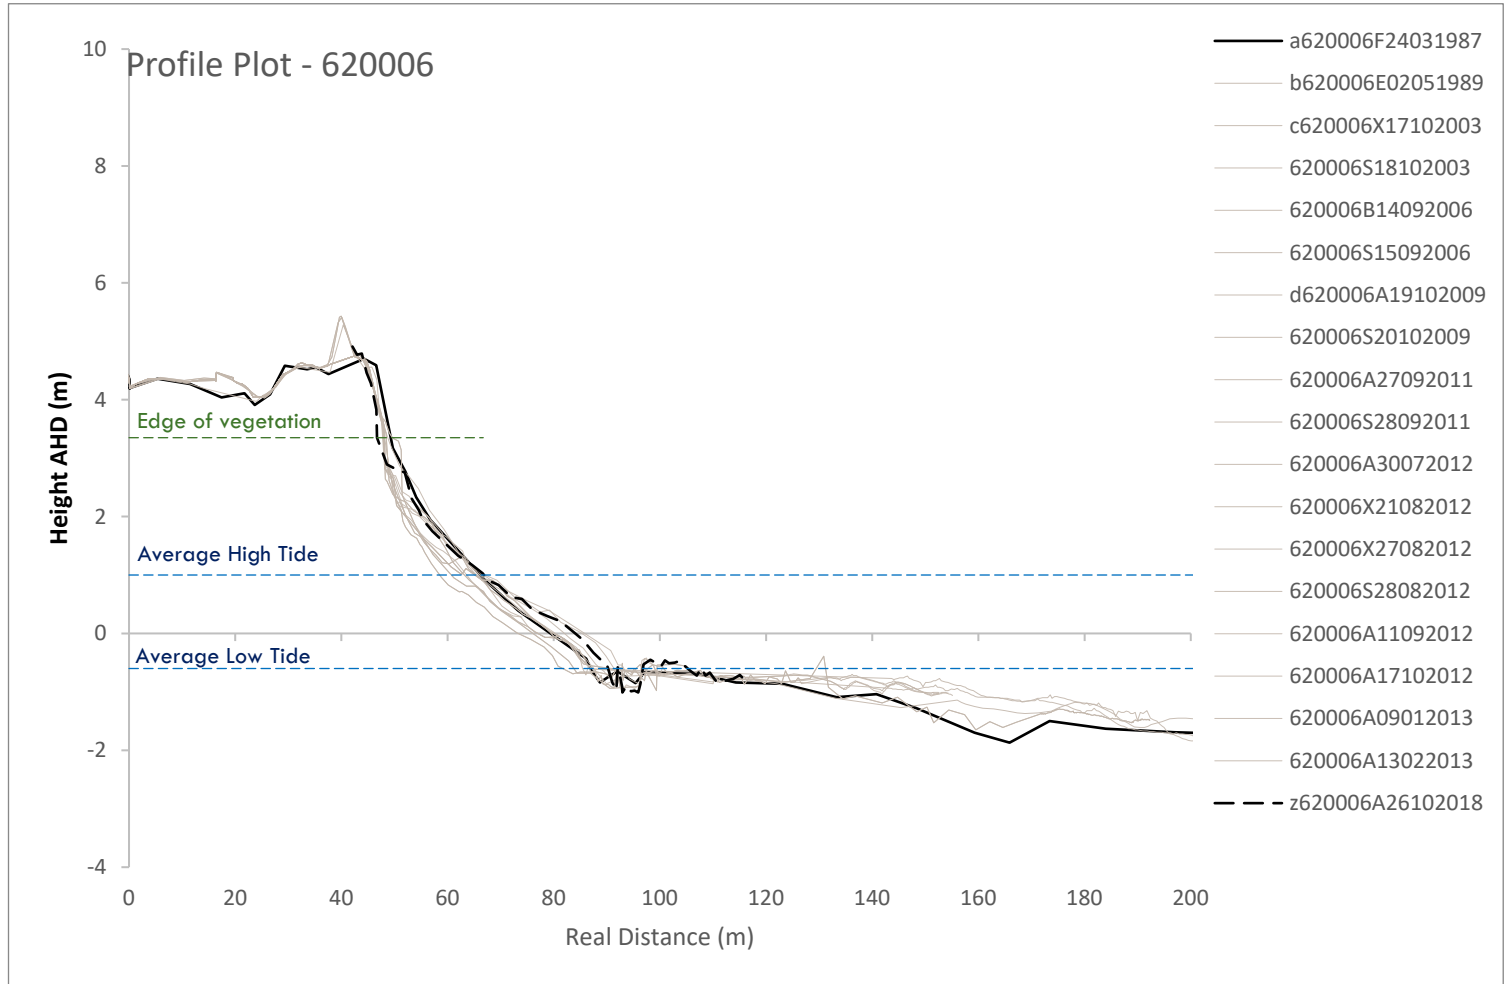
At elevations below 2.7m the 1987 and 2018 profiles are well correlated, notably all other profiles are more eroded. This would suggest an erosional pattern has been balanced by an accretional pattern in the subaerial zone for the monitoring time period (1986 to 2018) that ranges around 5m horizontally.

The upper portion of the escarpment (above 2.5m+ AHD) is undergoing erosion and it is possible that natural beach processes will be unable to restore sediment levels to 1986 levels in this location. Below the average tide line, all profiles are above 1987. The profile of 2018 was not taken below the low tide line and therefore current comparison cannot be made.

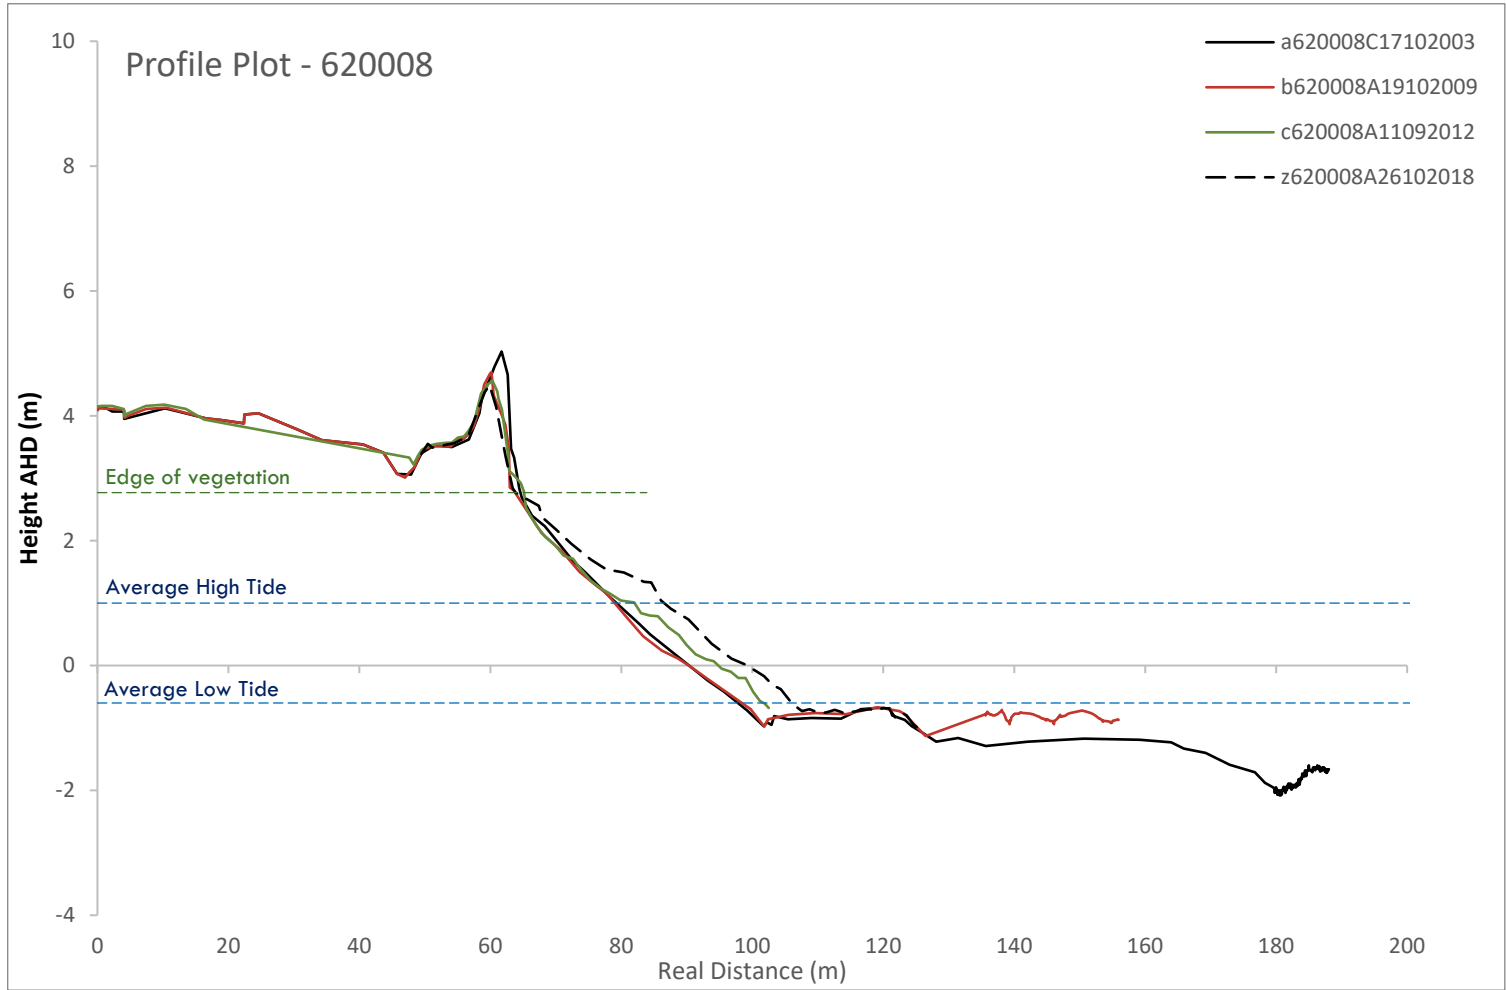
The Esplanade Beach (Near causeway) 620008

This is an area where Council has been accumulating sand mixed with seaweed wrack over the last ten years.

There is a noticeable erosion of the high point of the scarp and the steep face that indicates an erosion event after 2003 which has not been repeated. The material lost has not been replaced. (Note, 2004 was a significantly 'stormy' year).

The 2018 profile is the most accretional of all of the selected profiles. However, the 2018 survey was not continued into the subtidal zone, so no comparison is possible lower than the average low tide line.

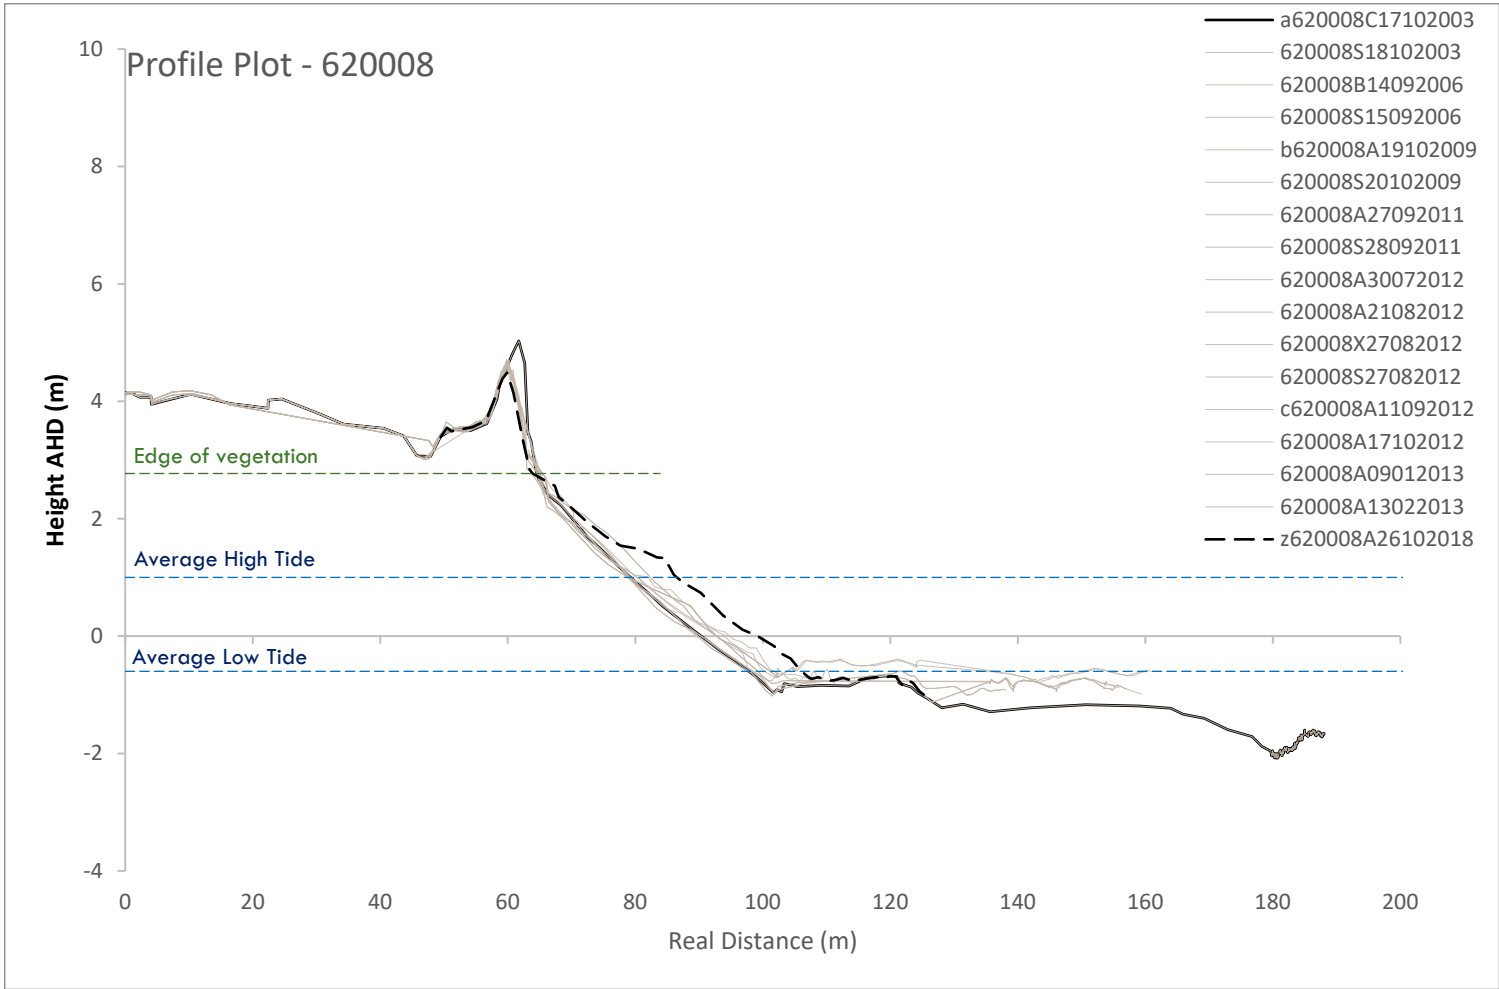
The Esplanade Beach (Near causeway) 620008

The beach in general has moved through a horizontal range of ~5m and has steadily accreted, building seawards from 2003 to 2018.

Note: This is an area where Council has been accumulating sand mixed with seaweed wrack over the last ten years.

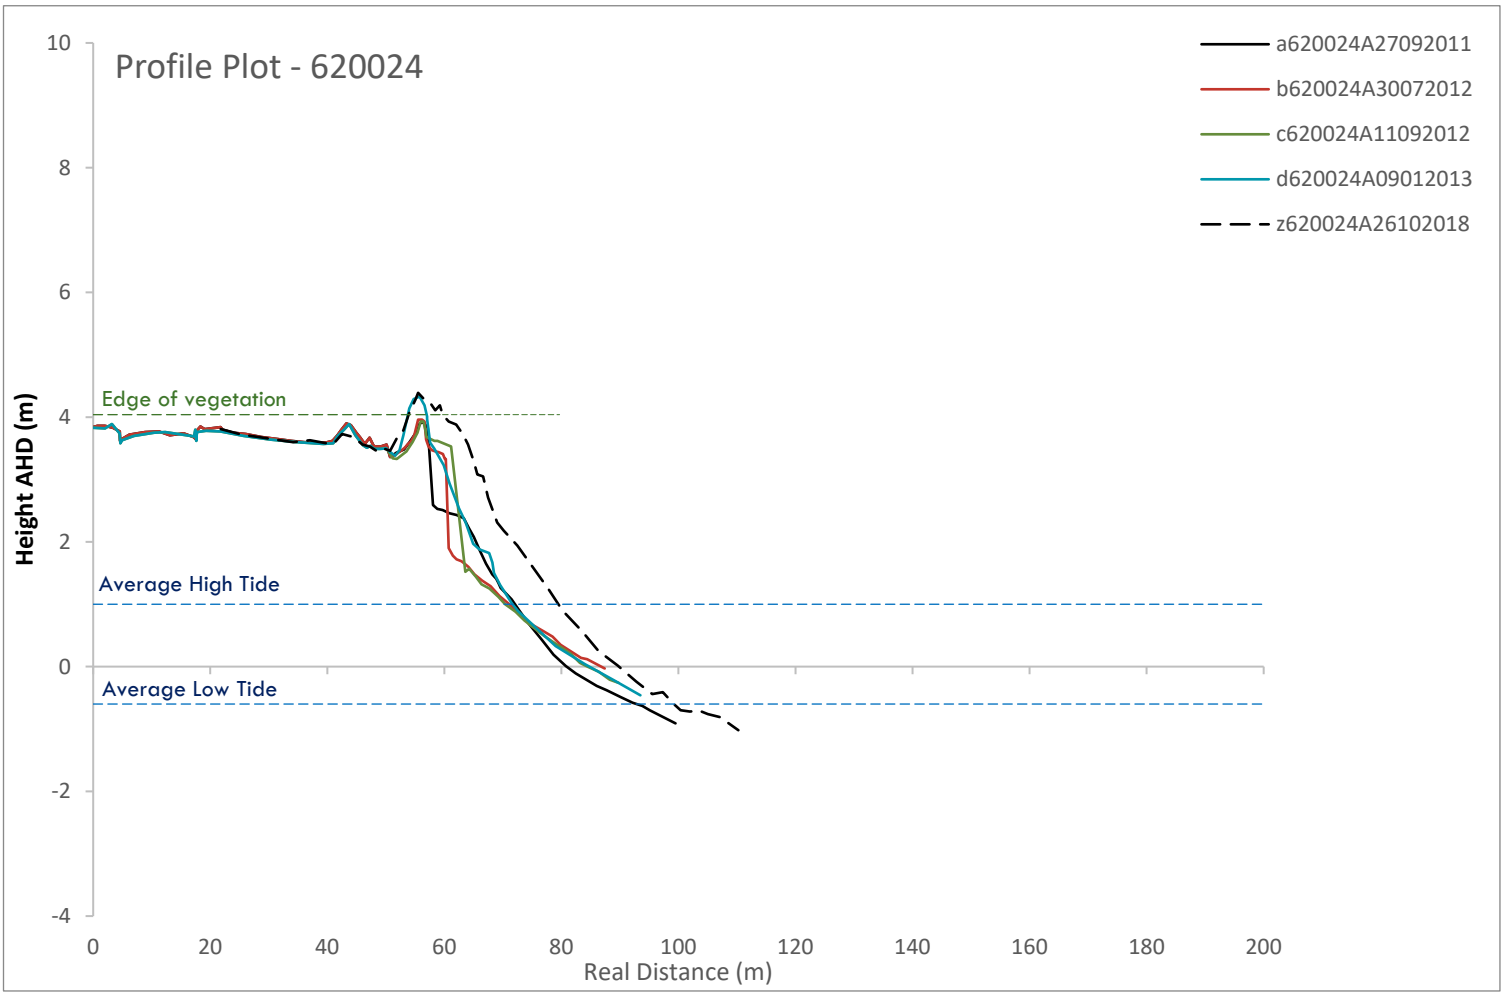
This profile was initiated due to the significant erosion that occurred 2004 to 2011 (likely caused by increased storminess in this era).

This section was sand nourished in 2012 which is observed in the square edge of the 2012 profile. The beach has accreted naturally from 2013 to 2018. However, this section of coast receded ~11m in period 2004 to 2011.

Therefore, this recent accretional pattern is mostly related to the beach recovering from a period of increased storminess (2004 to 2011), aided by the beach nourishment implemented in 2012.

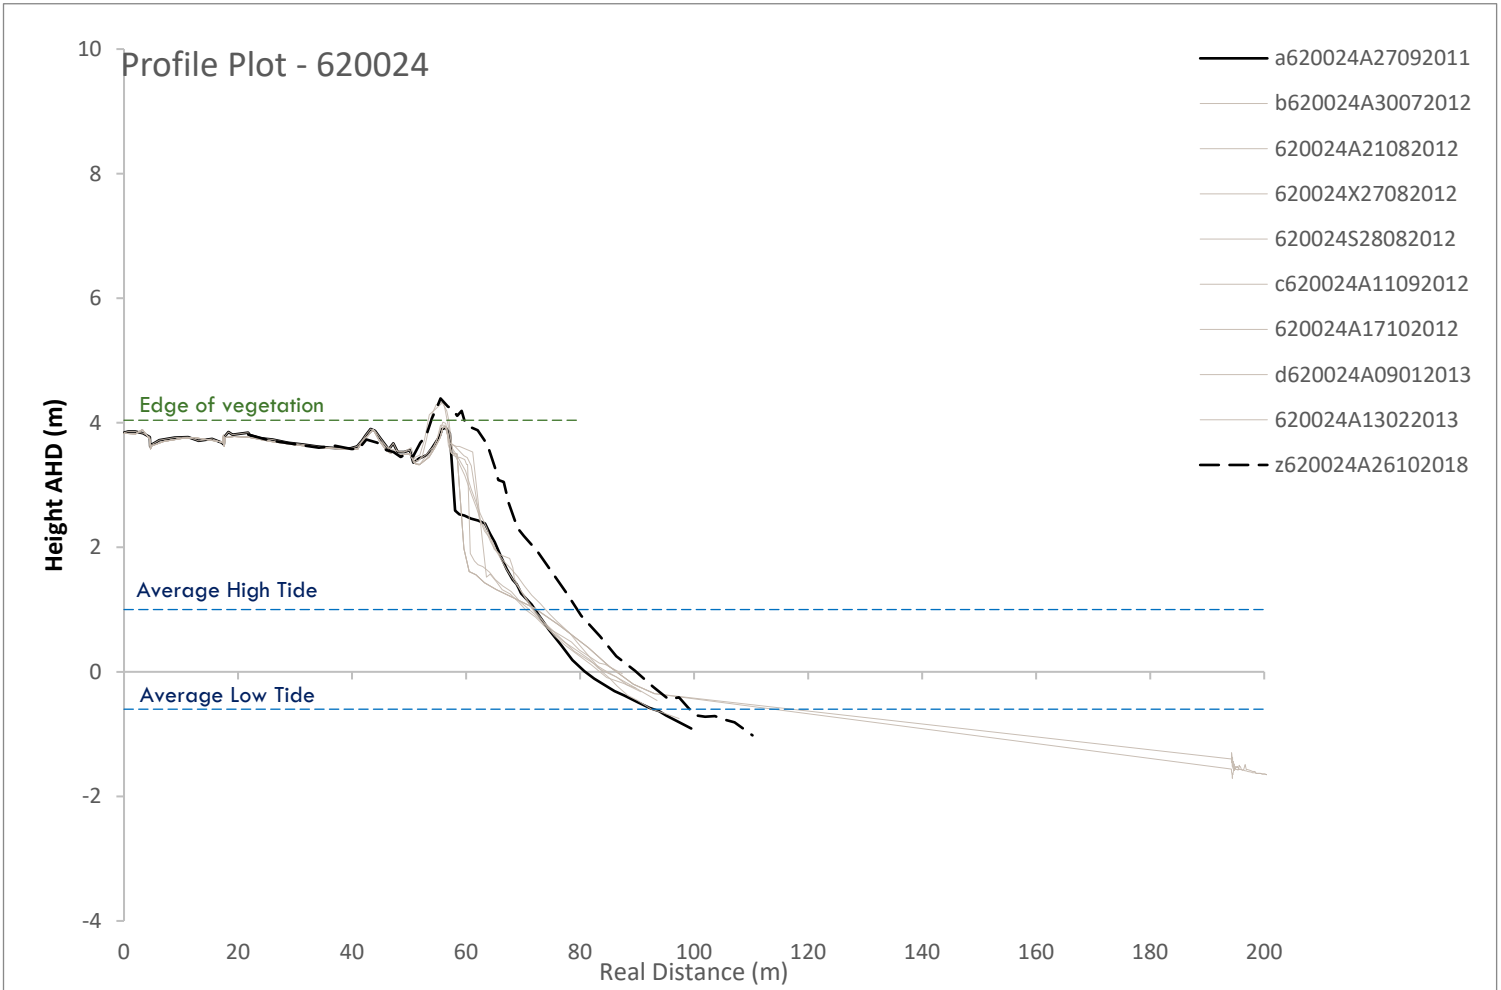
This section was sand nourished in 2012 which is observed in the square edge of the 2012 profile. The beach has accreted naturally from 2013 to 2018. However, this section of coast receded ~11m in period 2004 to 2011.

Therefore, this recent accretional pattern is mostly related to the beach recovering from a period of increased storminess (2004 to 2011), aided by the beach nourishment implemented in 2012.
