Coastal Adaptation Study &
Coastal Adaptation Strategy

VICTOR HARBOR CENTRAL

Cell
Fleurieu 11

For City of
Victor Harbor

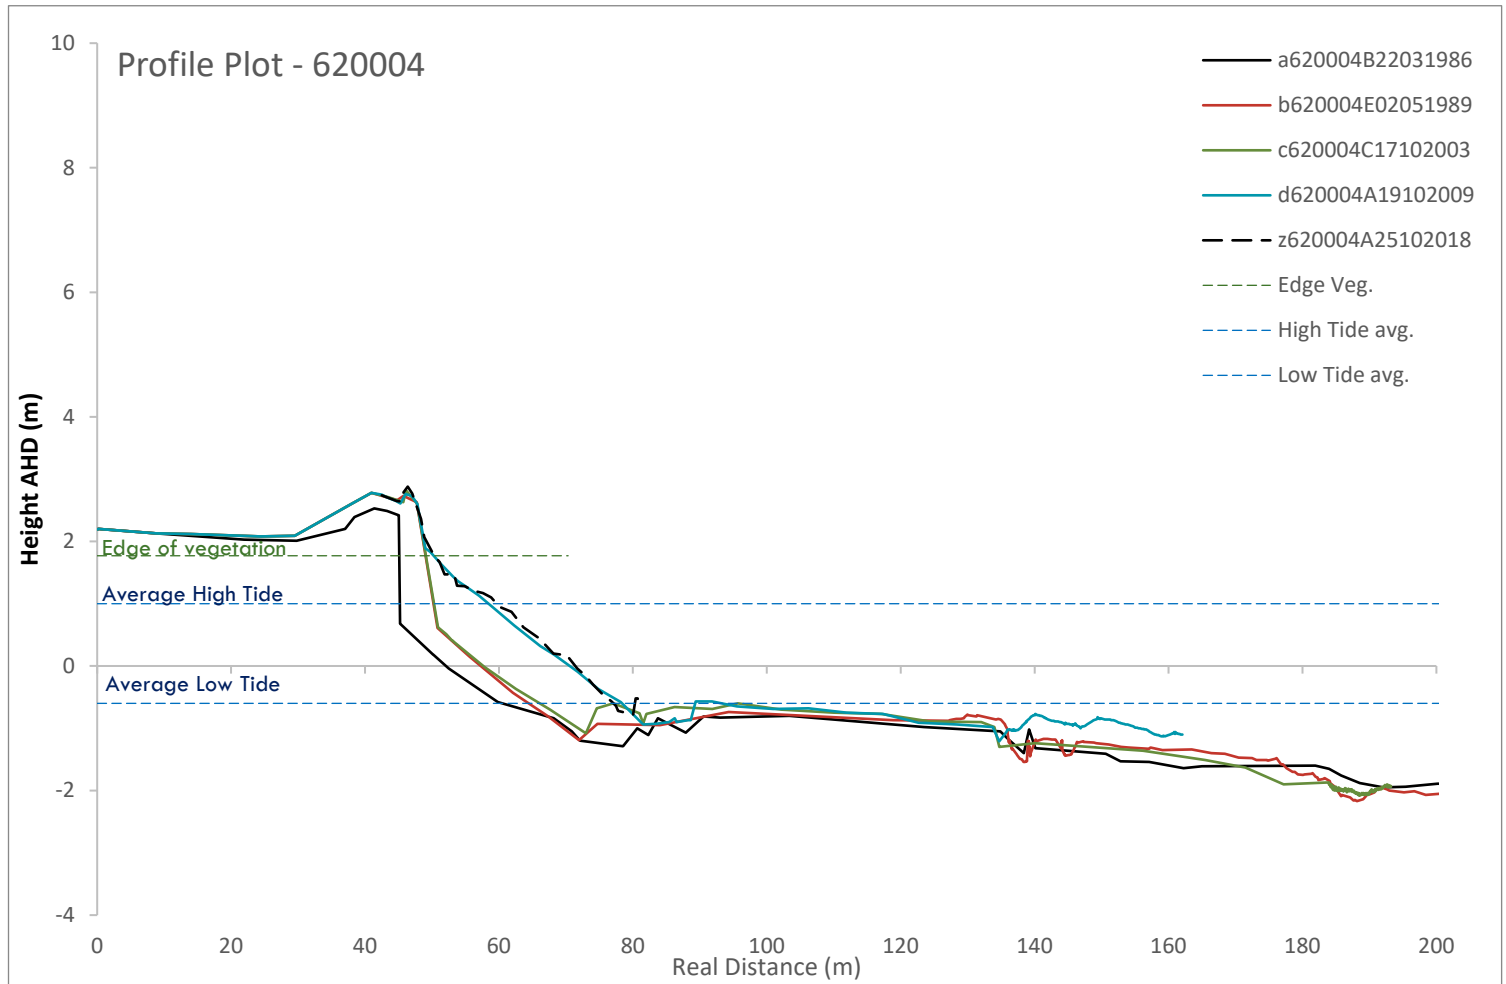
Seawards of ~75m, the shoreface is seagrass/reef dominated and appears to be relatively stable.

The vertical face of in the 1986 profile relates to the presence of a seawall in this location (installed in 1920 and repaired ~1975). Subsequent to a significant storm event in 1989, rock revetment was installed. The exact correlation of the 2009 and 2018 in the intertidal zone relate to the presence of rock protection.

Review note: in this context, the profile of 2003 does not make any logical sense. Did surveyors use upper level of 1989 and just start at the base?

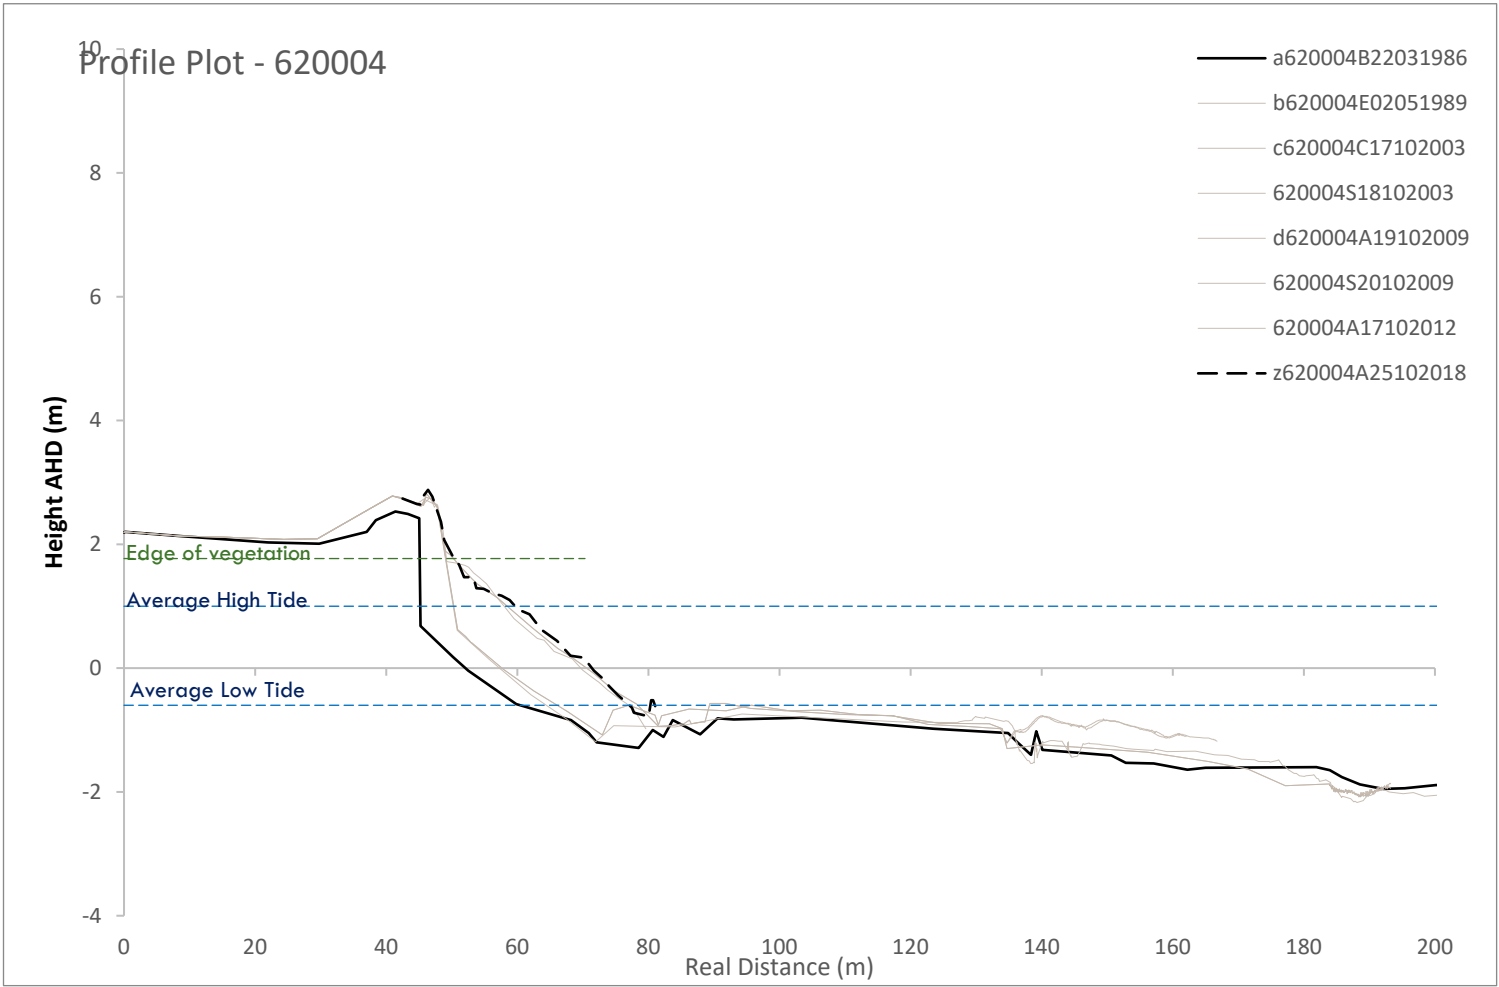
Overall, the subaerial zone shows the 2009 to 2018 survey lines as almost identical.

Below the 0m AHD water line, the profiles are very similar as per the reef dominated nearshore platform.

Summary note: The profile line above the low tide mark is now determined by rock revetment installed in 1989.

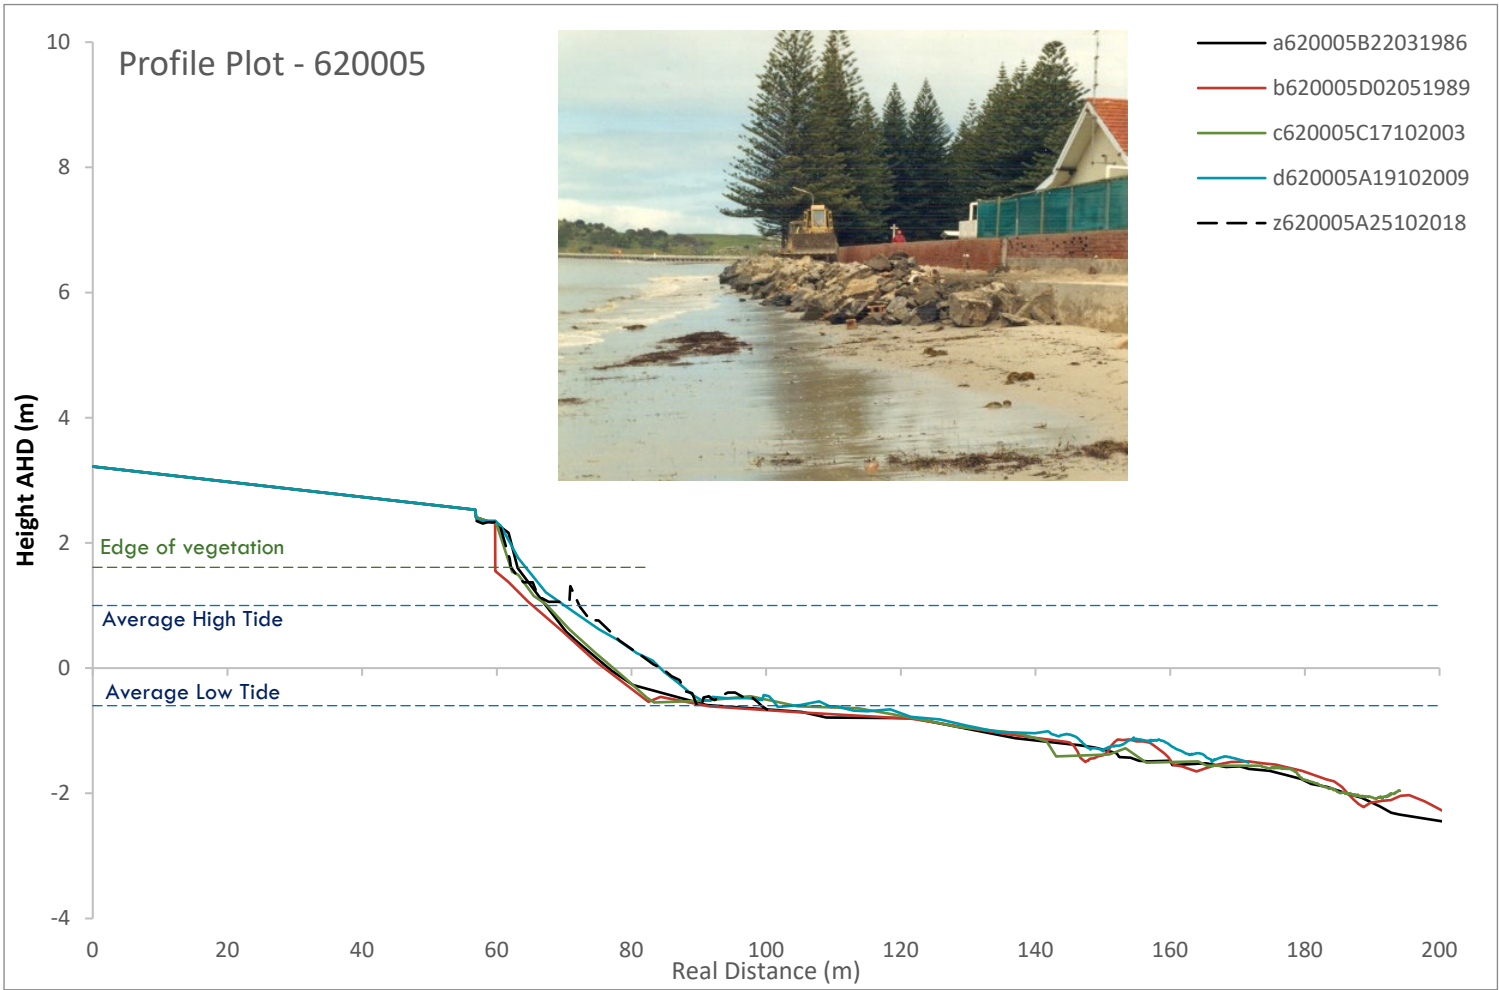
This region has been impacted by human intervention. First in maintaining a bank under the walking path (seen as a small horizontal line at the top of the coastal slope). Rock protection was first installed in 1989 (inset picture).

More recently, since 2018, concrete blocks have been installed. Therefore, the anomaly in the 2018 line at the high tide mark is likely to relate to former rock protection.

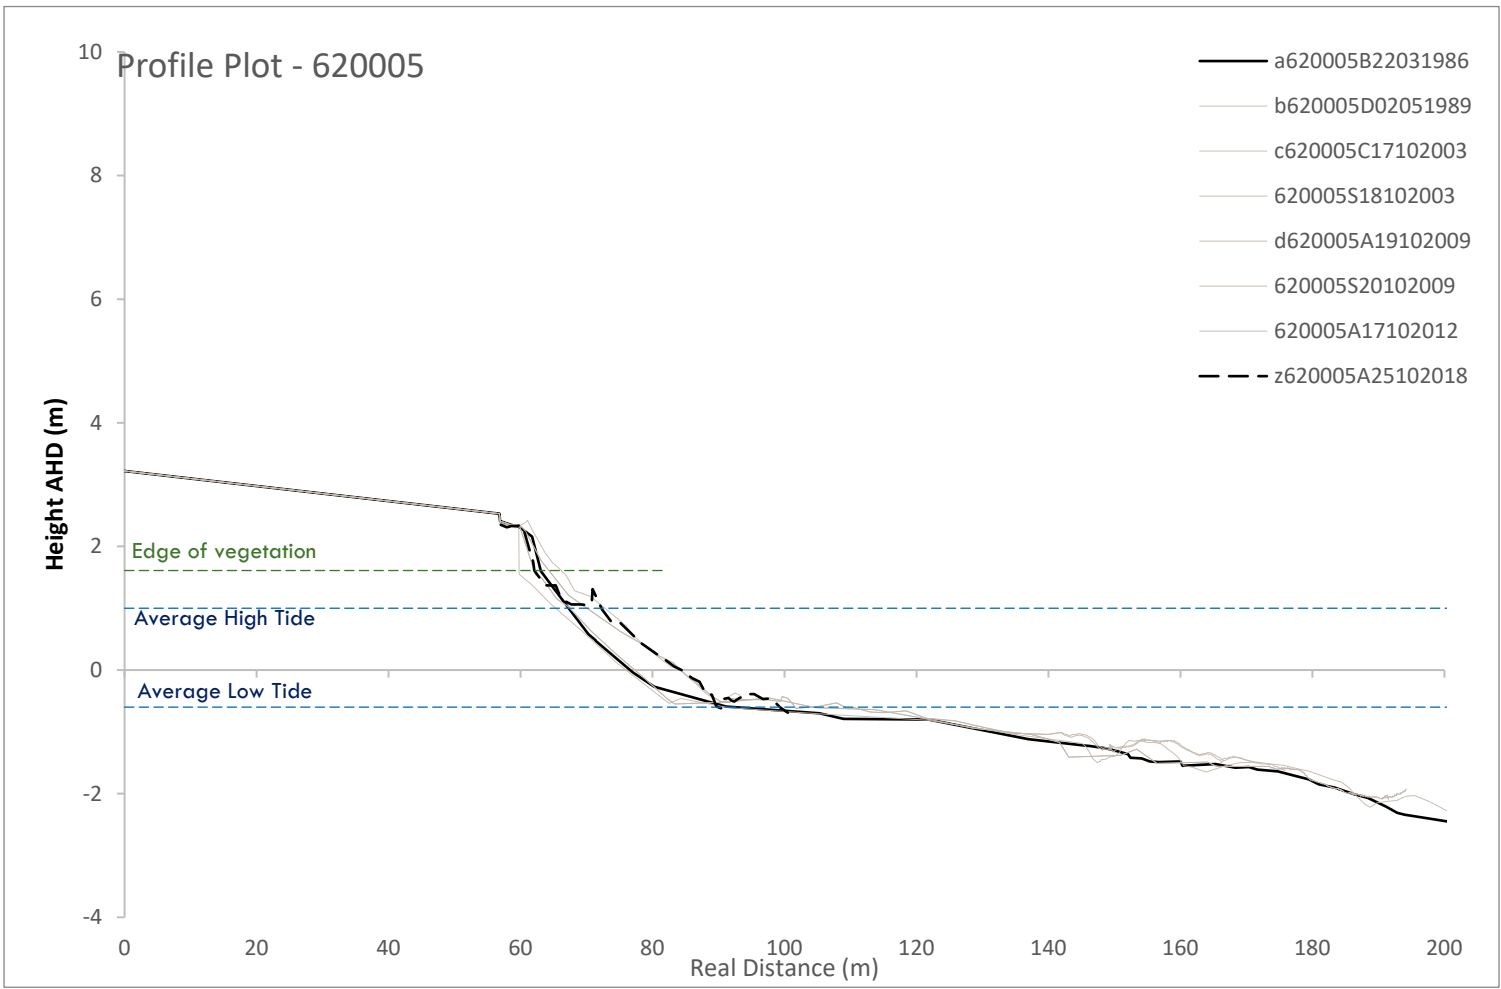
Bowling Club 620005
 The Coast Protection Board (CPB) has been surveying seafloor and coastal backshores since the 1970s around South Australia.
 The indicator lines for average tides and the edge of vegetation are for 2018.
 This beach appears to have been very stable in the subaerial zone since 2009 and is likely related to engineering works.

This region has been impacted by human intervention. First in maintaining a bank under the walking path (seen as a small horizontal line at the top of the coastal slope). Rock protection was first installed in 1989 (inset picture). More recently, since 2018, concrete blocks have been installed. Therefore, the anomaly in the 2018 line at the high tide mark is likely to relate to former rock protection.

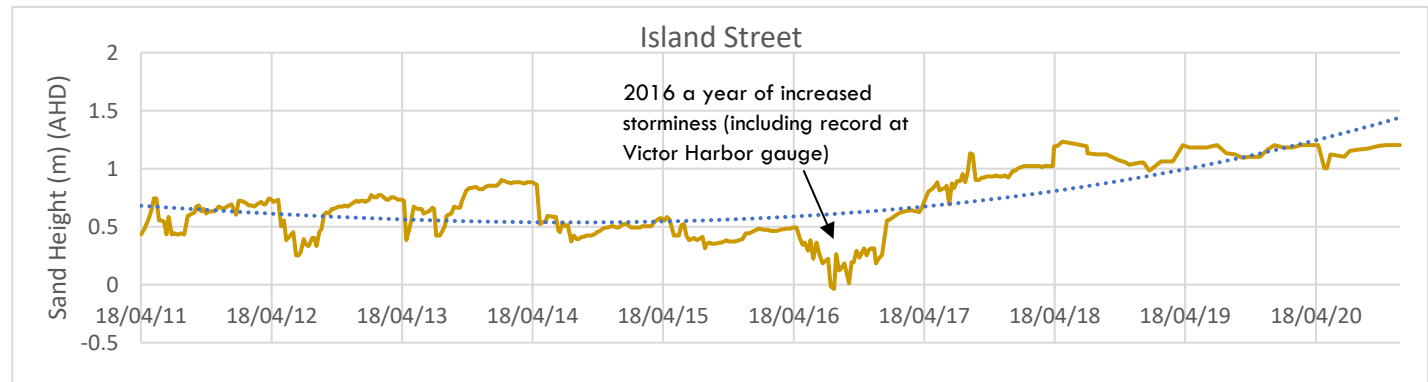
Island Street

This pole is positioned on the beach several metres seaward of the vegetation line (see photo previous page). This section of beach underwent some erosion 2004 to 2011. Sand levels have stabilised since 2011 and increased after 2016 (which was a year of increased storminess). The winter cycles of lower sand levels are observed up until 2016.

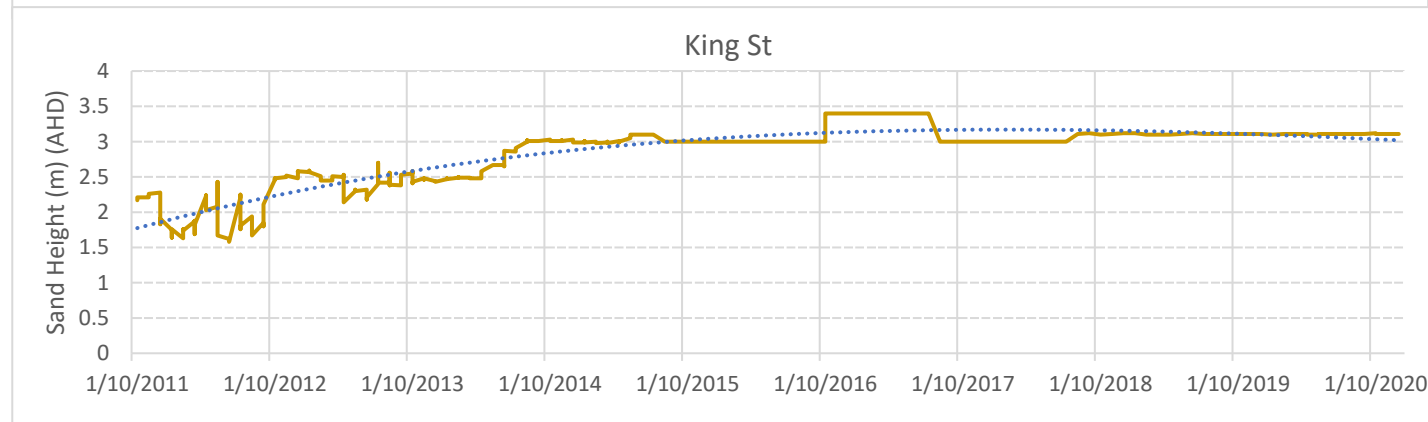
King Street

This pole is positioned within the dune slope (see photo previous page). This section of beach underwent significant erosion 2004 to 2011 and it is likely when the pole was installed that it was on the beach (not dune). Sand levels have recovered since and the dune rebuilt. These findings are congruent with DEM comparison and shoreline analysis.

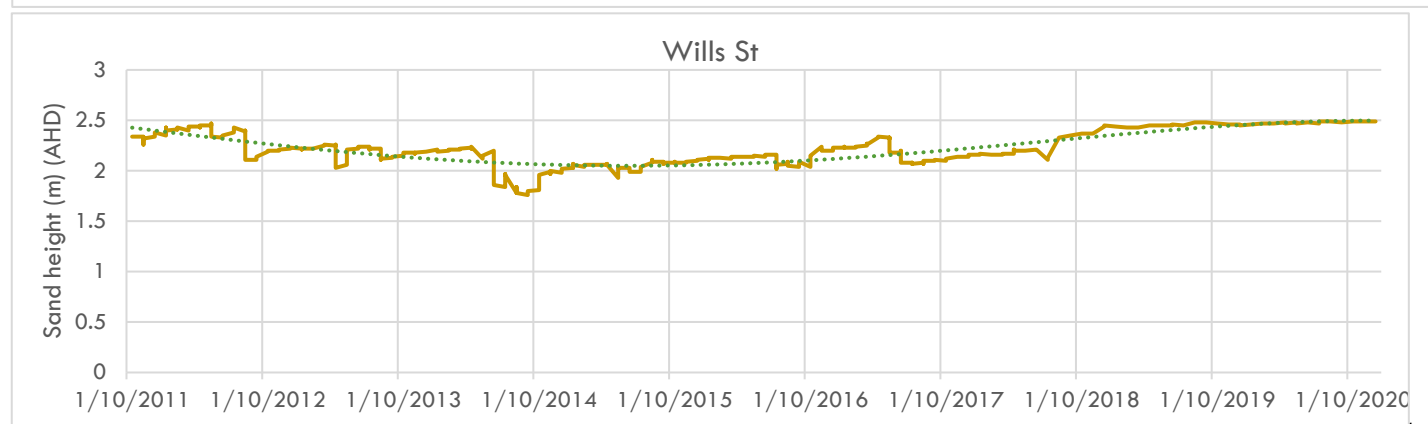
Wills Street

This pole is positioned on the beach several metres seaward of the vegetation line (see photograph on previous page). This area was less impact by erosion in 2004 to 2011. The winter sand cycles are observed in most years. These findings are congruent with the DEM comparison (which shows no increase in sand levels and shoreline analysis, which shows little movement).

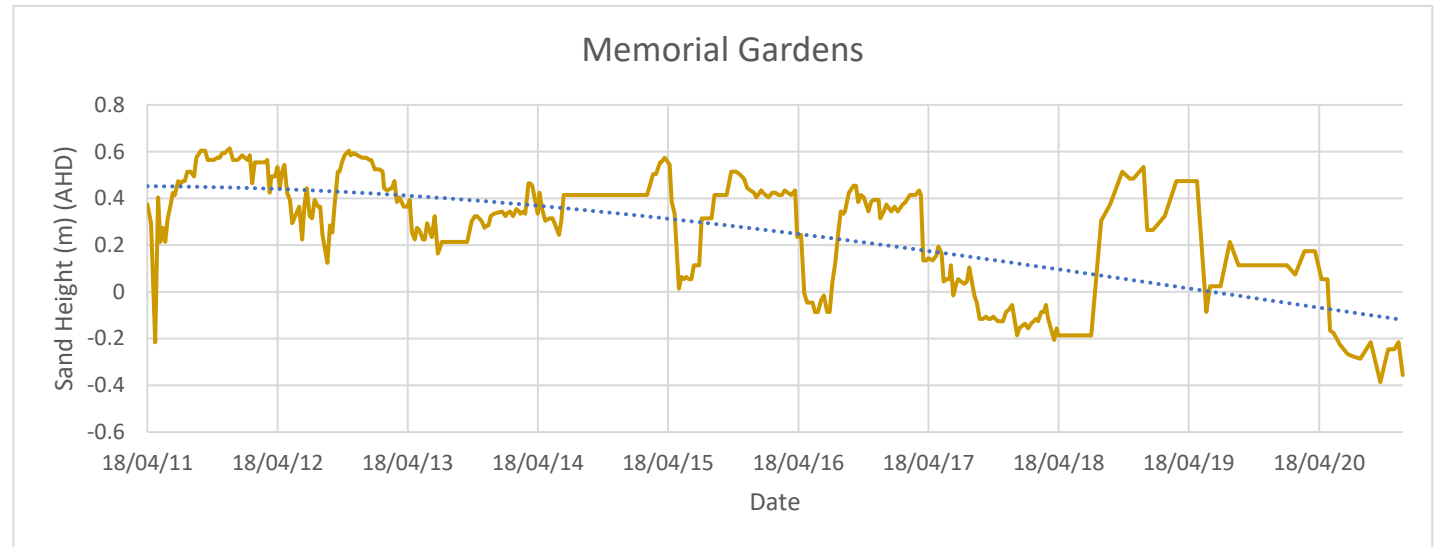
Soldiers' Memorial Gardens

This pole is positioned on the beach several metres approximately 2m seaward of the base of the rock protection which was installed in 1989. Therefore, in the context of all the beach poles this pole is positioned at the lowest point on the beach profile in the intertidal zone. The lower sand levels are evident in relation to winter cycles. Overall, the sand levels on the beach have been declining in this location from 2011 to 2020. This trend is more difficult to identify in the profile analysis (note – the 2018 profile line concluded at the low tide mark).

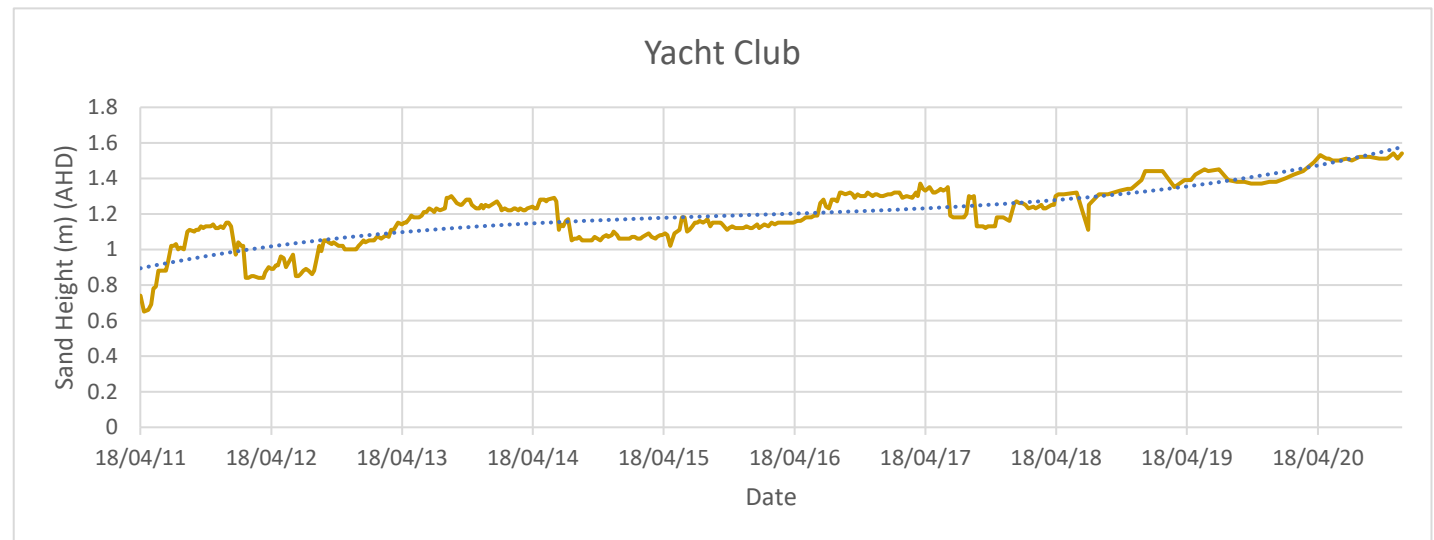
Yacht Club

This pole is positioned a few metres above the current wave runup area. However, in 2011 it may have been in this location of the beach profile. The long-term trend since 2011 is for increasing sand levels in the location of this beach pole.

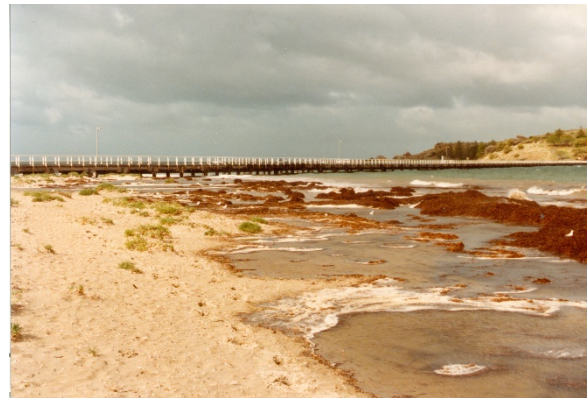
However, the storm damage archives are not correlated with any of these events. The event of 14 May 1987 (third highest on record) is the only event in which we have photographic evidence (Figures a, b, c). Significant swell action is not observed in any of these photographs. In fact, the water adjacent Soldiers Memorial Gardens is best described as ‘still’ due to its position in the lee of the south-west wind.

Figure a. Esplanade Beach. Third highest recorded storm on 14 May 1987. (Photograph - Coast Protection Board, 19870514).

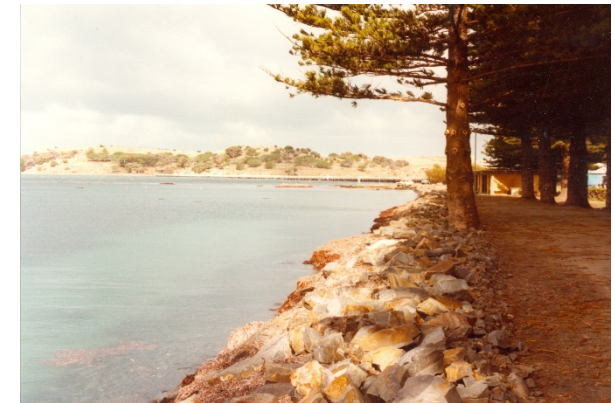
Figure b. Soldiers Memorial Gardens. Third highest recorded storm on 14 May 1987. (Photograph - Coast Protection Board, 19870514).

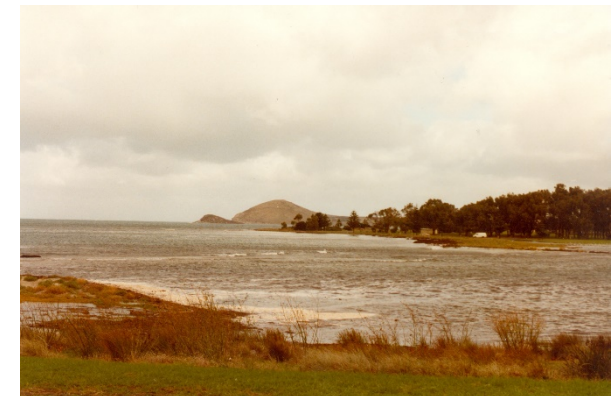
Figure c. Inman River. Third highest recorded storm on 14 May 1987. (Photograph - Coast Protection Board, 19870514).

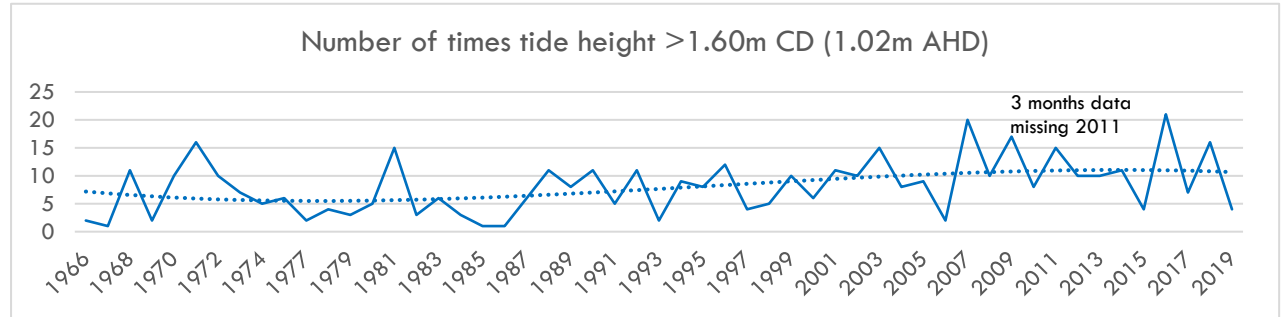
The conclusion of this project is that the larger contributing factor of the erosion was increased 'storminess' from the Southern Ocean in this time period. Integrated Coasts evaluated the tide gauge record and found that there was an increased periodicity of higher storm events in the period 2007 to 2011. It is likely that the repeated higher storm and tidal action caused sand loss from which the beach was unable to recover (See graph next page).

Figure a (above). Number of times Victor Harbor exceeded 1.60m CD (1.02m AHD) from 1965 to 2019.

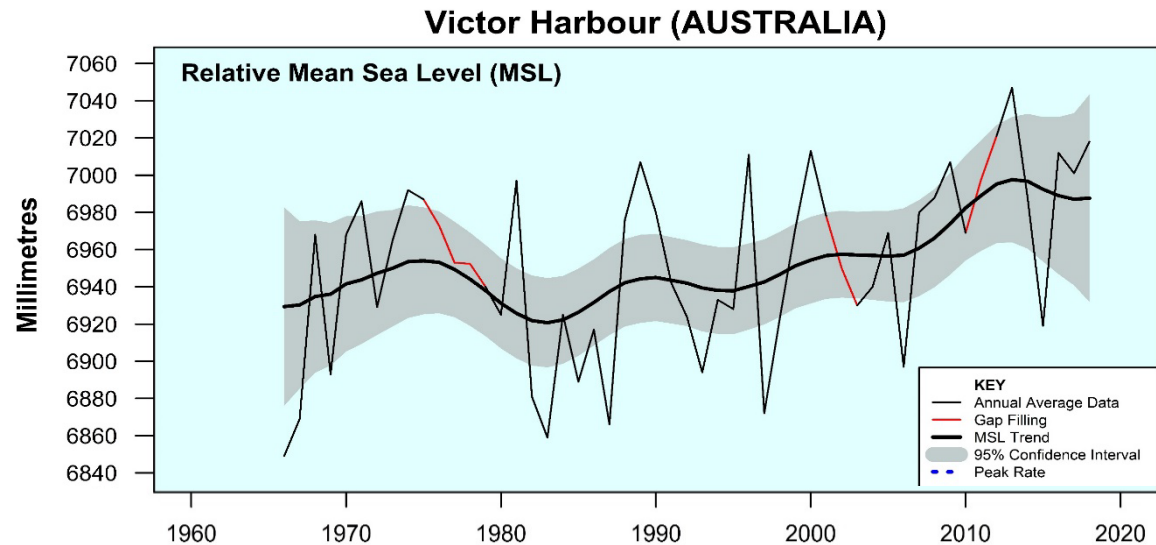
applied a 20-year analysis time frame to the data to identify mean sea level rise trends (Figure b). A more rapid increase in sea level is observed post 2005, but it is important to remember that this analysis also includes normal variability rather than being indicative of a longer underlying trend of a rate of sea level rise.

Without dismissing the issue of sand littoral supply entirely, it is likely that the erosion of the beach was primarily caused by increased exposure at a periodicity from which the beach was unable to recover. It is unlikely that sandbag groynes would be an effective control measure in this context.

Figure b (right). Relative mean sea level rise using 20-year time frame analysis. Dr P. Watson advises that a 50-year time frame analysis is required to determine the rate of sea level rise that is less impacted by natural variability. The application to this study is the observed increase in rate post 2005 which correlates to the increased erosion of Esplanade Beach. Source: Dr. P. Watson (email correspondence).

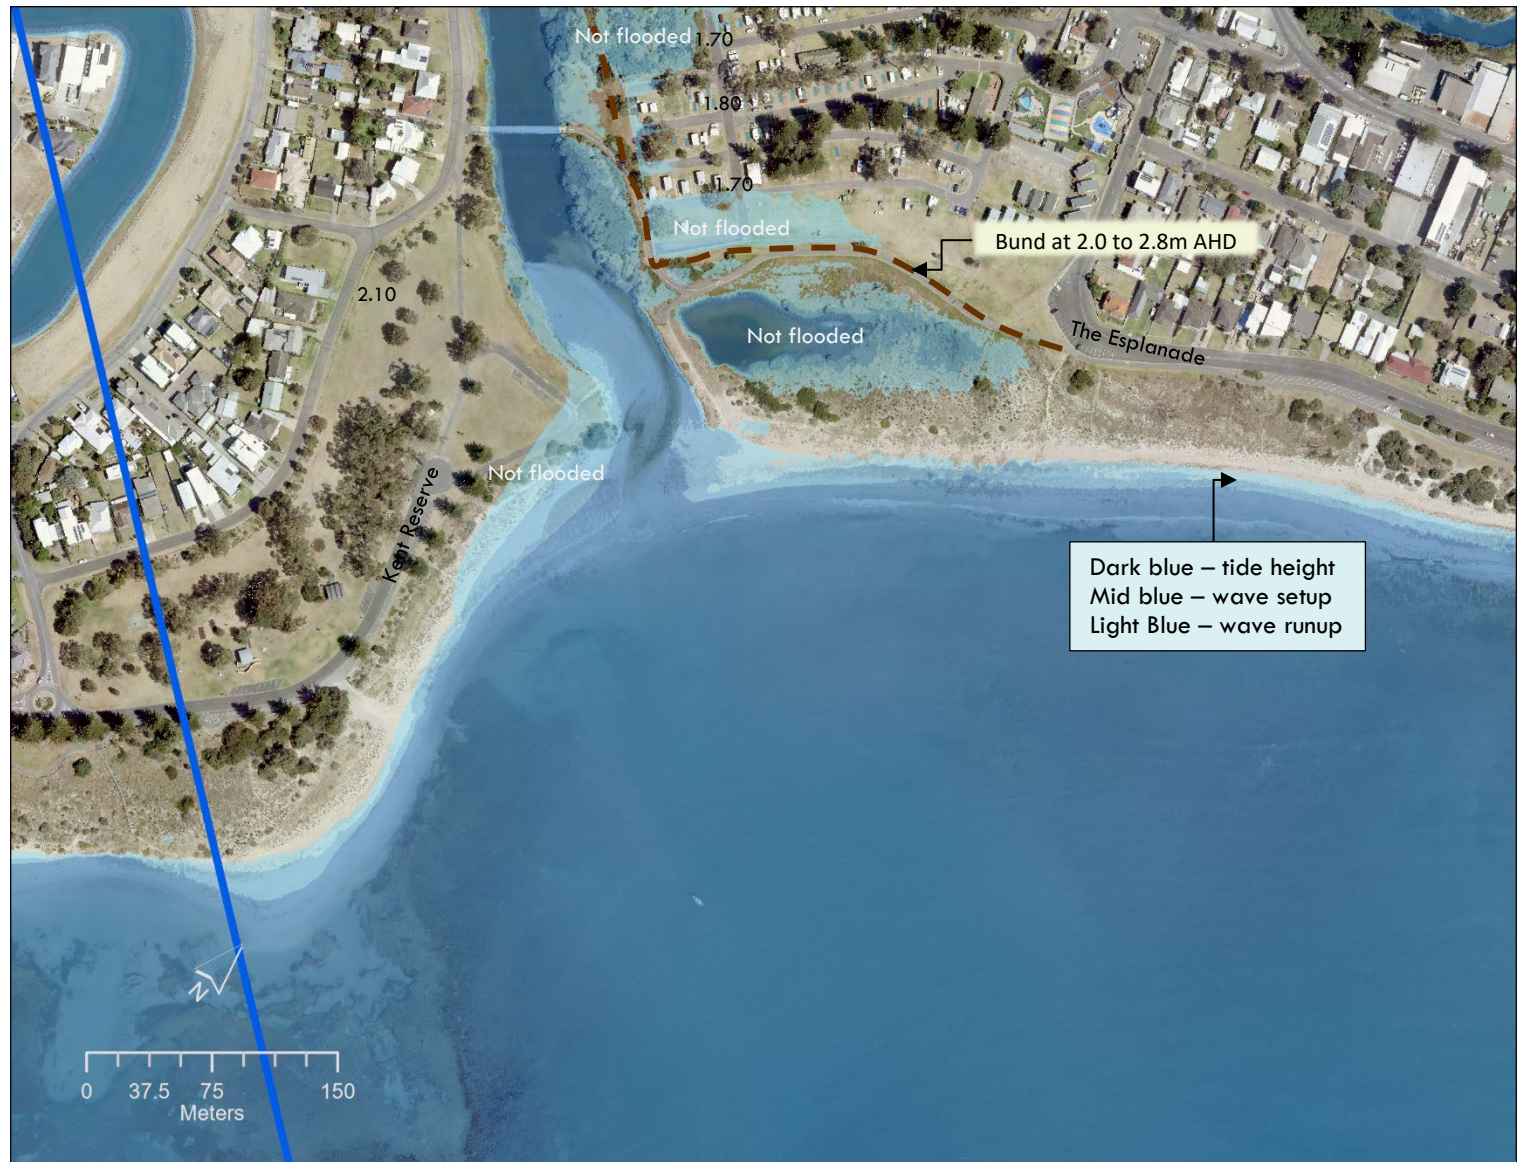
5. Coastal exposure – routine high water (2020)

Assessment: The model is rendering this event with too much depth. This is probably because wave set up and wave runup would not penetrate into this region for this event.

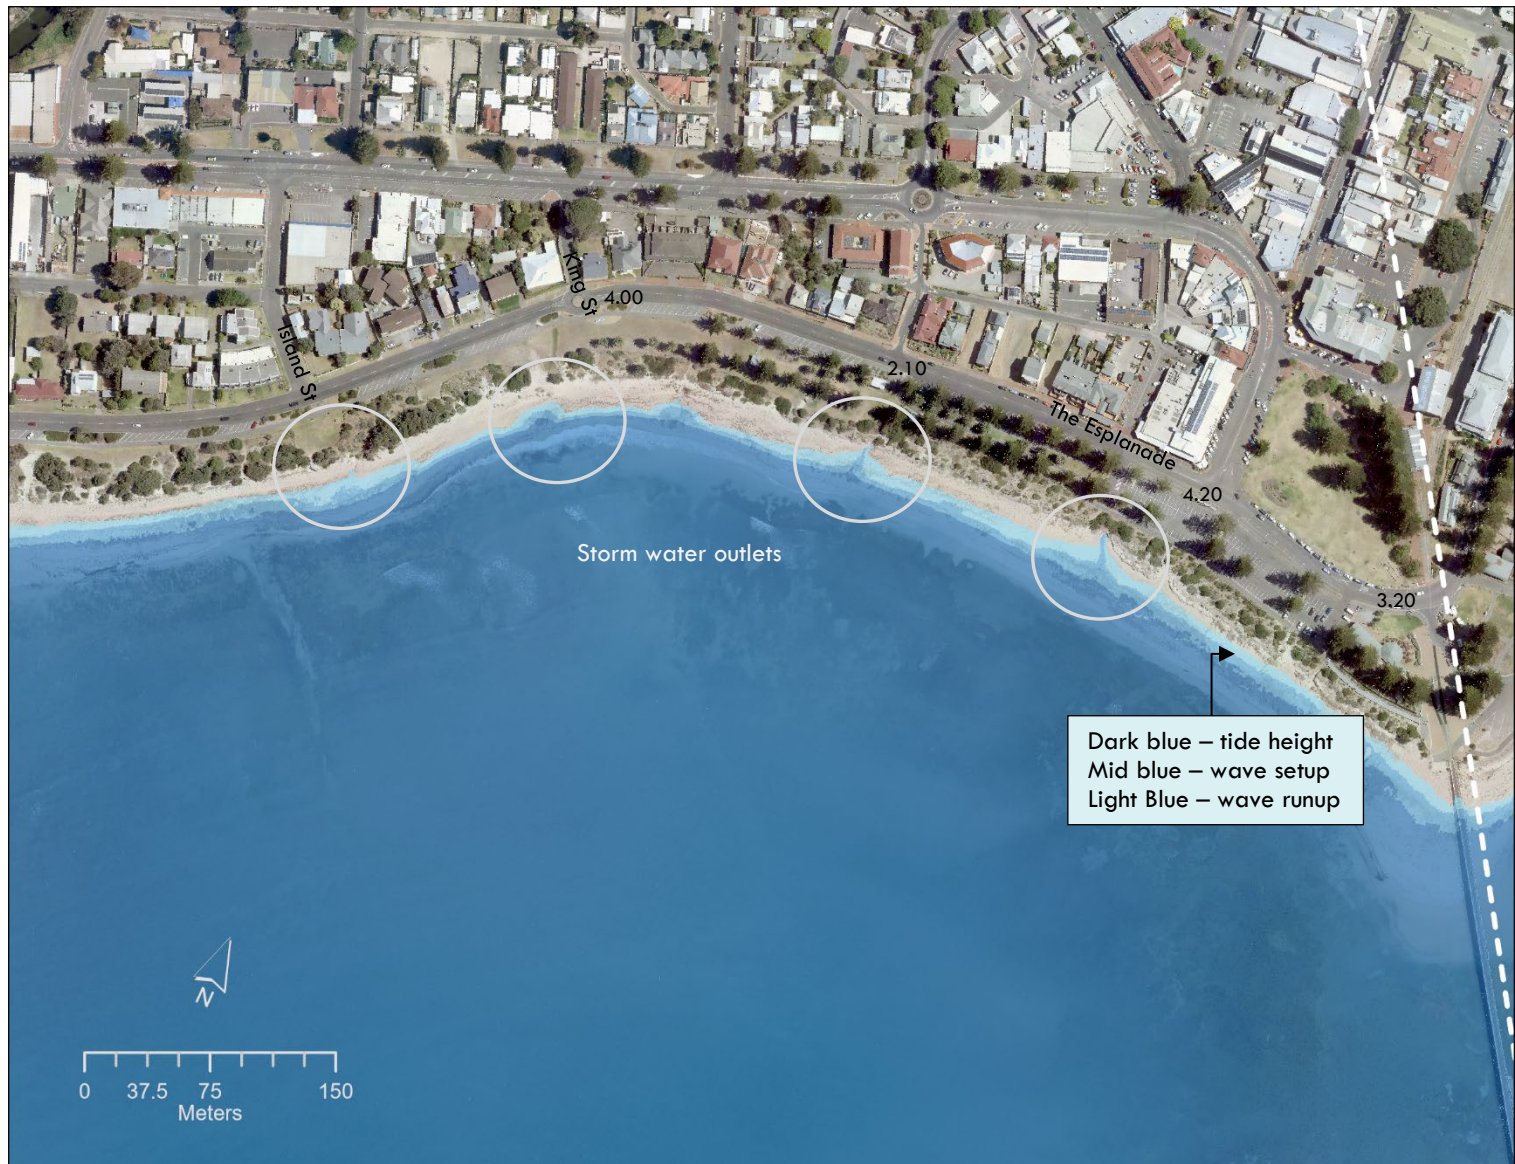
5. Coastal exposure – routine high water (2020)

Assessment: The modelling is congruent with observations and the current impact on beach on the western side but may be too low on eastern side.

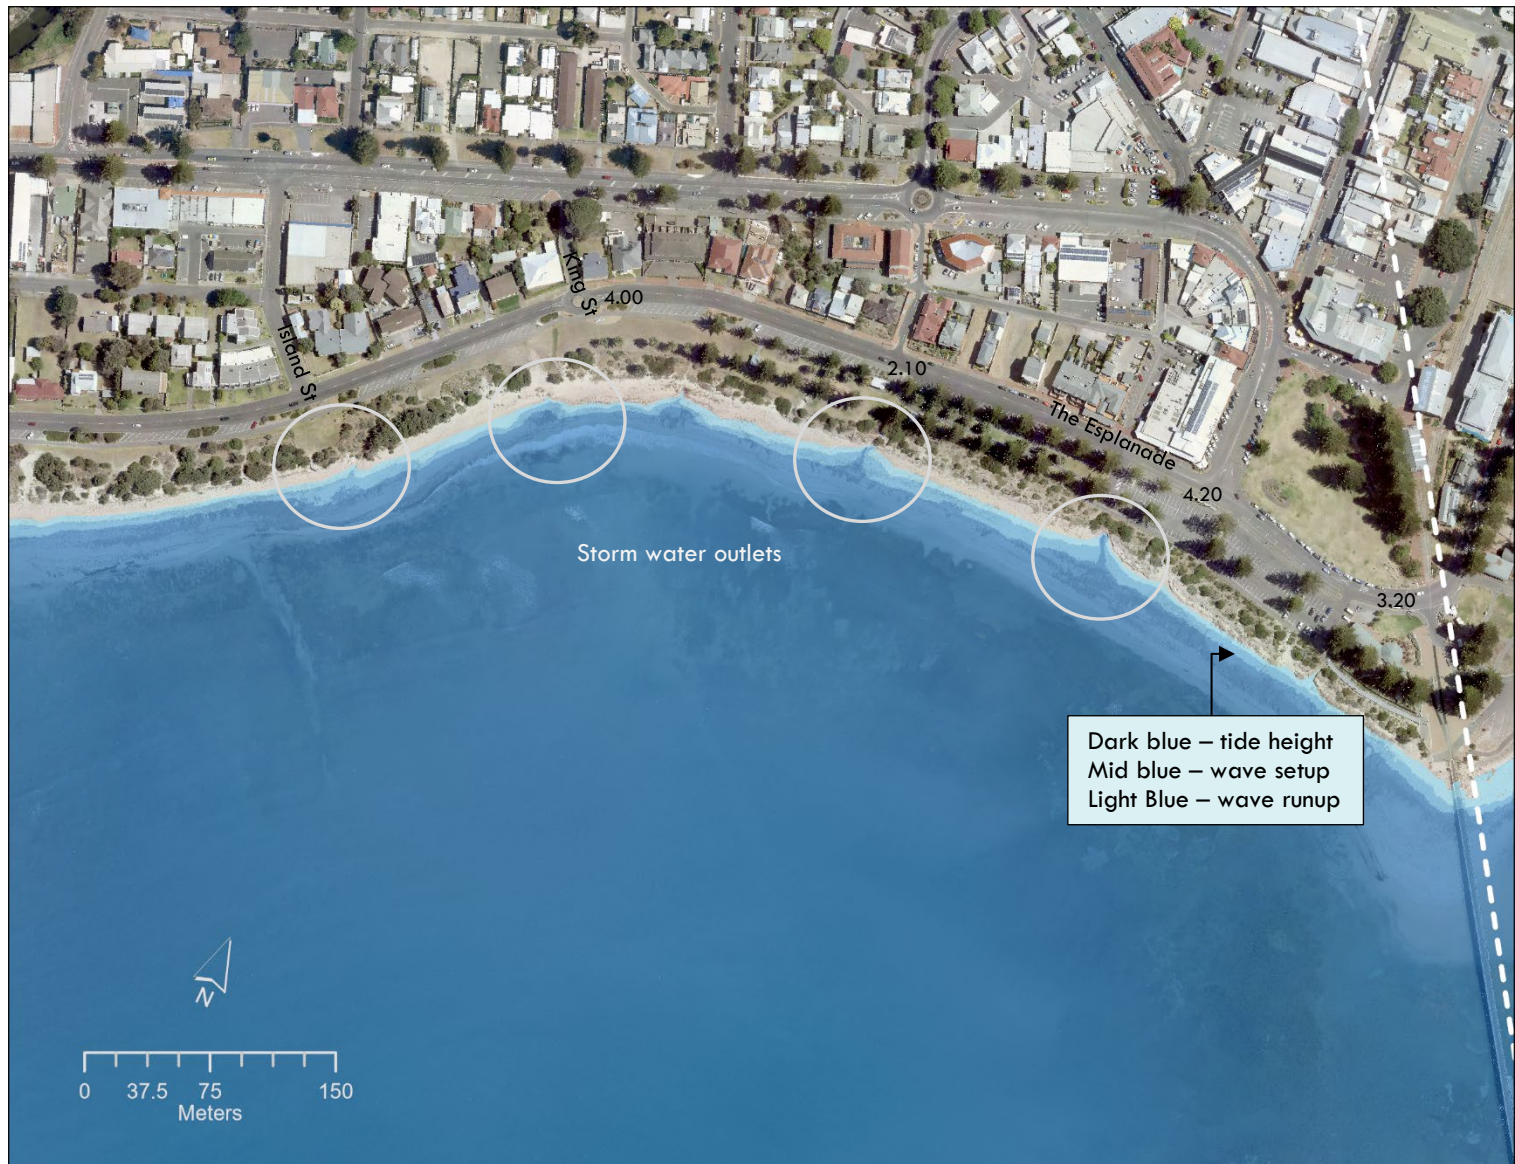
5. Coastal exposure – routine high water (2050)

Routine highwater events at 0.30m higher than present are likely to cause the dunes/ vegetation line to recede. (Note, the modelling may be rendered too low for this event).

Note the lower sand levels in locations of storm water outlets.

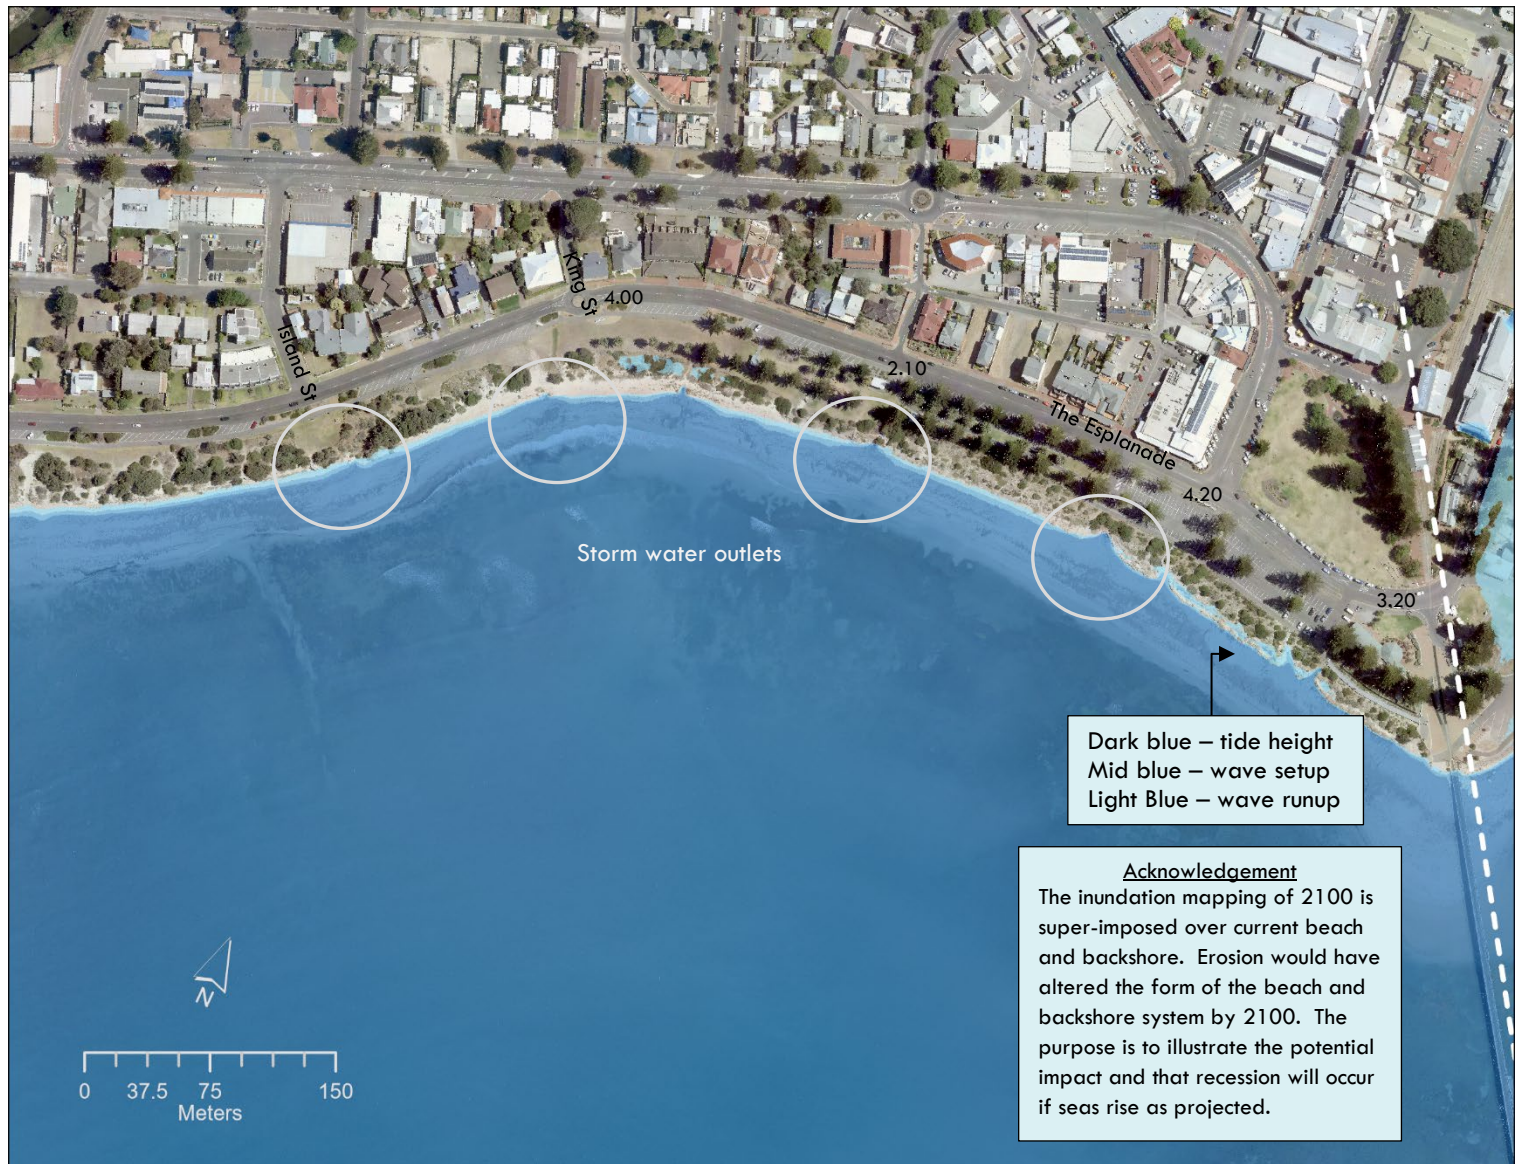
5. Coastal exposure – routine high water (2100)

Routine highwater events at 1.0m higher than present would cause significant recession of the dunes. Either they would retreat (and only if there were no hold points in the backshore) or be eroded away. The latter is more likely.

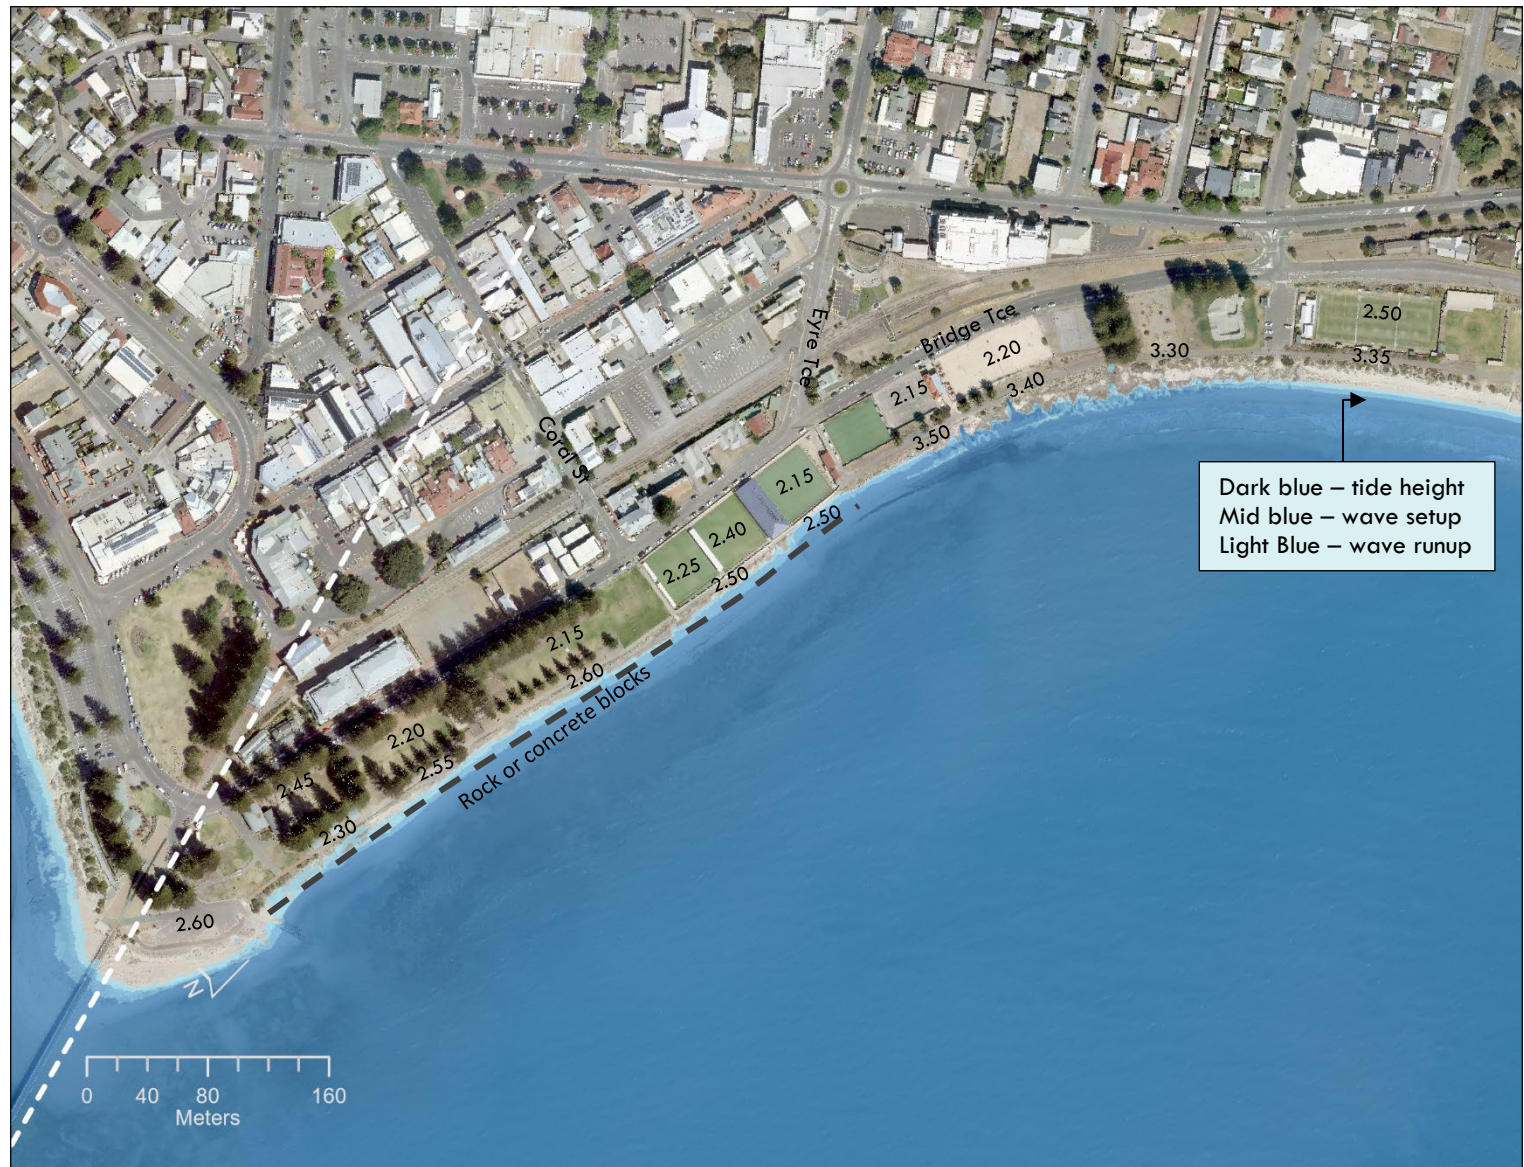
5. Current exposure – routine high water (2020)

Assessment: The modelling appears congruent with observations in this location. Heights AHD have been added to key locations.
