Coastal Adaptation Study &
Coastal Adaptation Strategy

VICTOR HARBOR CENTRAL

Cell
Fleurieu 11

For City of
Victor Harbor

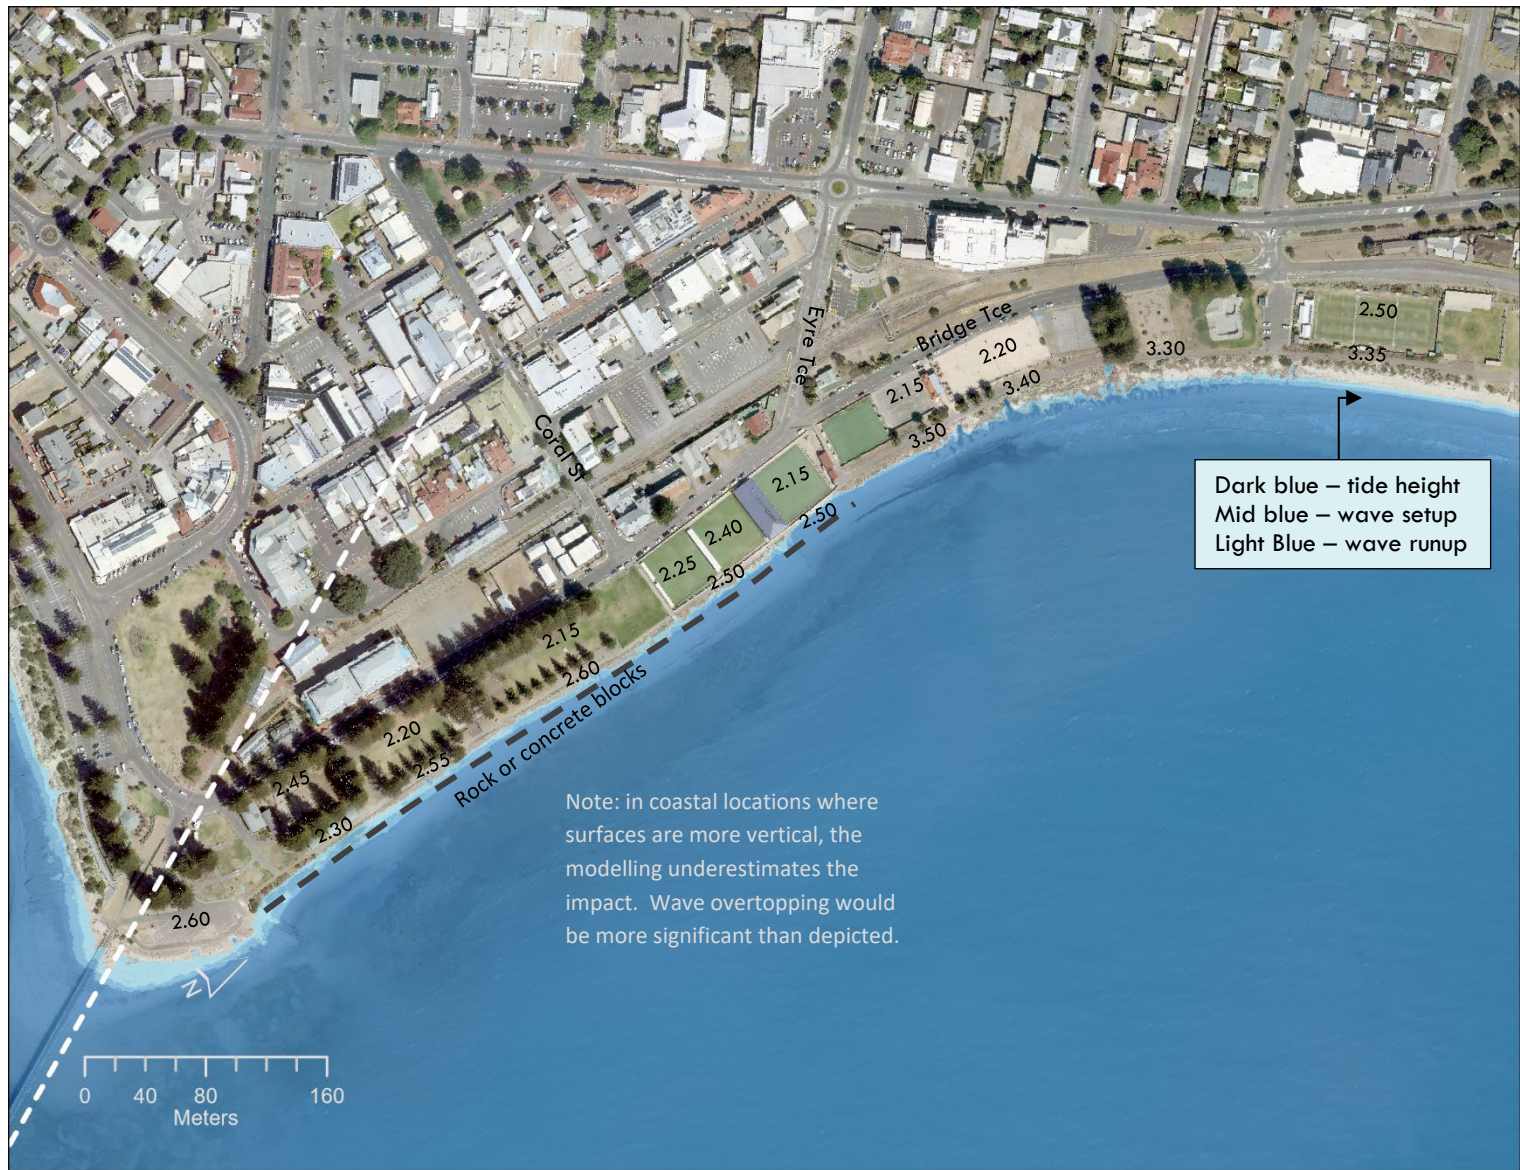
5. Coastal exposure – routine high water (2050)

Routine highwater events at 0.30m higher than present in the context of rock and concrete block protection are likely to cause further loss of sand on the beach (which currently is in decline). In areas, some recession of the beach is likely. Frequent overtopping is likely to occur adjacent the Soldiers Memorial Gardens.

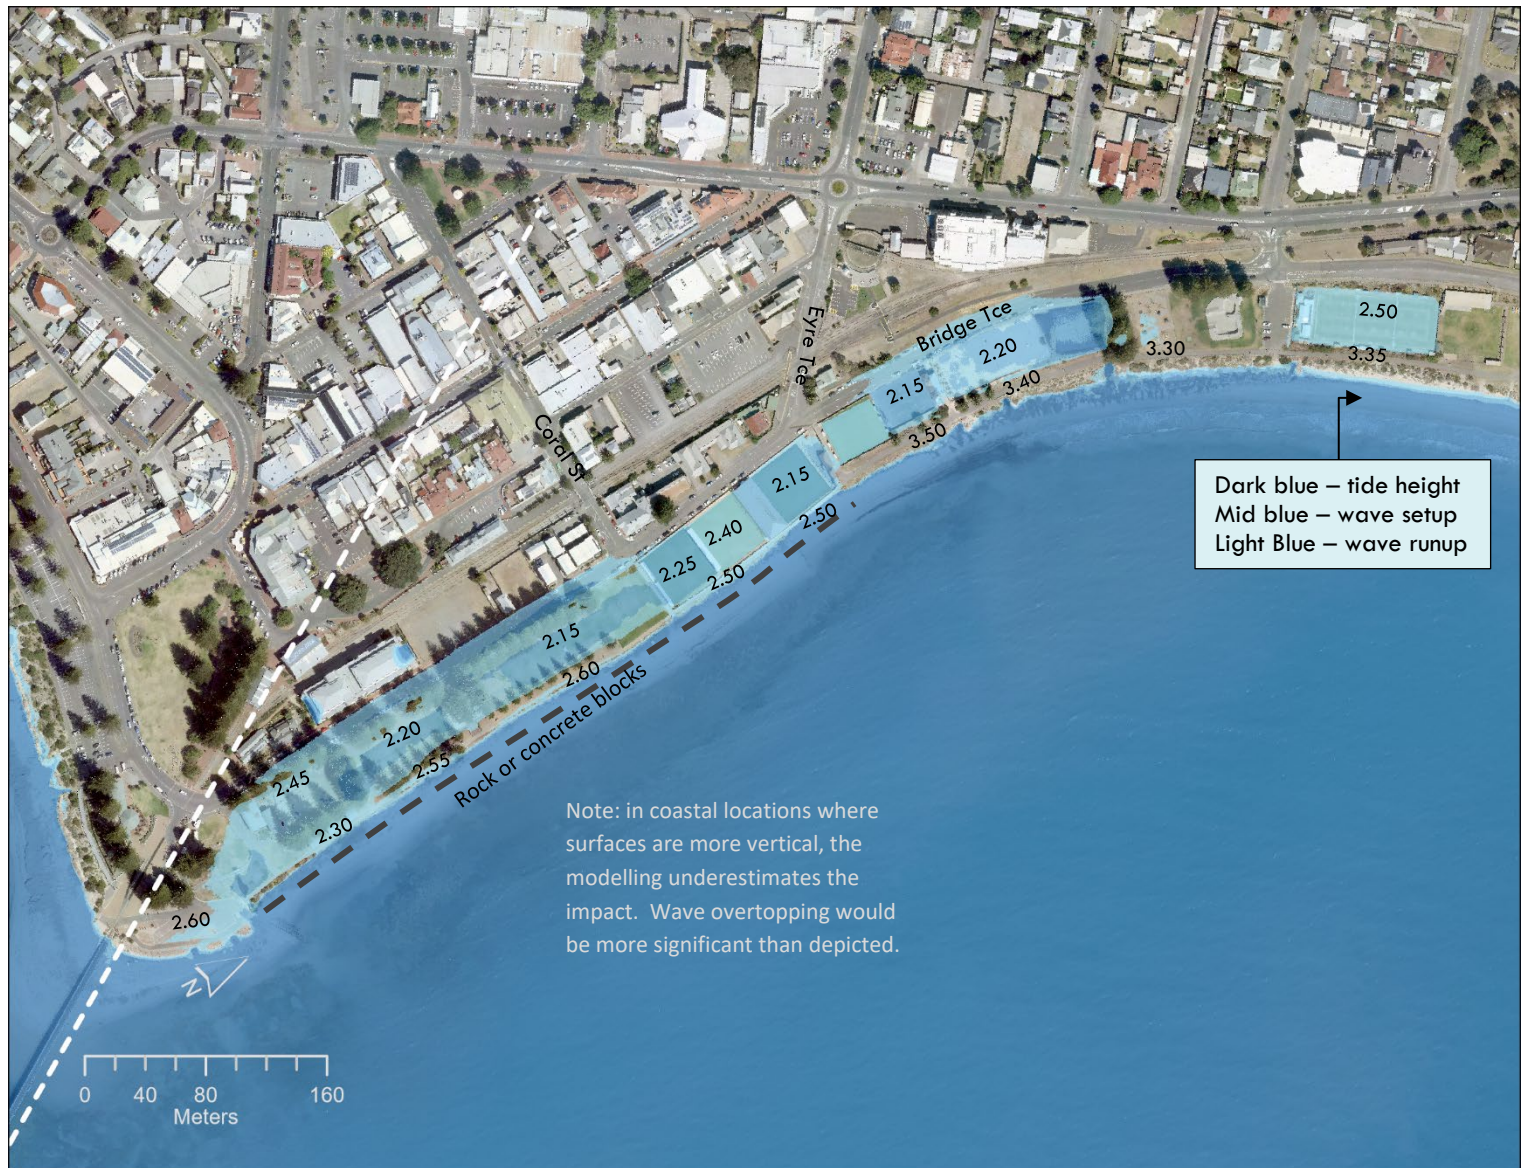
5. Coastal exposure – routine high water (2100)

Routine high water at 1.0m higher than present would completely inundate the reserve back to Flinders Parade. This is congruent with the geomorphological finding that this area was likely formed at the Holocene high stand (~4-5000 years ago) when seas were 1m higher than present.

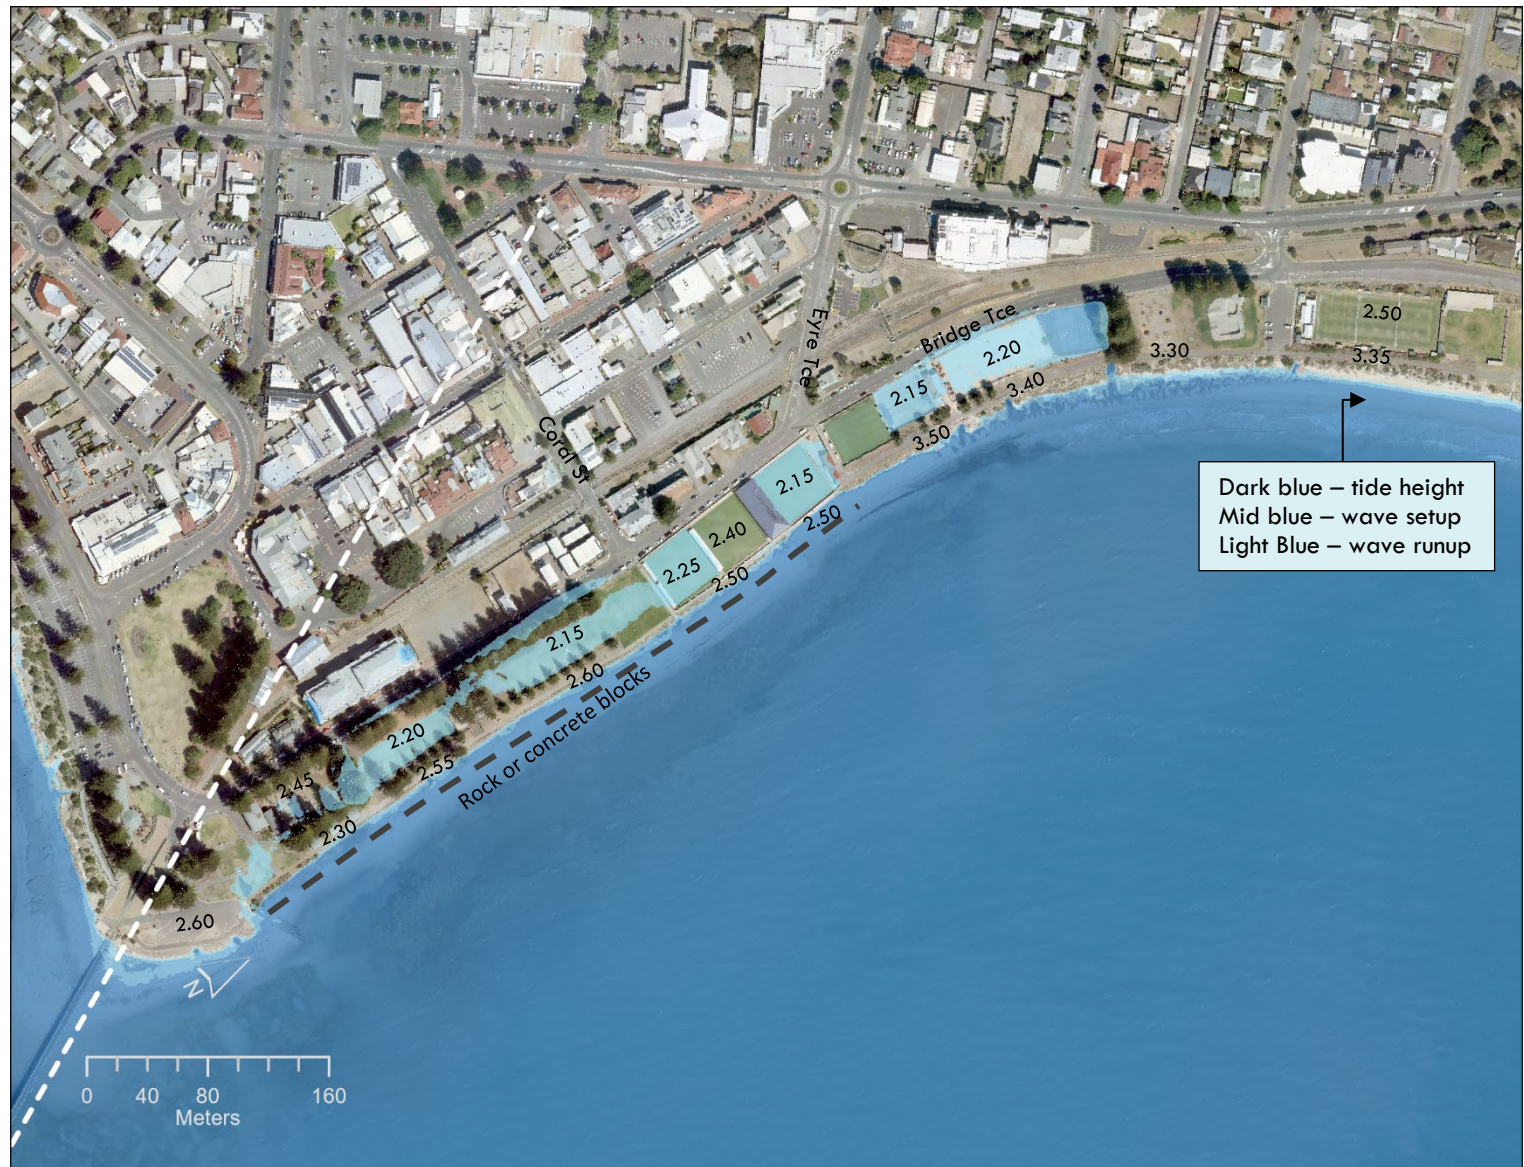
5. Coastal exposure – storm surge (2020)

Note, impact of waves on vertical surfaces is significantly higher than modelled. The modelling shows that this event would overtop the protection works and promenade and flood most of the reserve and playing fields.

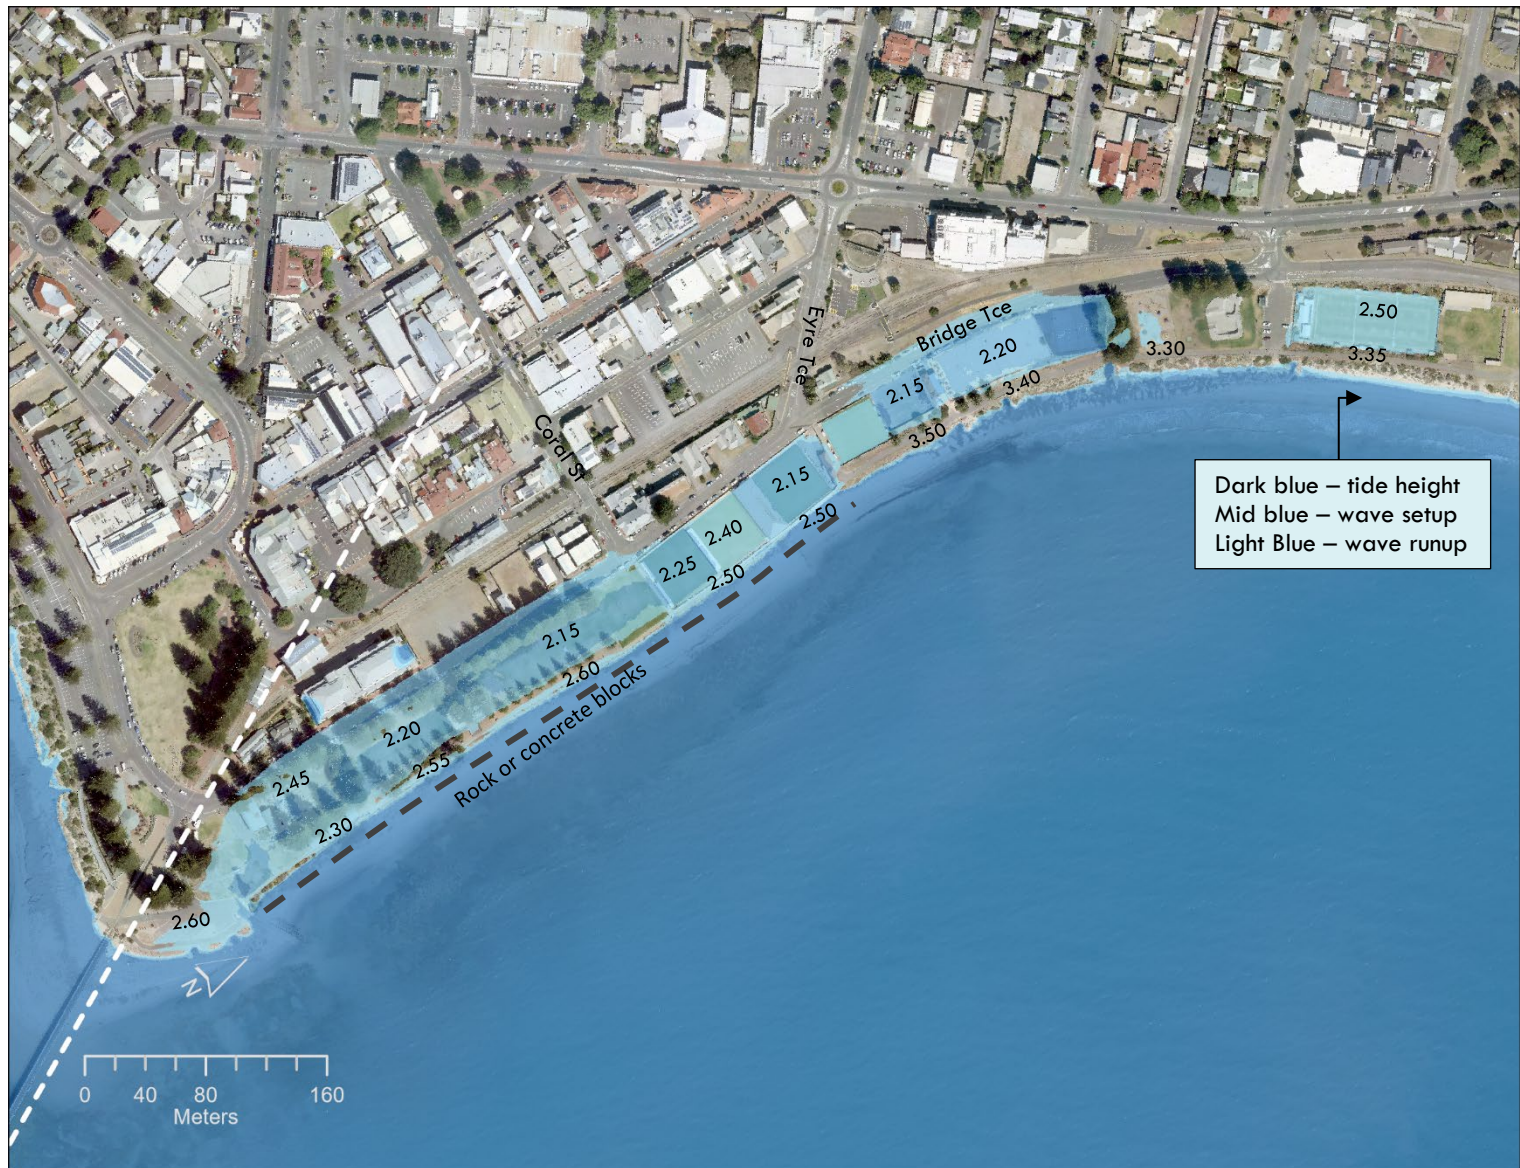
5. Coastal exposure – storm surge (2050)

The scenario modelling indicates that most of reserve would be significantly over topped with water depths in Soldiers Memorial Gardens up to 0.50m and up to 0.40m in the bowling club, tennis courts etc. Note, impact of waves on vertical surfaces is significantly higher than modelled.

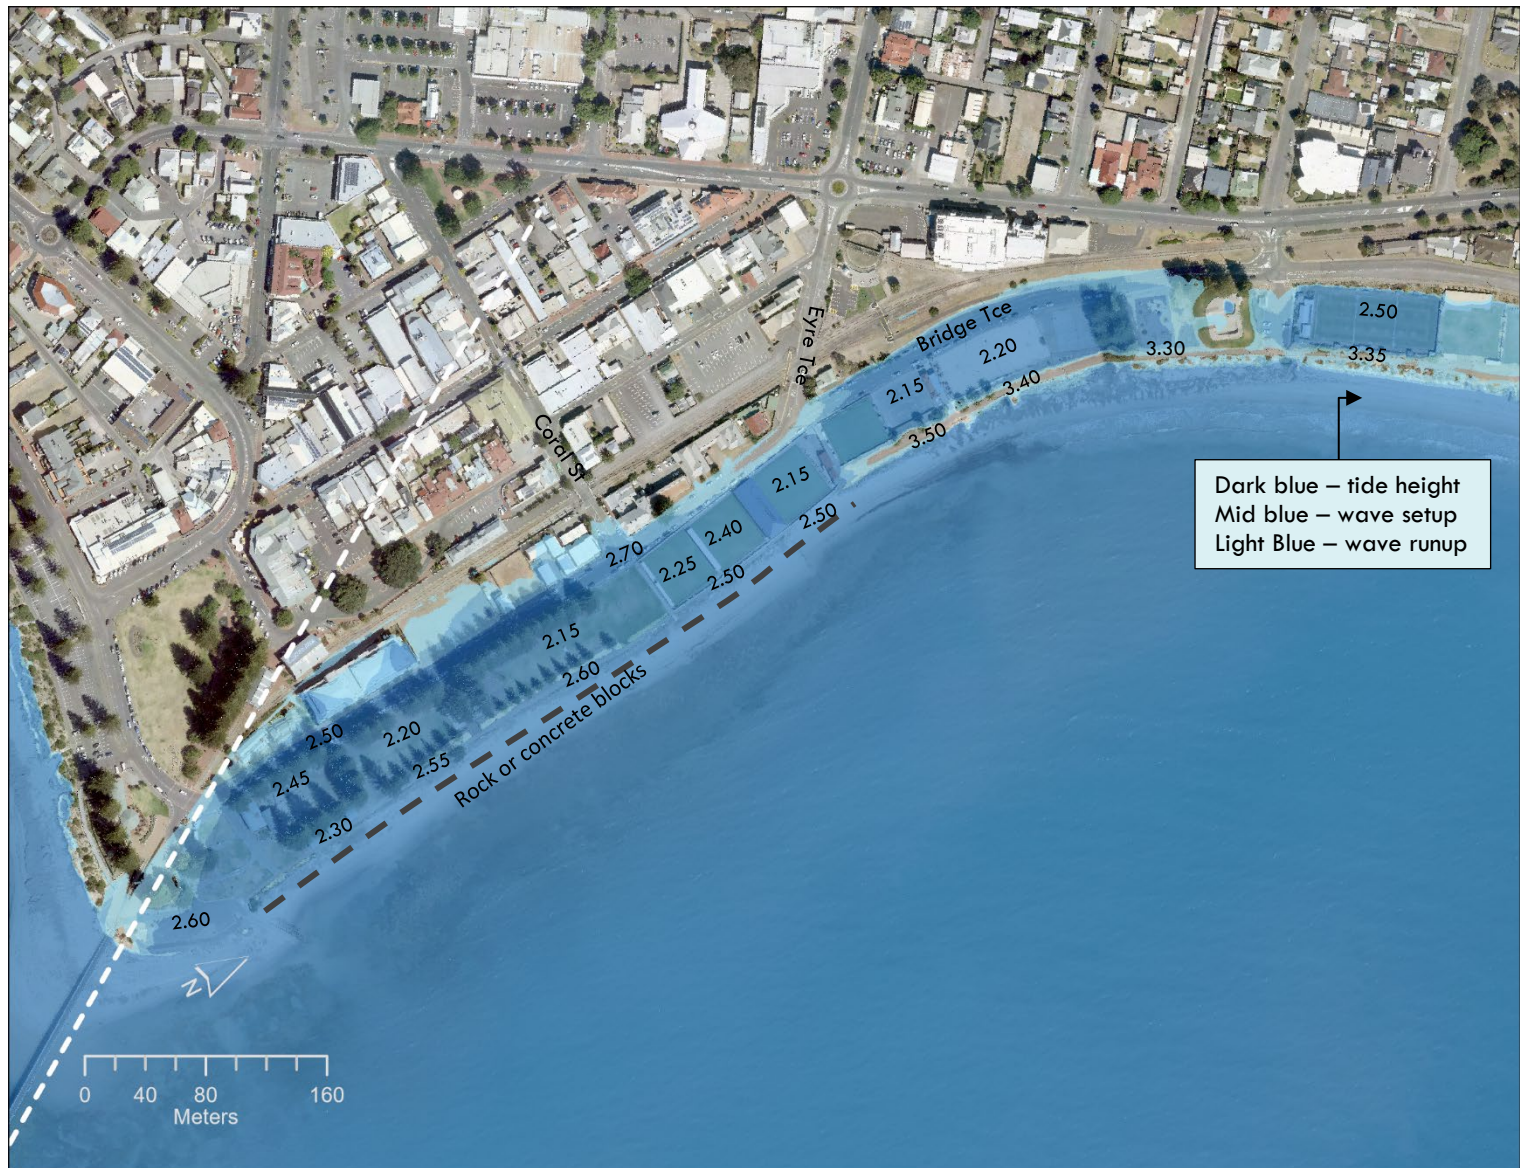
5. Coastal exposure – storm surge (2100)

The scenario modelling indicates that the reserve would be significantly overtopped, and water is likely to flow over Flinders Parade at depths up to 0.50m. Water depths in Soldiers Memorial Gardens would be up to 1.20m and up to 1.10m in the bowling club, tennis courts, volleyball court. Note, impact of waves on vertical surfaces is significantly higher than modelled.

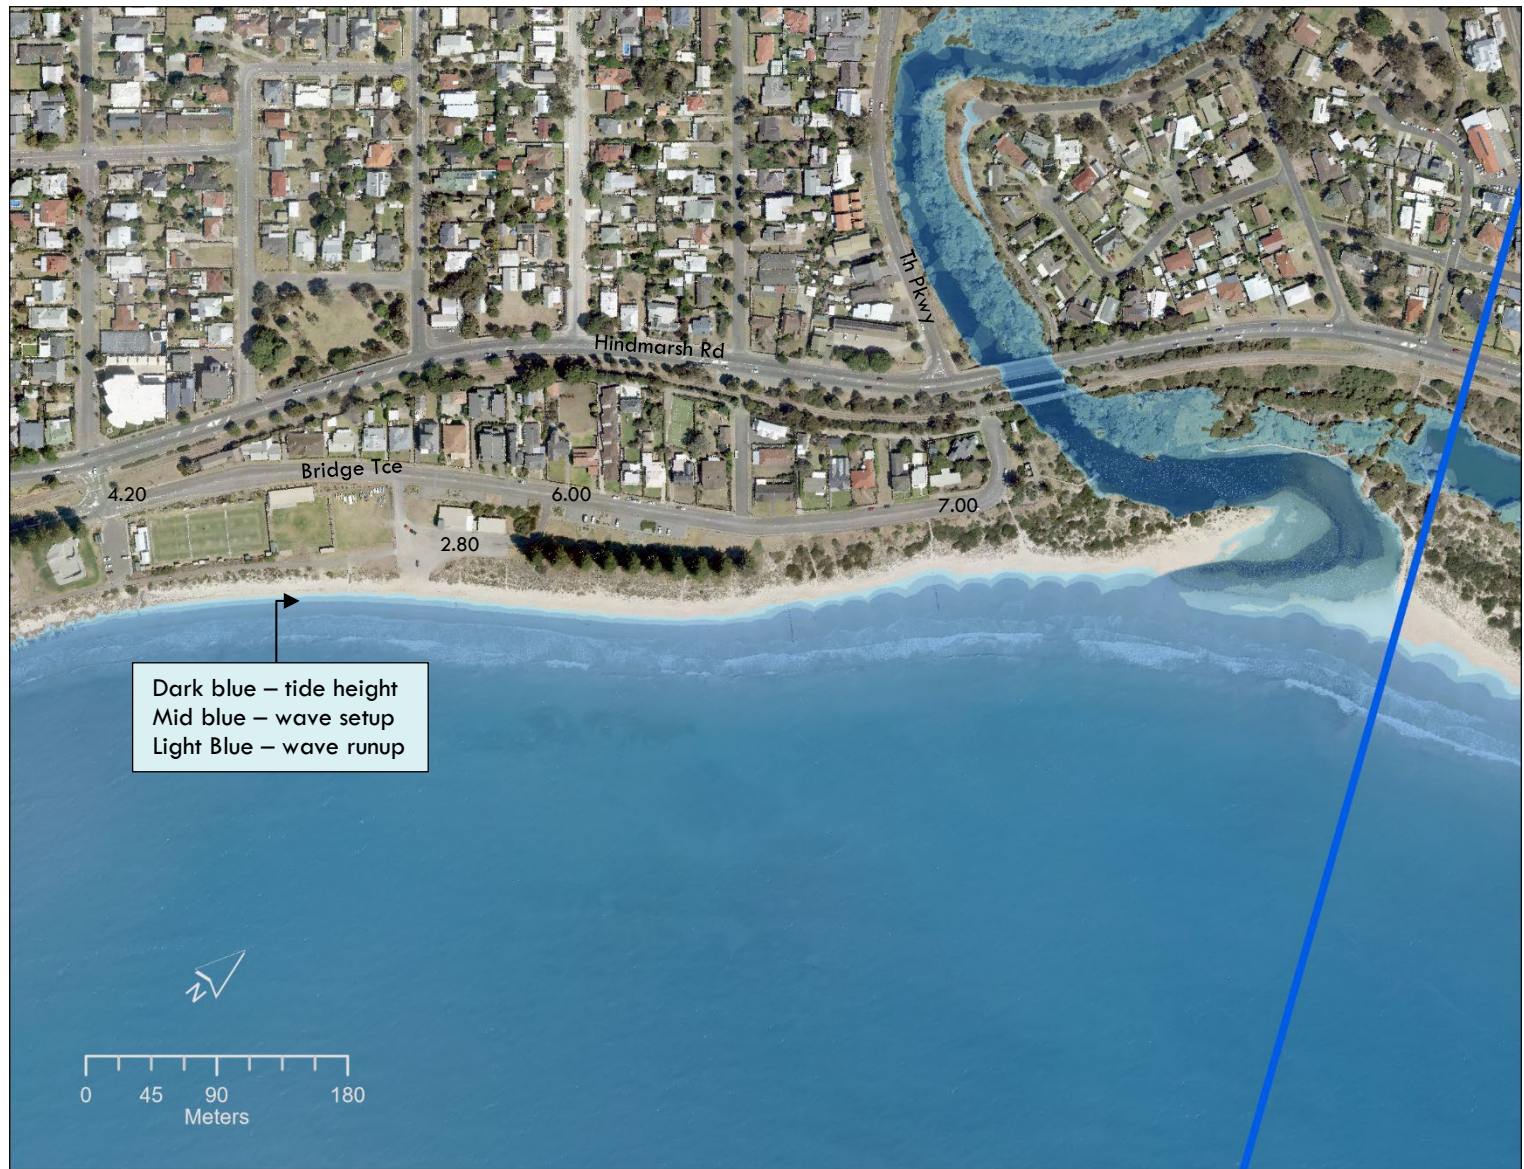
5. Coastal exposure – routine high water (2020)

Assessment: The modelling is congruent with observations and the current impact on beach and backshore is low.

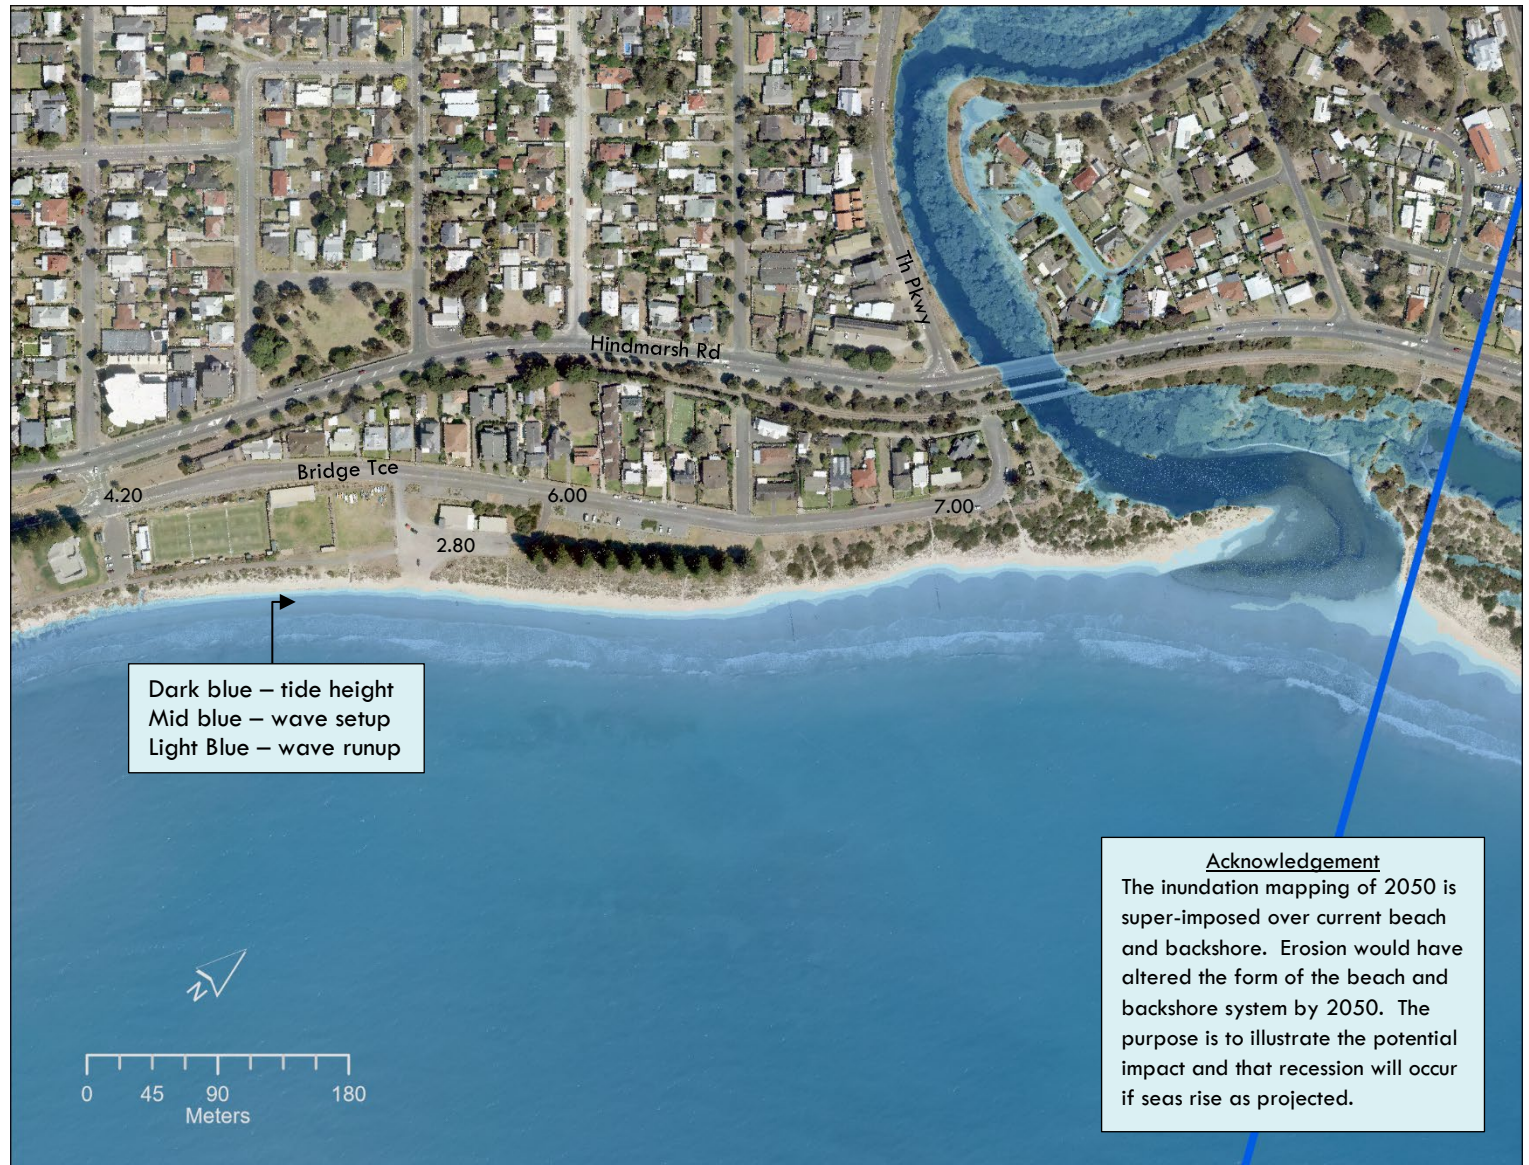
5. Coastal exposure – routine high water (2050)

Modelling indicates the impact would be relatively low.

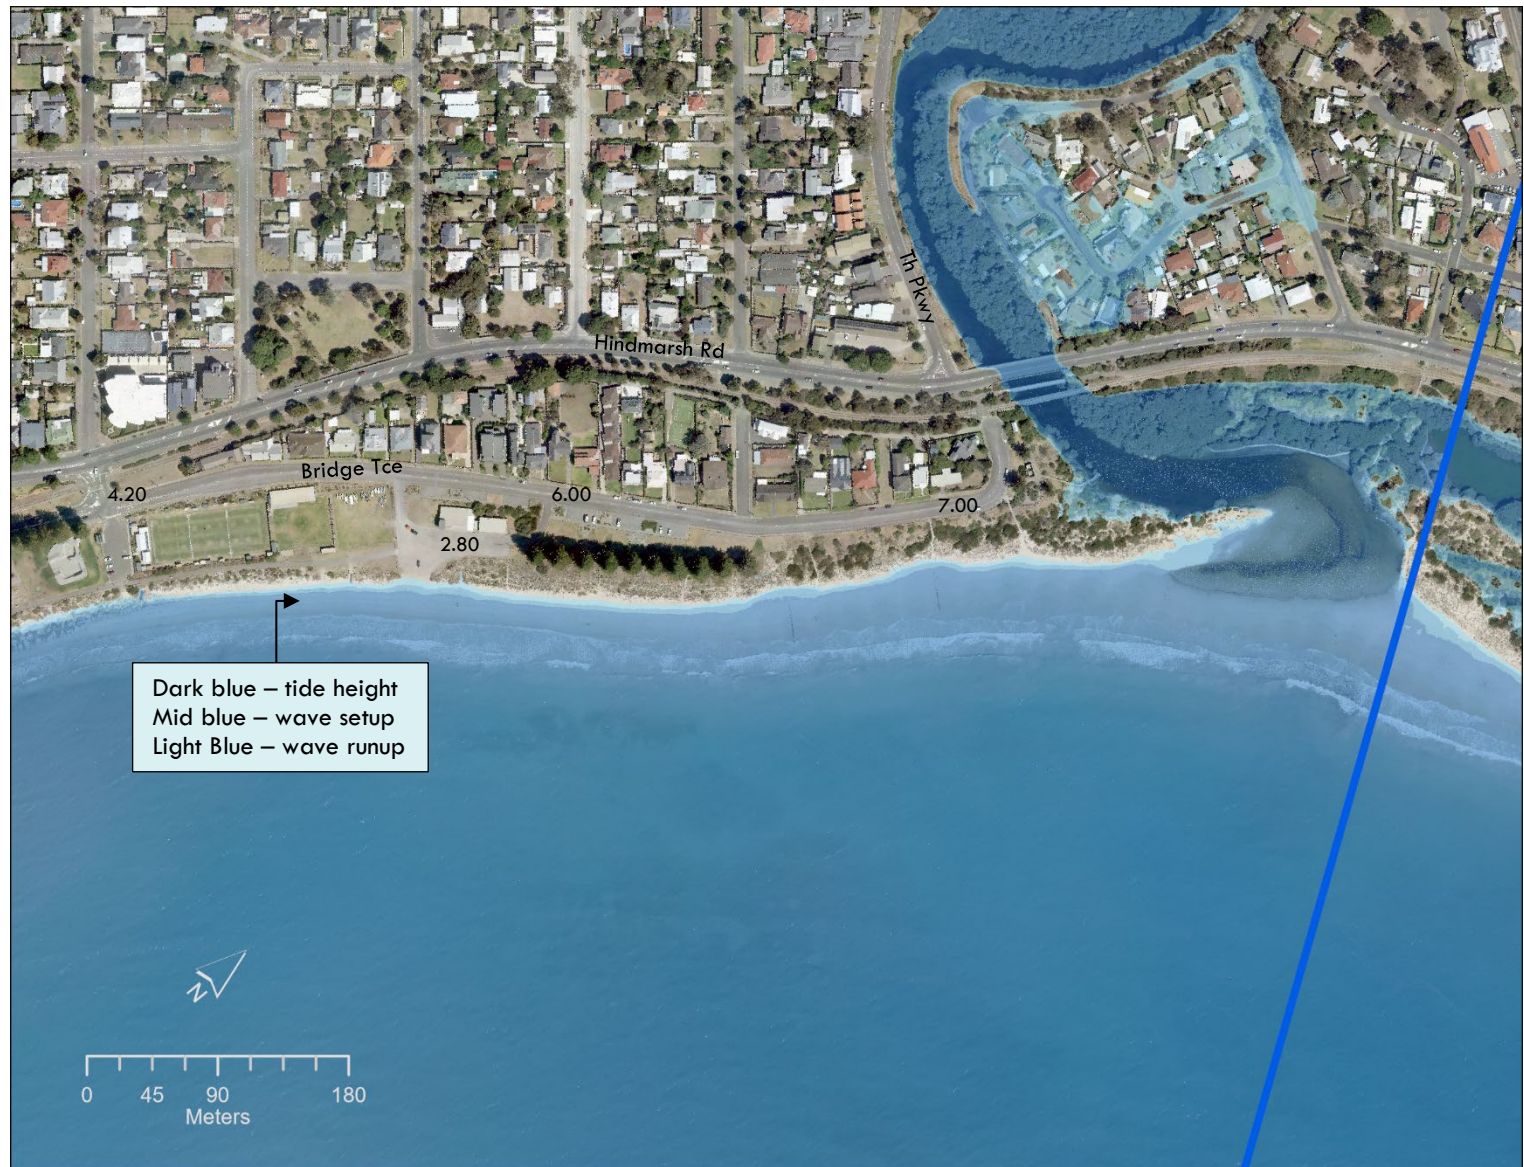
The current 1 in 100-year event would have significant impact on the dunes and some overtopping is likely. However, in the context of a rare event, the beaches and dunes could be expected to rebuild in this location.

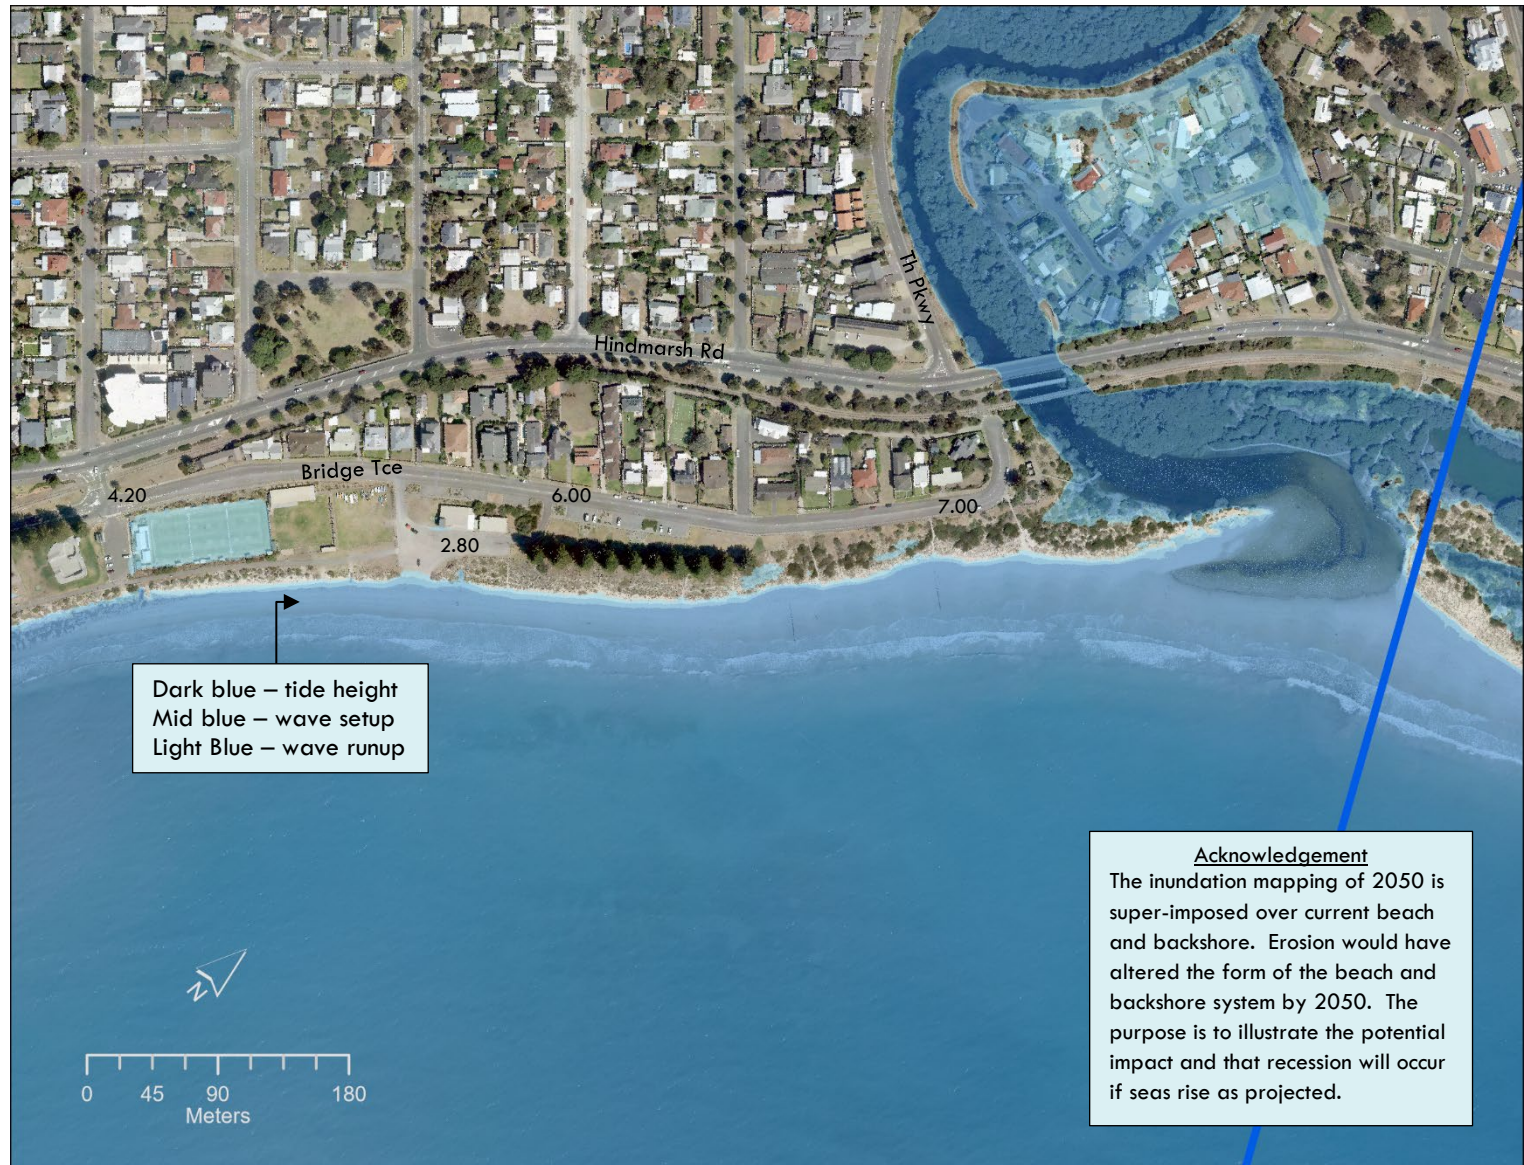
5. Coastal exposure – storm surge (2050)

The 1 in 100-year event in 2050 would have significant impact on the dunes and some overtopping is likely. In the context of increasing routine high-water events, some erosion and recession of these dunes is likely.

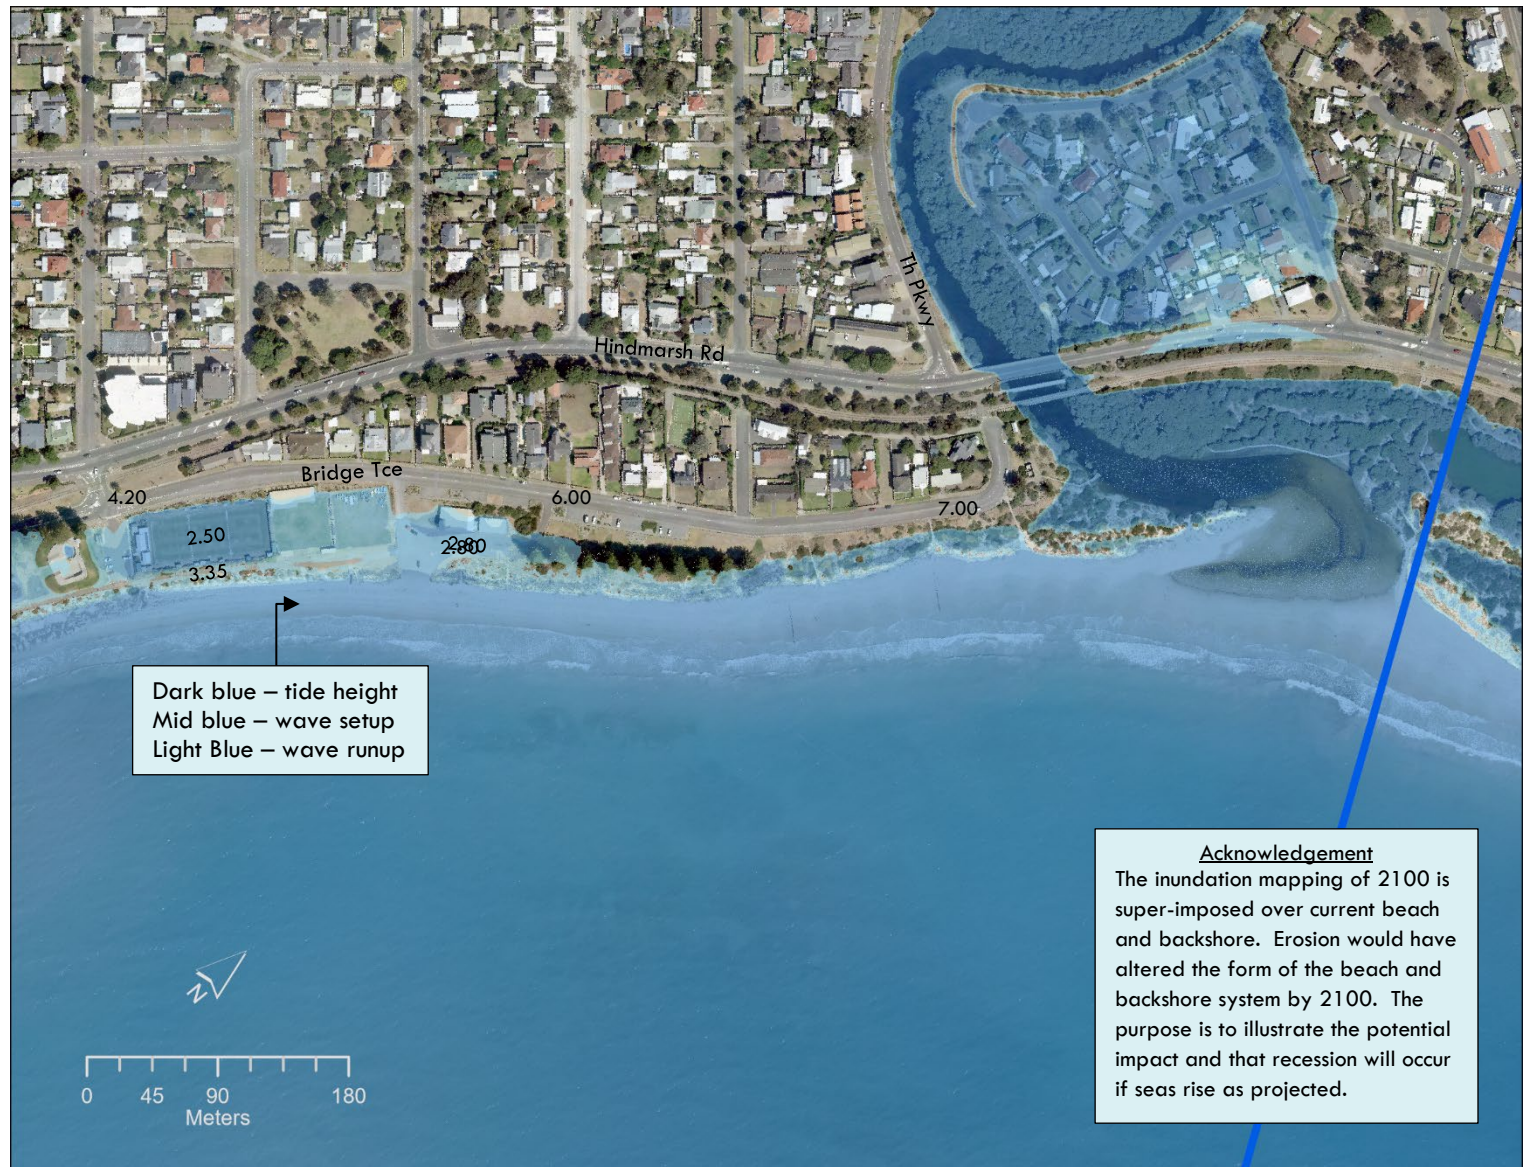
5. Coastal exposure – storm surge (2100)

The 1 in 100-year event projected for 2100 would significantly overtop the dunes and walking path. Playing fields would be inundated up to depths of 0.50m. The car park in front of the yacht club would be inundated up to 0.40m with waves likely interacting with the building. In the context of the routine tides projected for 2100, it is likely that the dune system would erode away and the shoreline retreat.

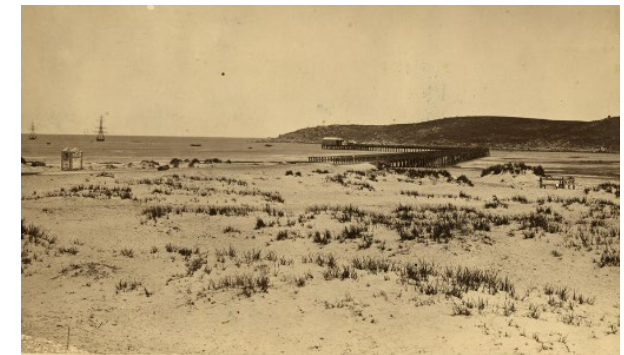
Figure a. Police Point was likely formed 4-5000 when seas were 1m higher than present and coastal areas upon which the gardens and playing fields are now situated were sand dunes.

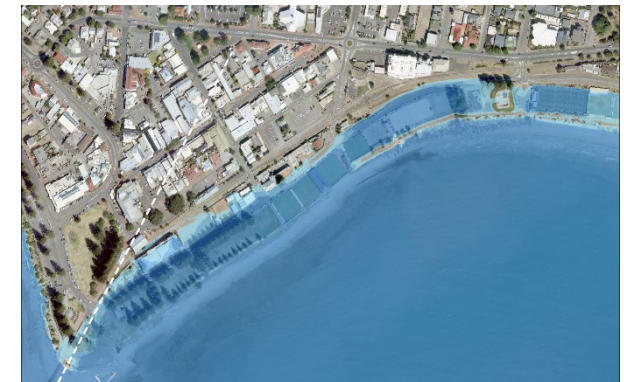
Figure b. Sea flood mapping for projected sea level rise of 1m by 2100 suggests a future coastline under natural conditions that aligns with Flinders Parade and Bridge Terrace.

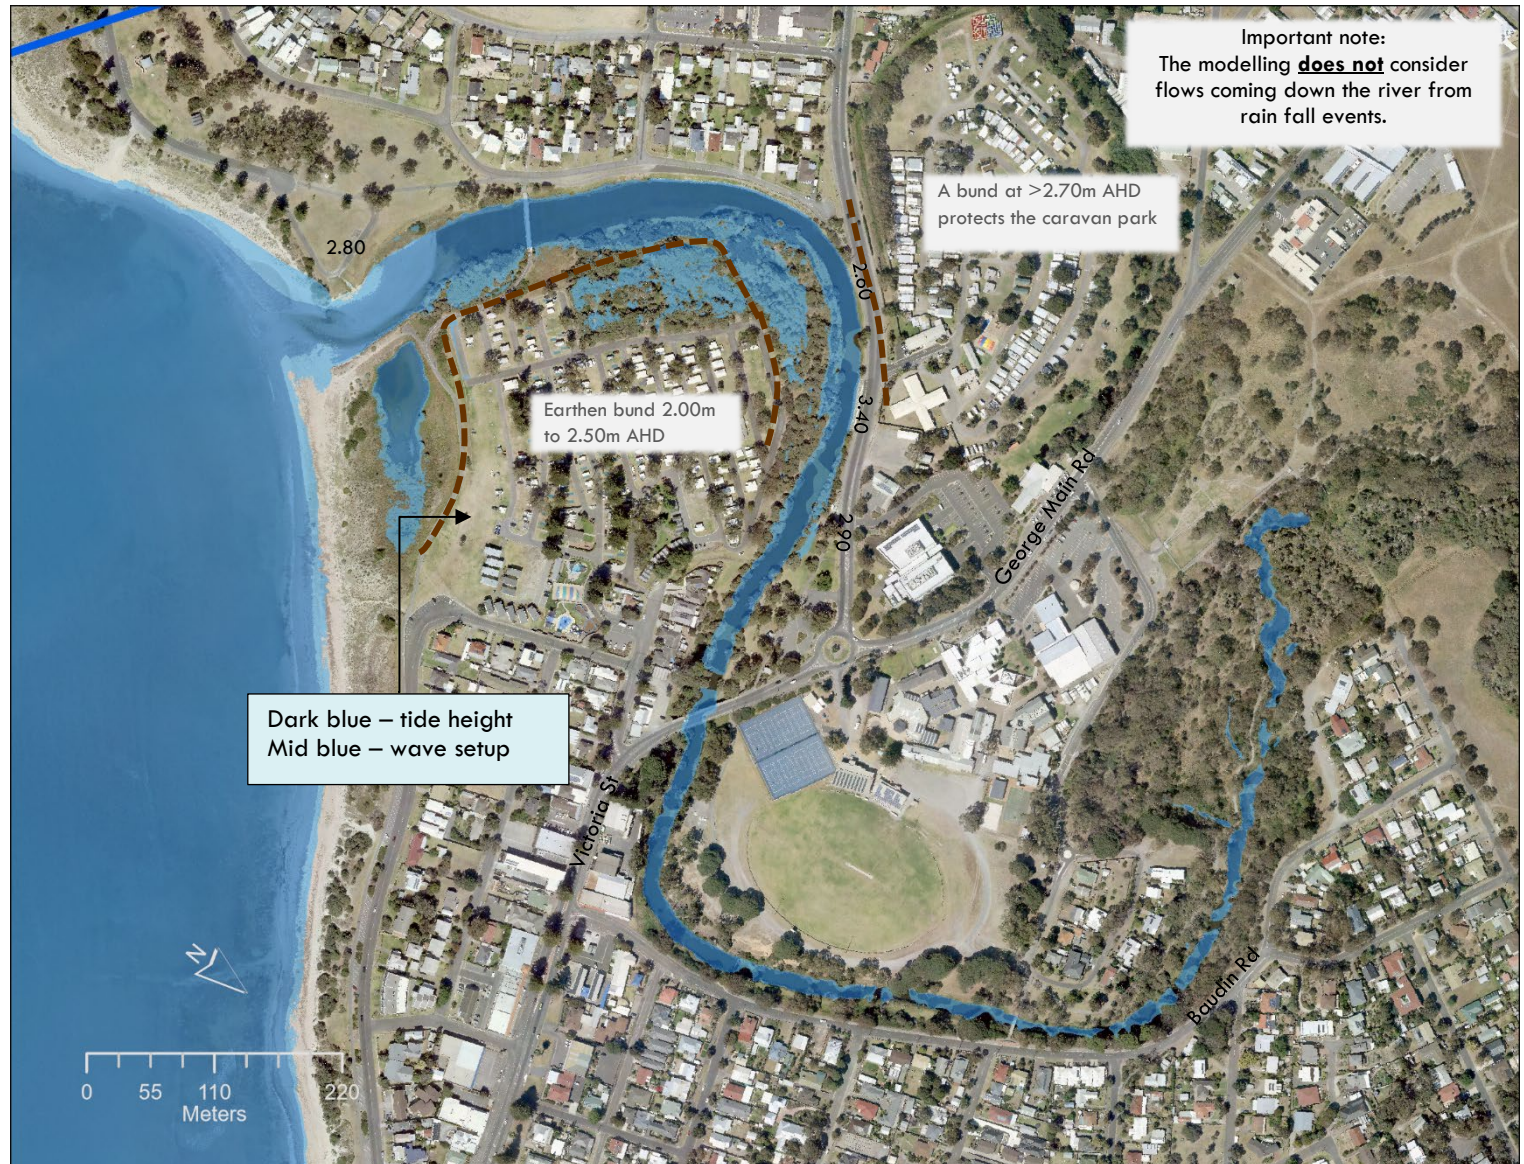
The caravan park is protected by an earthen bund at heights 2.00m to 2.50m AHD. (Note this bund has not been surveyed but height estimated within the digital elevation model). Routine high-water is not having any impact in the caravan park or surrounding areas.

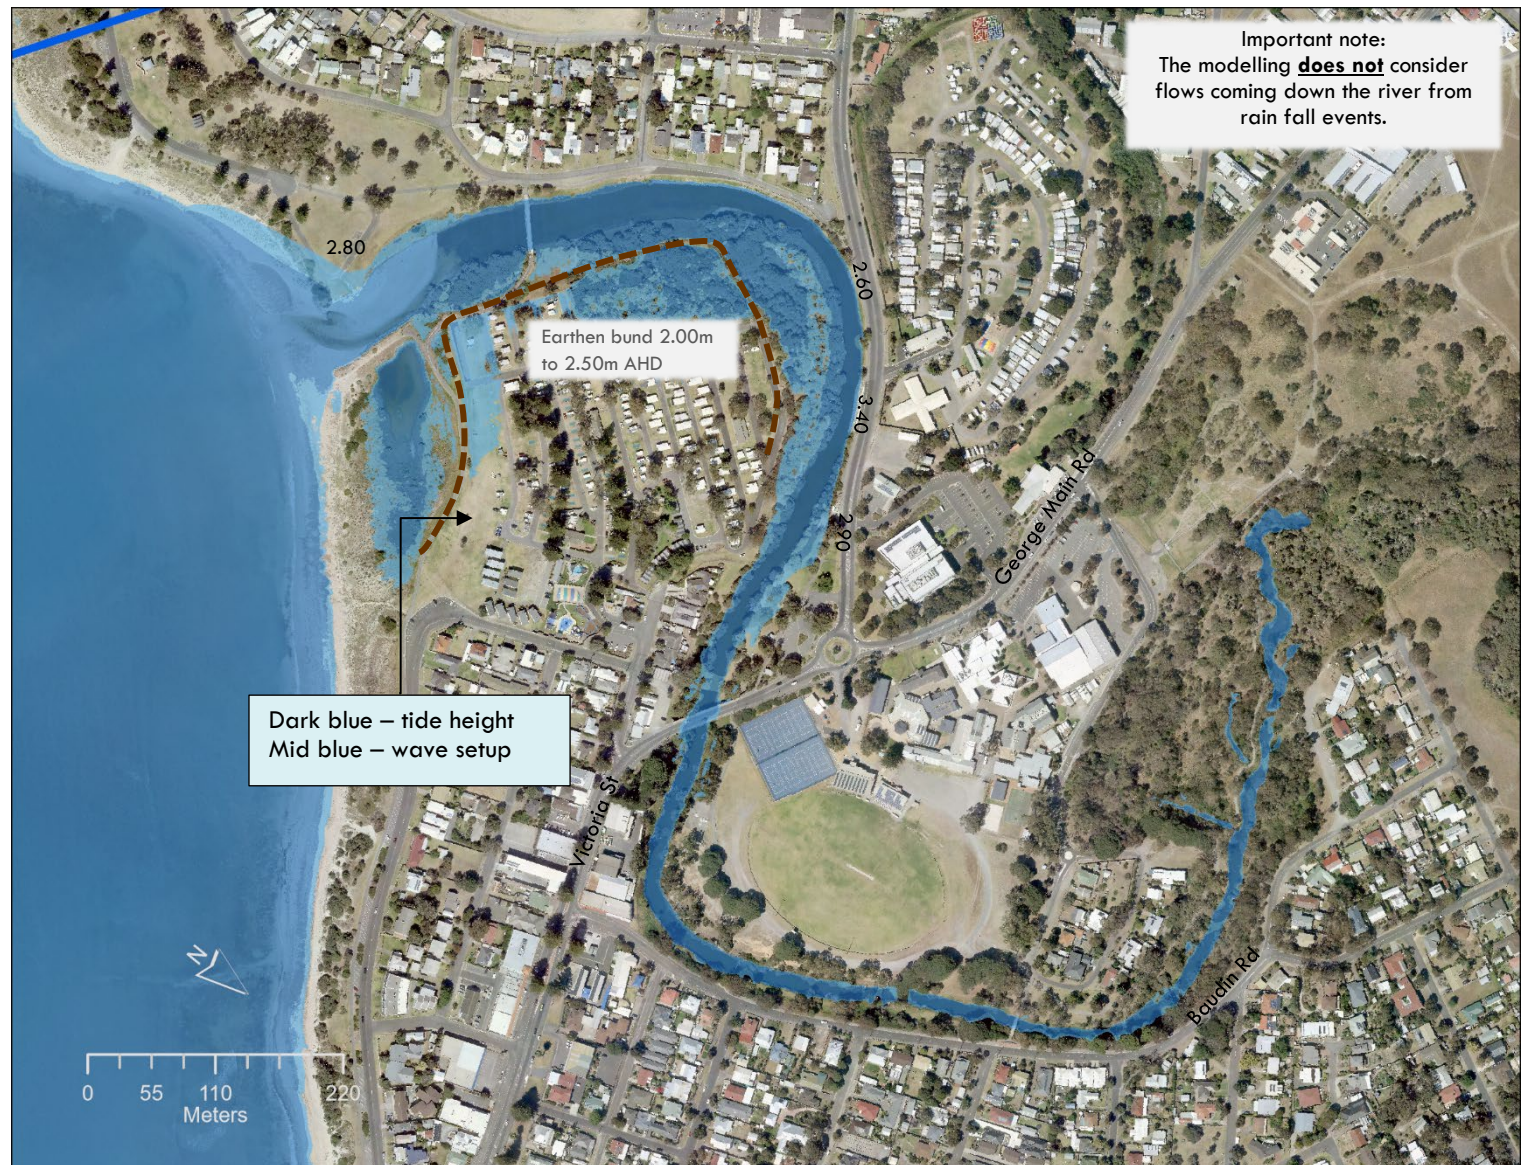
5. Coastal exposure – Routine high water (2050)

The caravan park is protected by an earthen bund at heights 2.00m to 2.50m AHD. (Note this bund has not been surveyed but height estimated within the digital elevation model). Routine high-water at 2050 is unlikely to have any impact in the caravan park or surrounding areas.
