Coastal Adaptation Study &
Coastal Adaptation Strategy

VICTOR HARBOR CENTRAL

Cell
Fleurieu 11

For City of
Victor Harbor

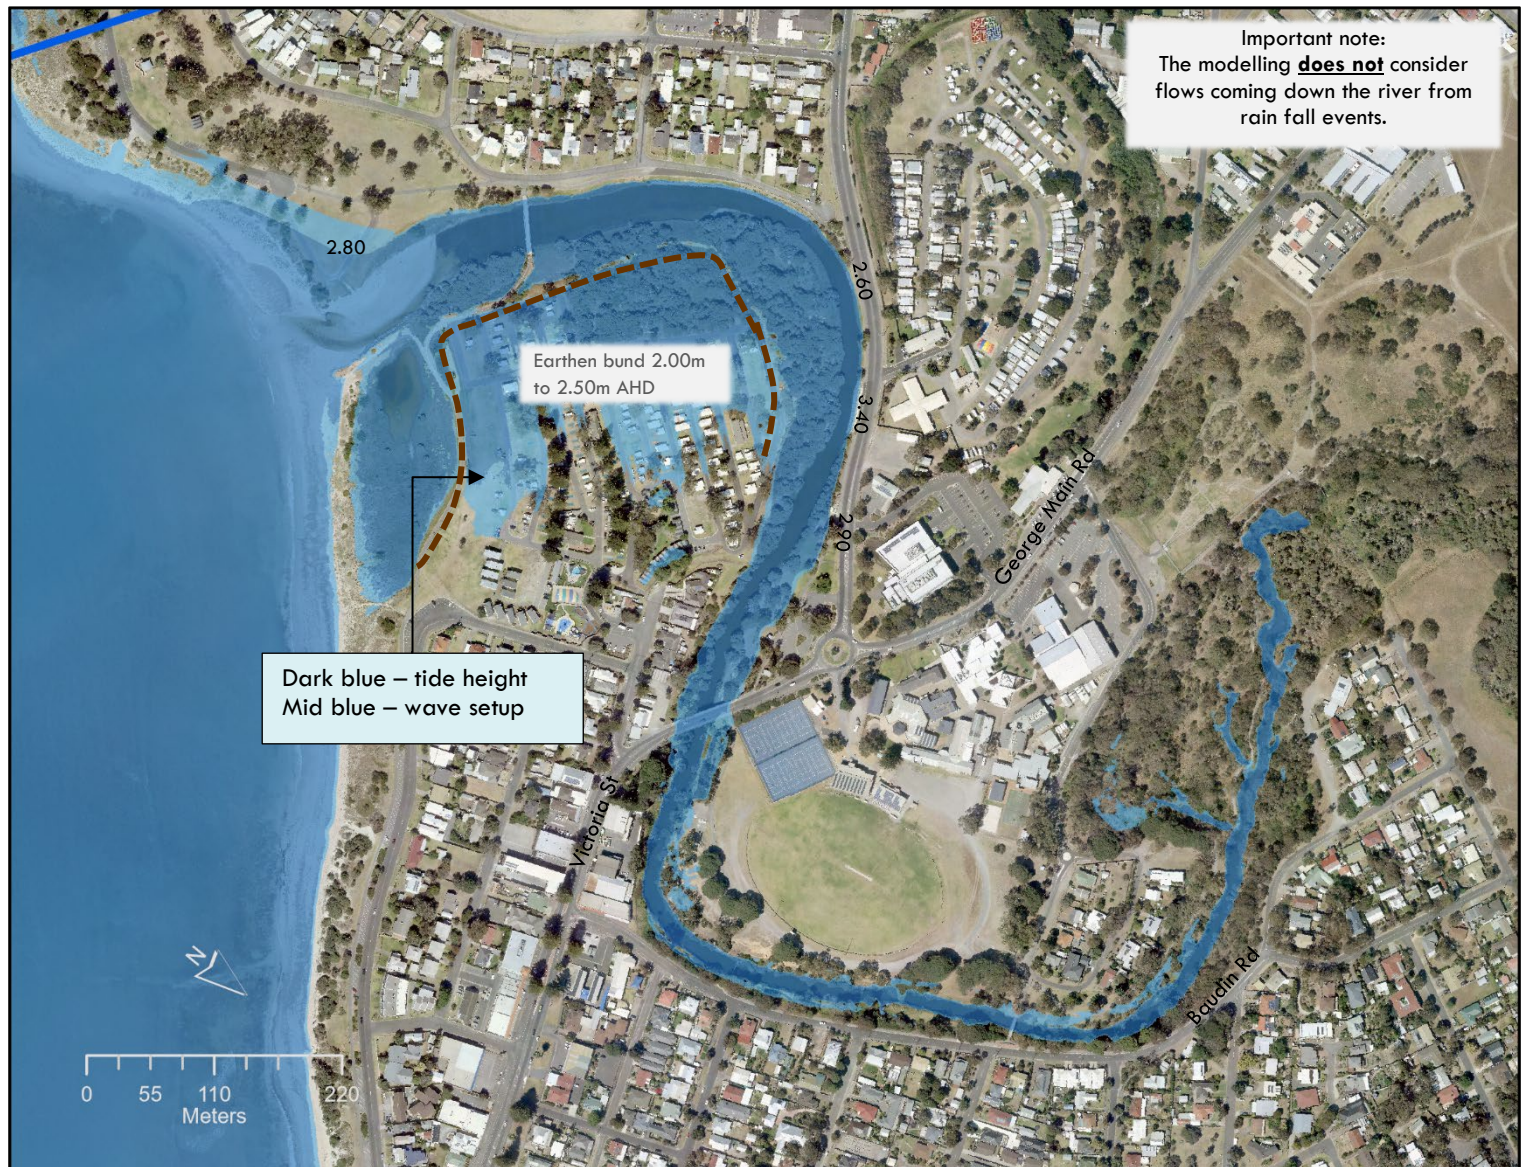
5. Coastal exposure – Storm surge (2020)

The modelling within the estuary is likely to be depicted higher than actual due to the presence of wave setup. The bund around the caravan park is likely to be adequate.

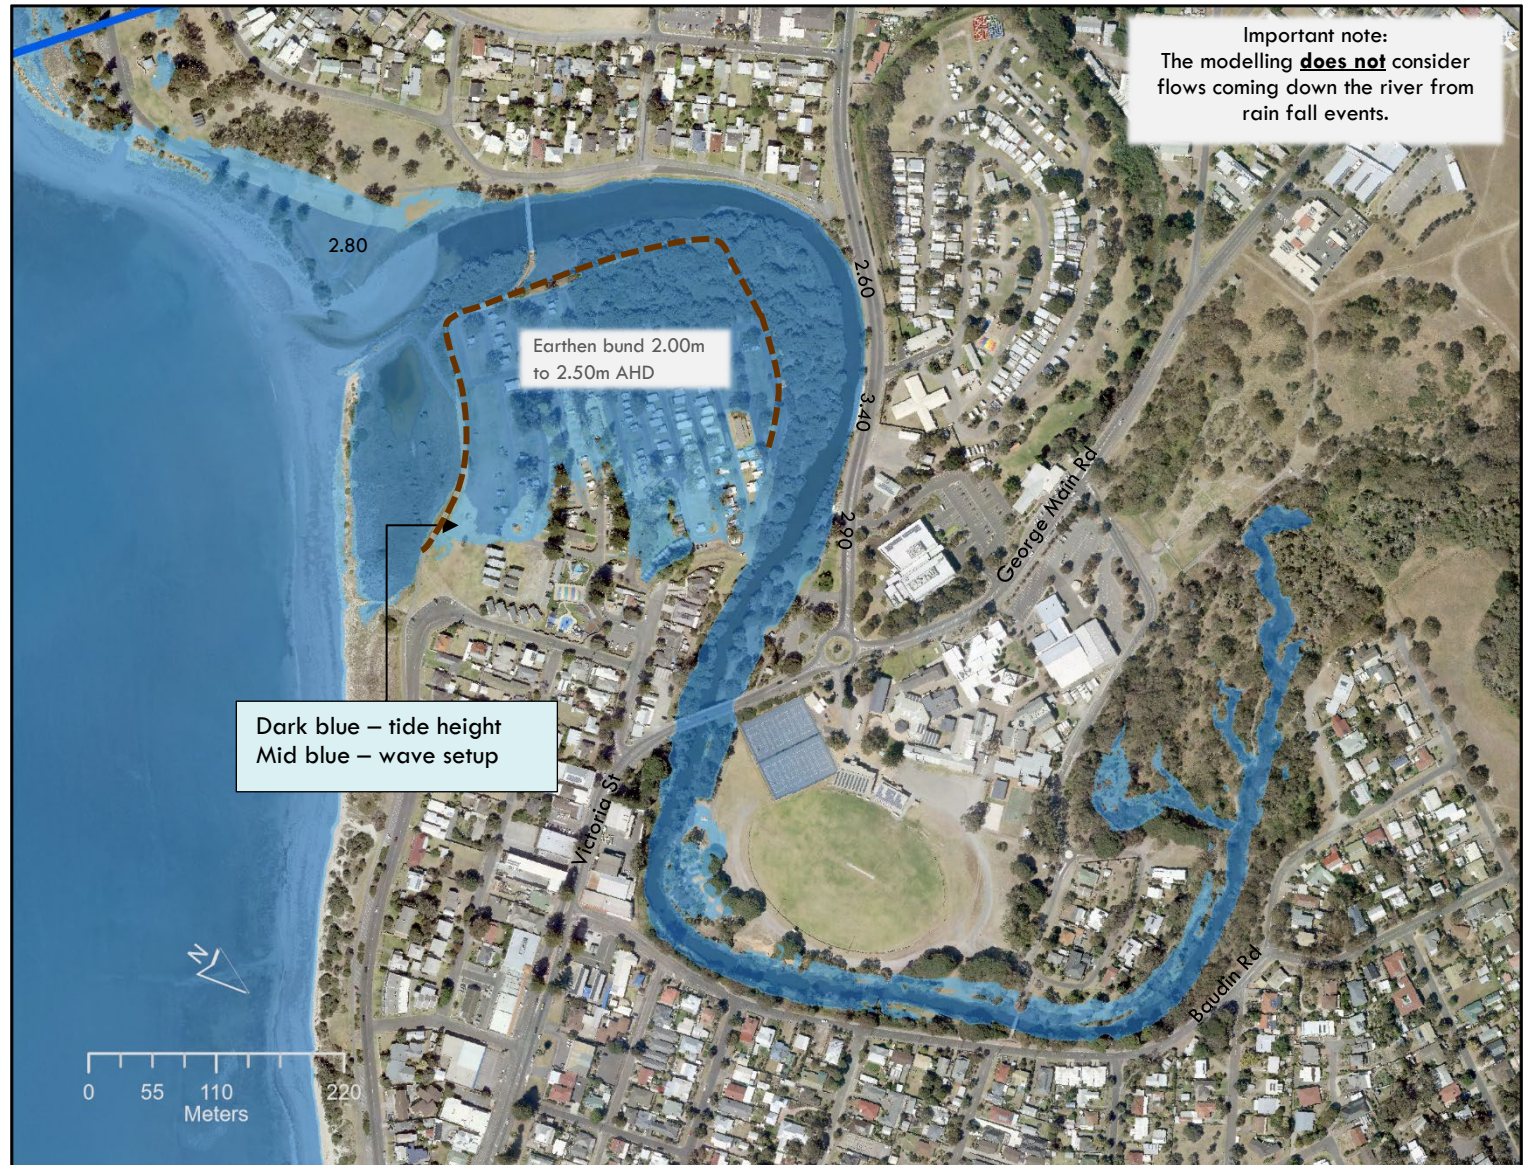
5. Coastal exposure – Storm surge (2050)

Some sea water flooding over the embankments may disrupt the ecology.

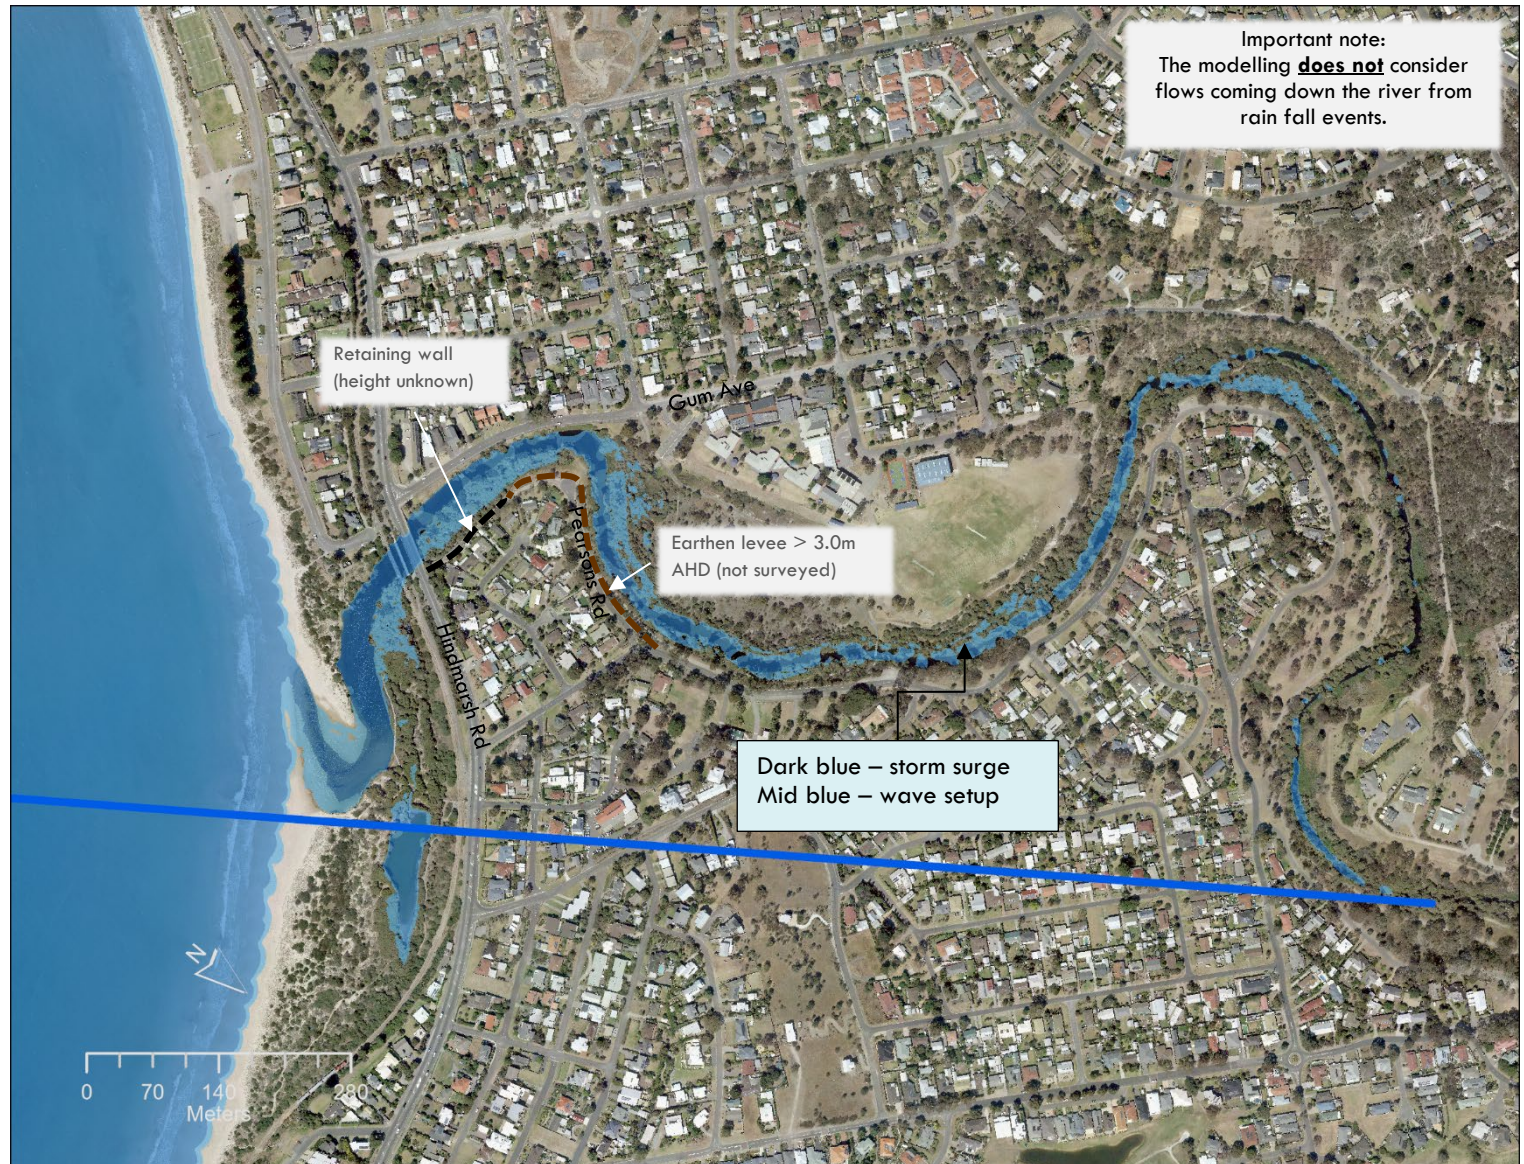
This scenario is the current scenario and impacts are current. Council informs that the mouth of the river is opened mechanically when river levels become too high in the lower estuary. Residents inform that the walkway under the bridge becomes flooded on occasions (and this is also related to mouth opening).

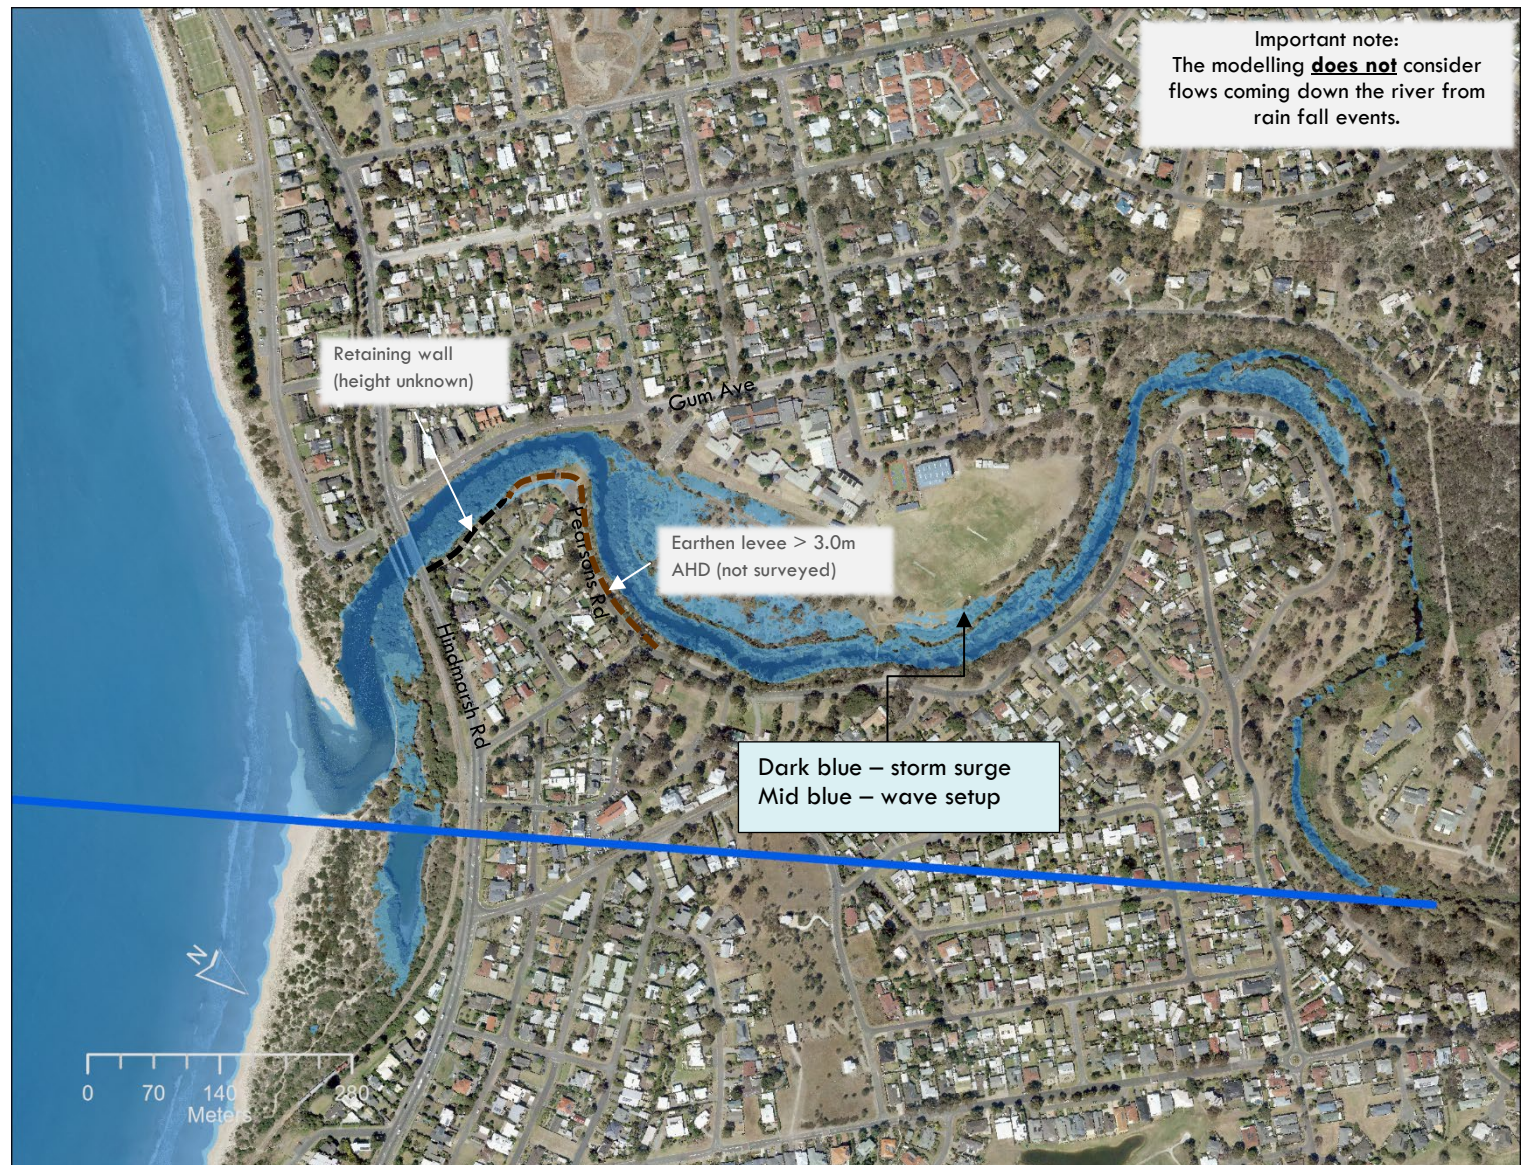
5. Coastal exposure – Routine high water (2050)

The scenario for 2050 indicates increased incursion of seawater into the floodplain area south of the high school. Anecdotes from residents suggest that this area is sometimes currently flooded (but this may relate to rain fall events). The residential area between Hindmarsh Road and Persons Rd is protected by an earthen levee and concrete retaining wall.

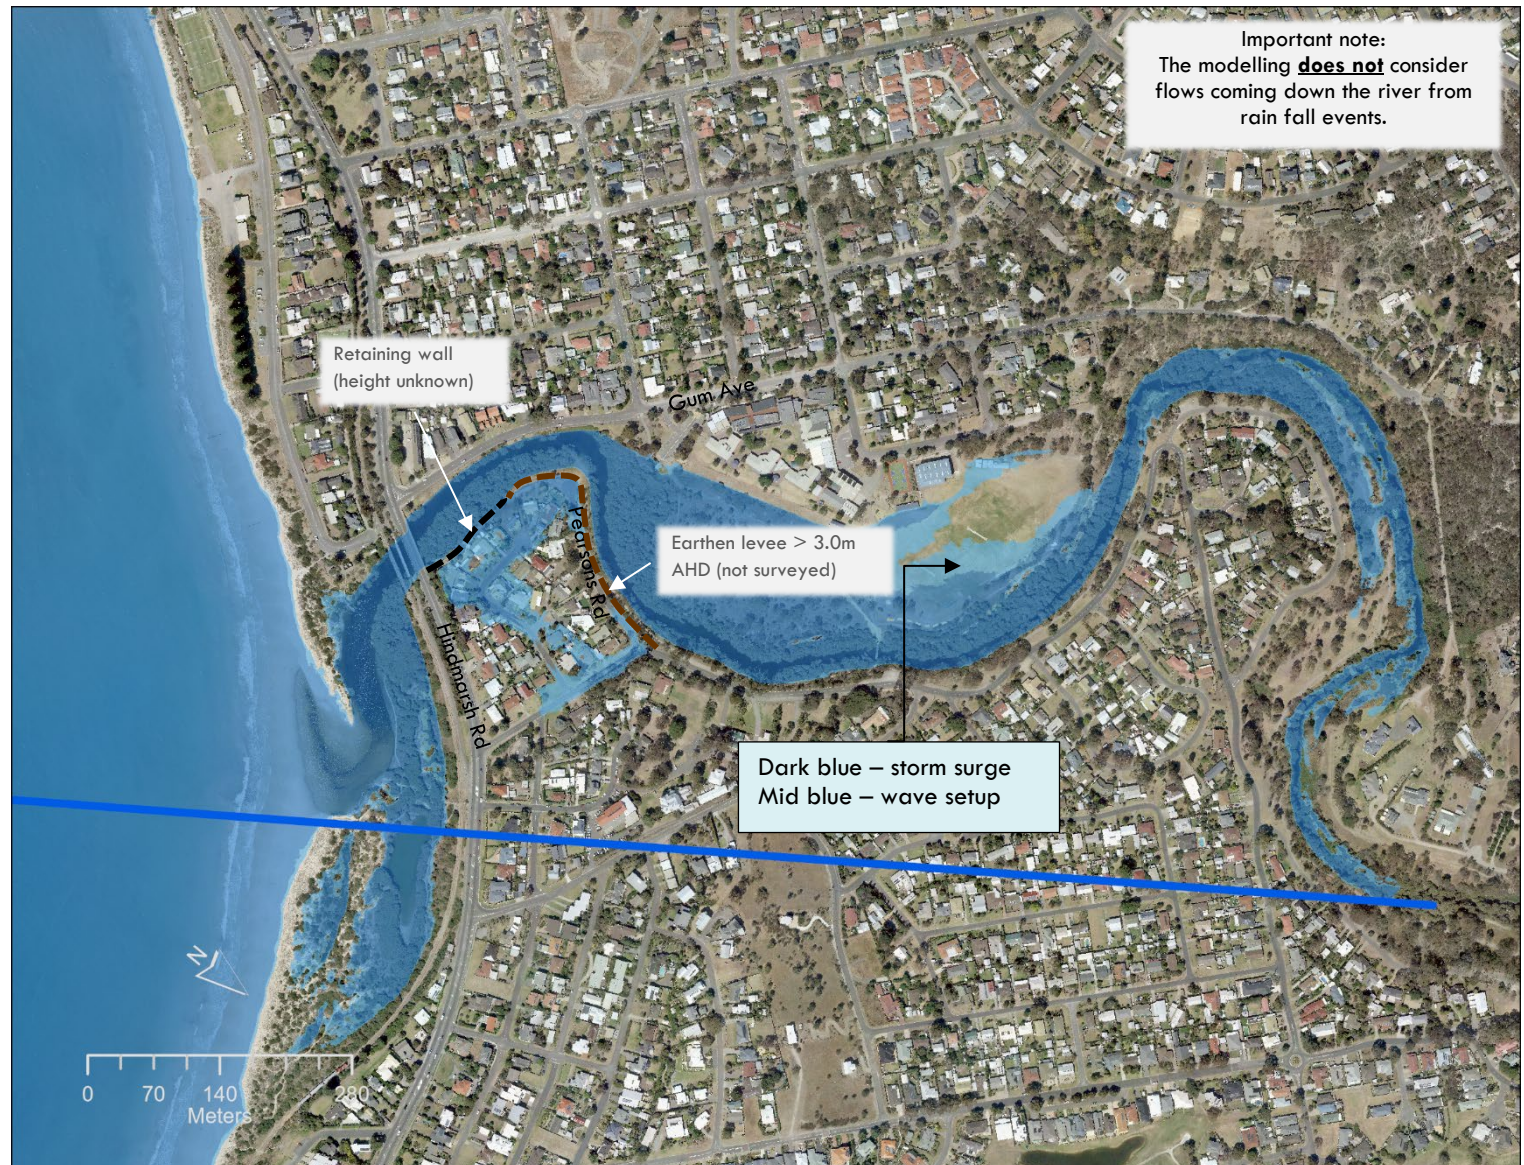
5. Coastal exposure – Routine high water (2100)

The scenario for 2100 indicates significant and regular incursion of seawater into the floodplain area south of the high school. The residential area between Hindmarsh Road and Persons Rd is protected by an earthen levee and concrete retaining wall. The earthen levee is at an appropriate height, but the height of the retaining wall is unknown.

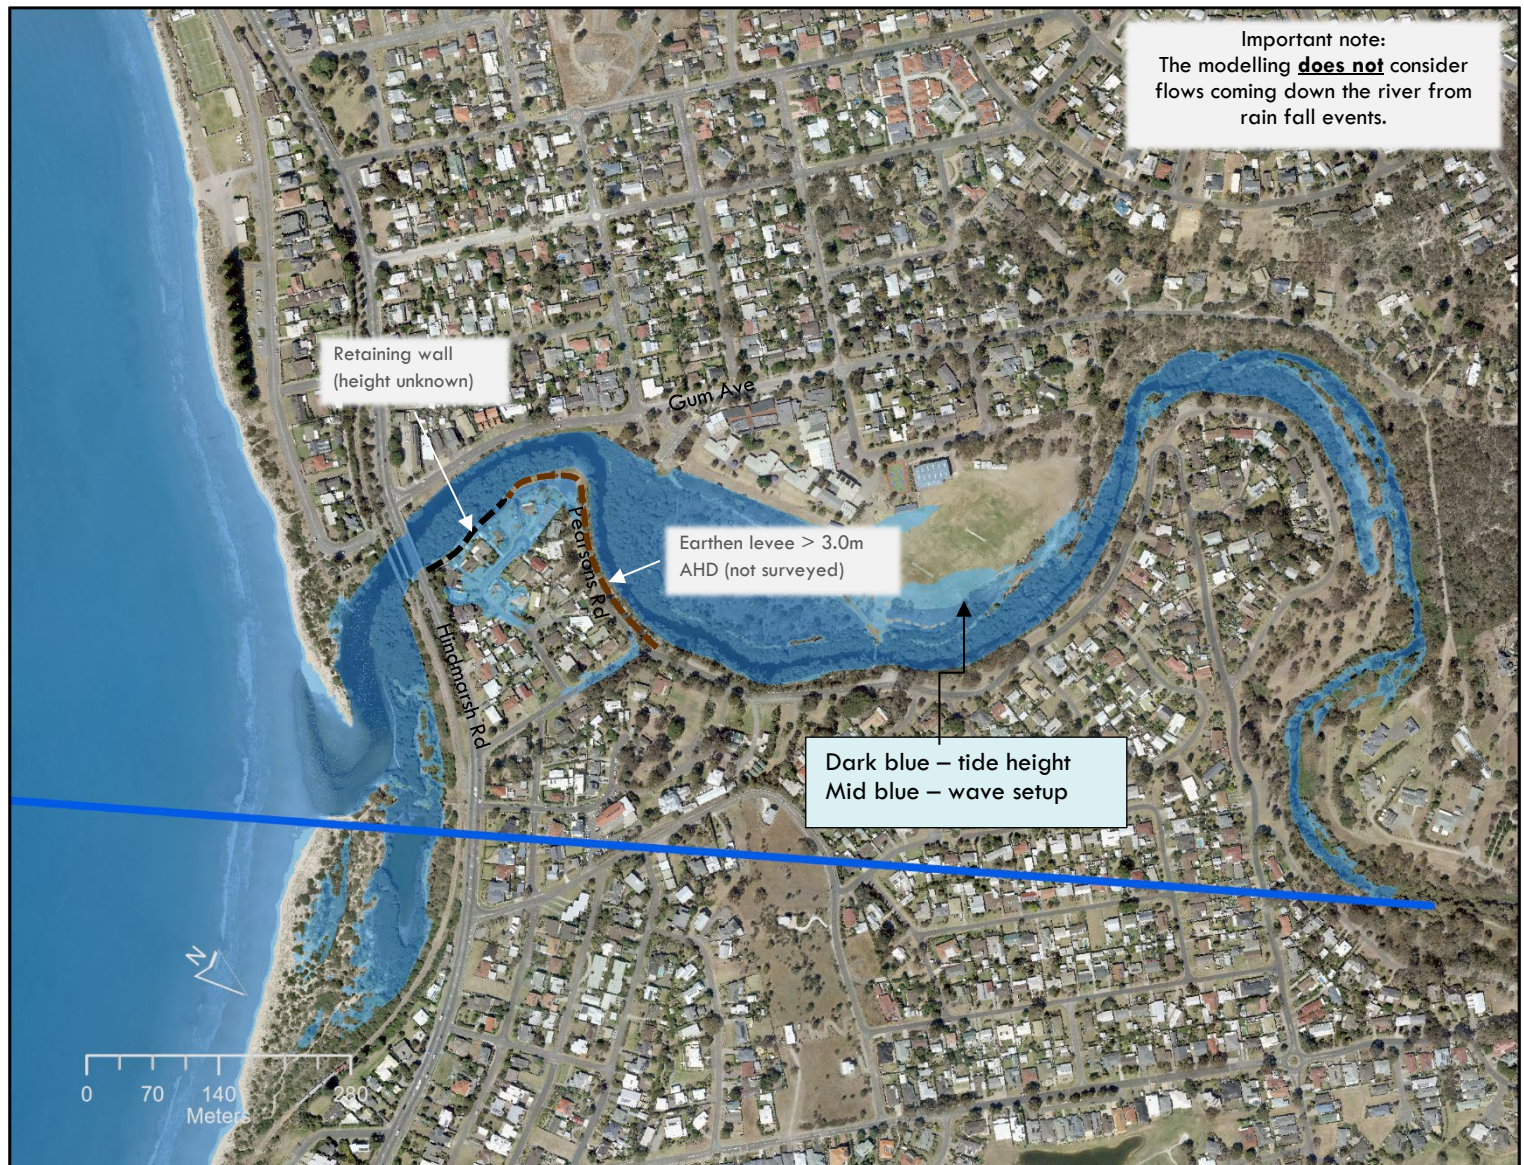
5. Coastal exposure – Storm surge (2020)

The scenario for 2020 suggests that if the 1 in 100-year event occurred, the flood plain south of the high school would be inundated. This would depend on the nature of the mouth at the time and possible flow rates and volume of water. The residential area between Hindmarsh Road and Persons Rd is protected by an earthen levee and concrete retaining wall. The earthen levee is at an appropriate height, but the height of the retaining wall is unknown (further research).

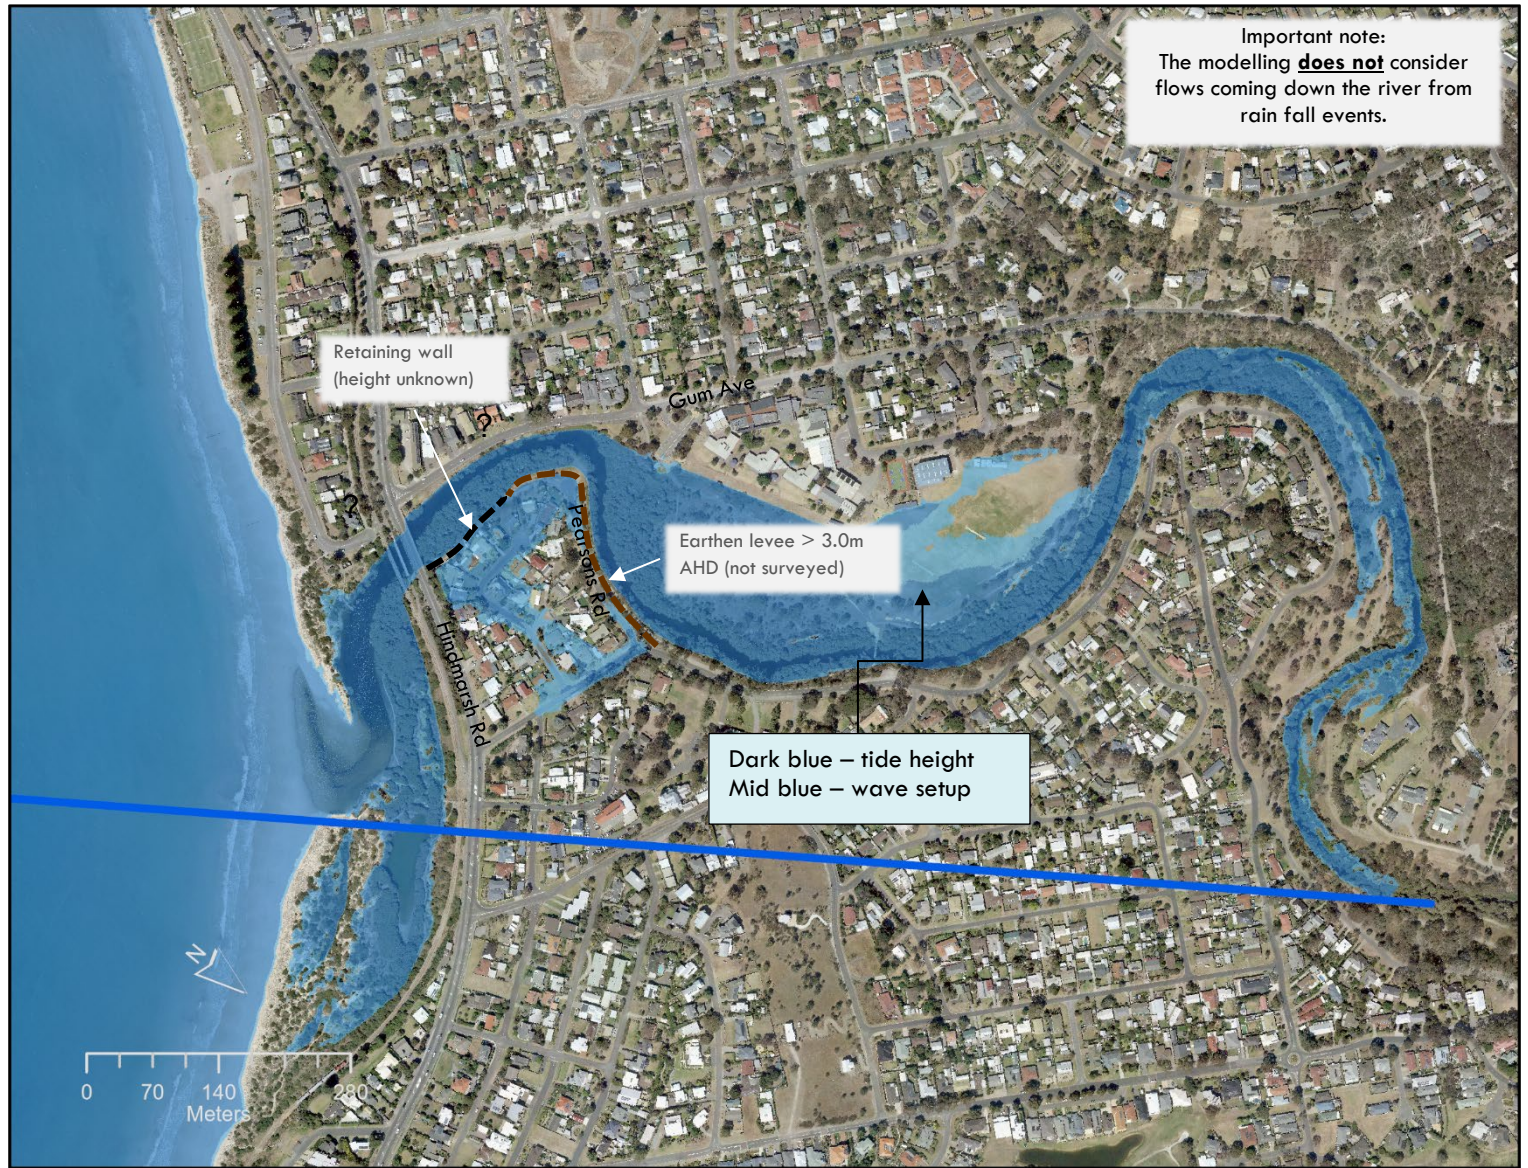
5. Coastal exposure – Storm surge (2050)

The scenario for 2050 suggests that if the 1 in 100-year event occurred, the flood plain south of the high school would be inundated. This would depend on the nature of the mouth at the time and possible flow rates and volume of water. The residential area between Hindmarsh Road and Persons Rd is protected by an earthen levee and concrete retaining wall. The earthen levee is at an appropriate height, but the height of the retaining wall is unknown (further research).

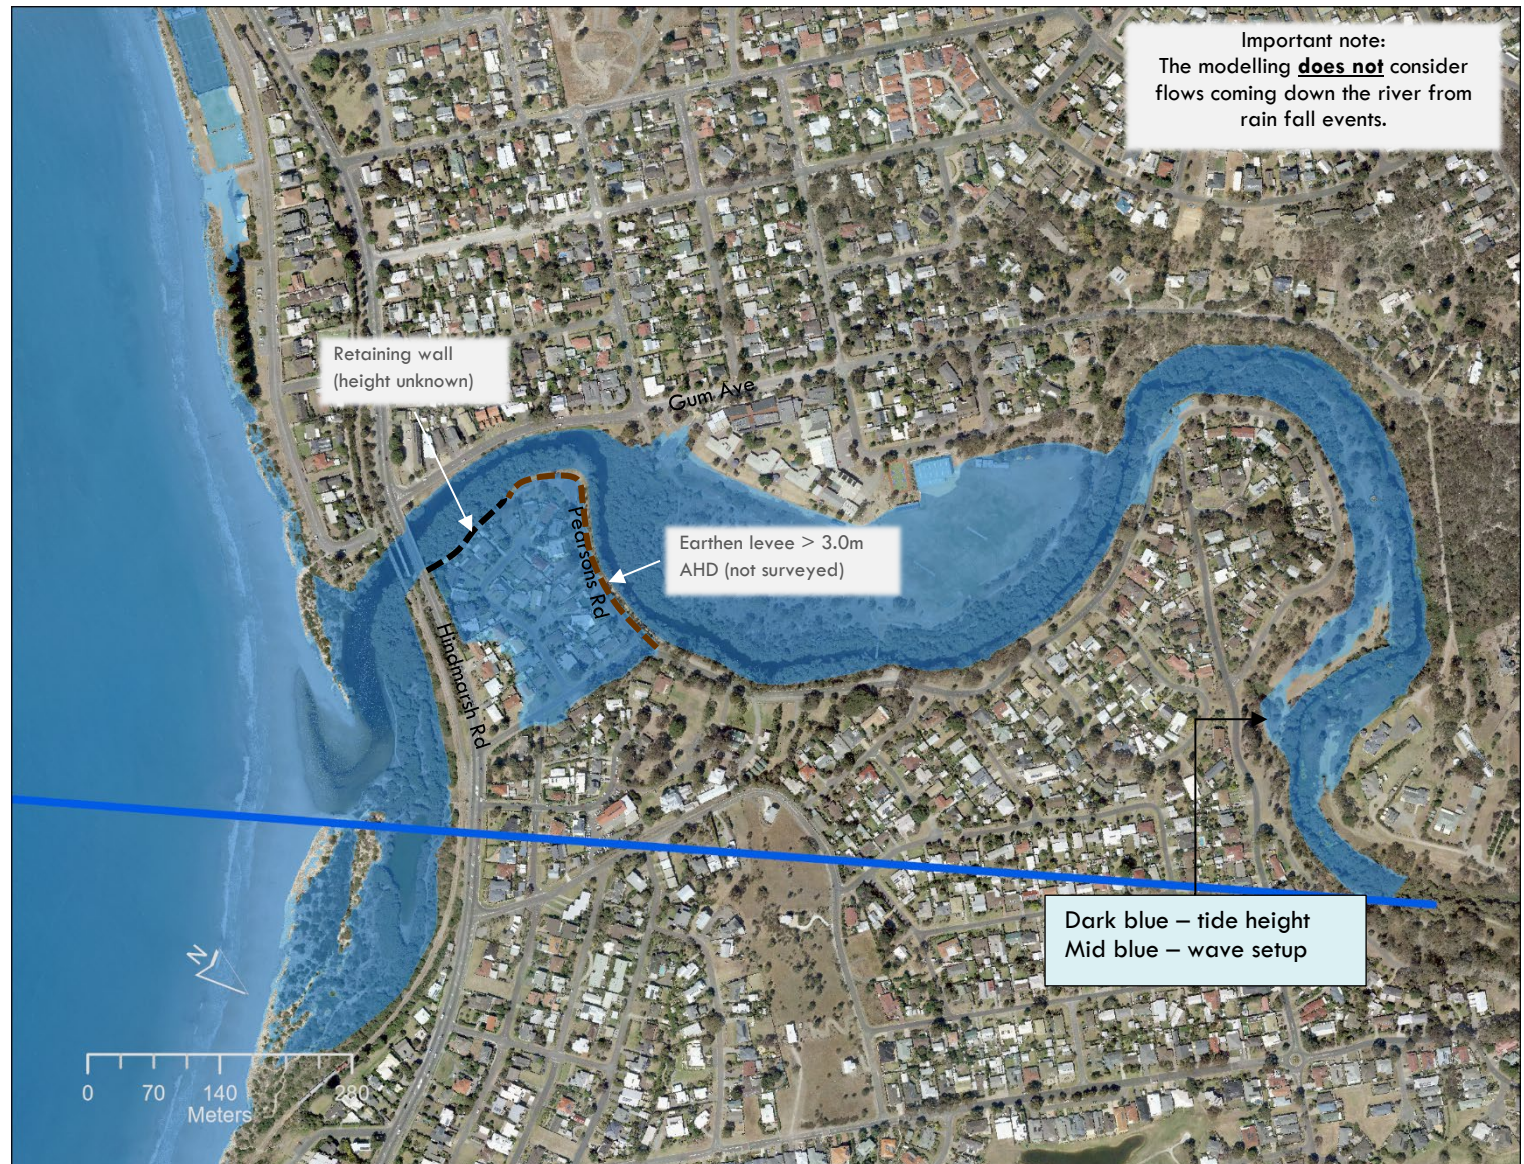
5. Coastal exposure – Storm surge (2100)

The scenario for 2100 indicates that if the 1 in 100-year event occurred, the flood plain south of the high school would be inundated but the high school would remain largely unaffected.
The residential area between Hindmarsh Road and Persons Rd is protected by an earthen levee and concrete retaining wall. The earthen levee is at an appropriate height, but the height of the retaining wall is unknown. Further research required.

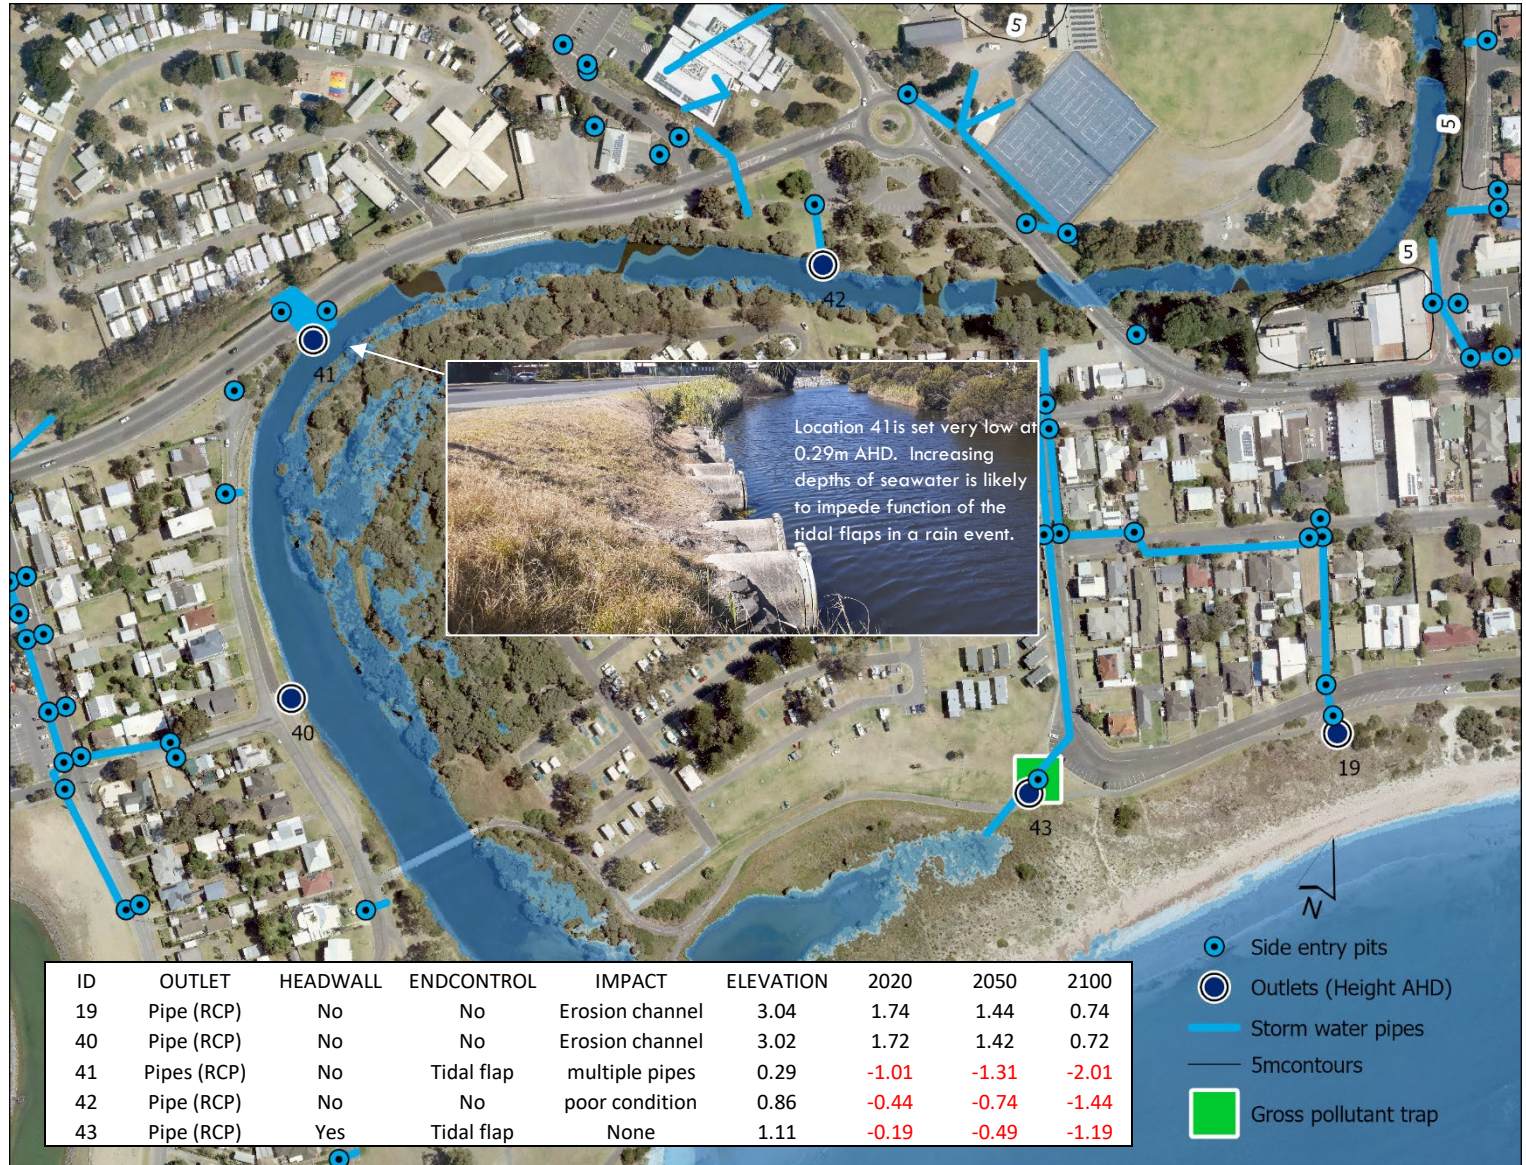
Location 41 is prime storm water infrastructure draining water from the northern side of Bay Road (see inset photograph). Regarding 42, storm water can flow down the bank. Other locations are likely to maintain function.

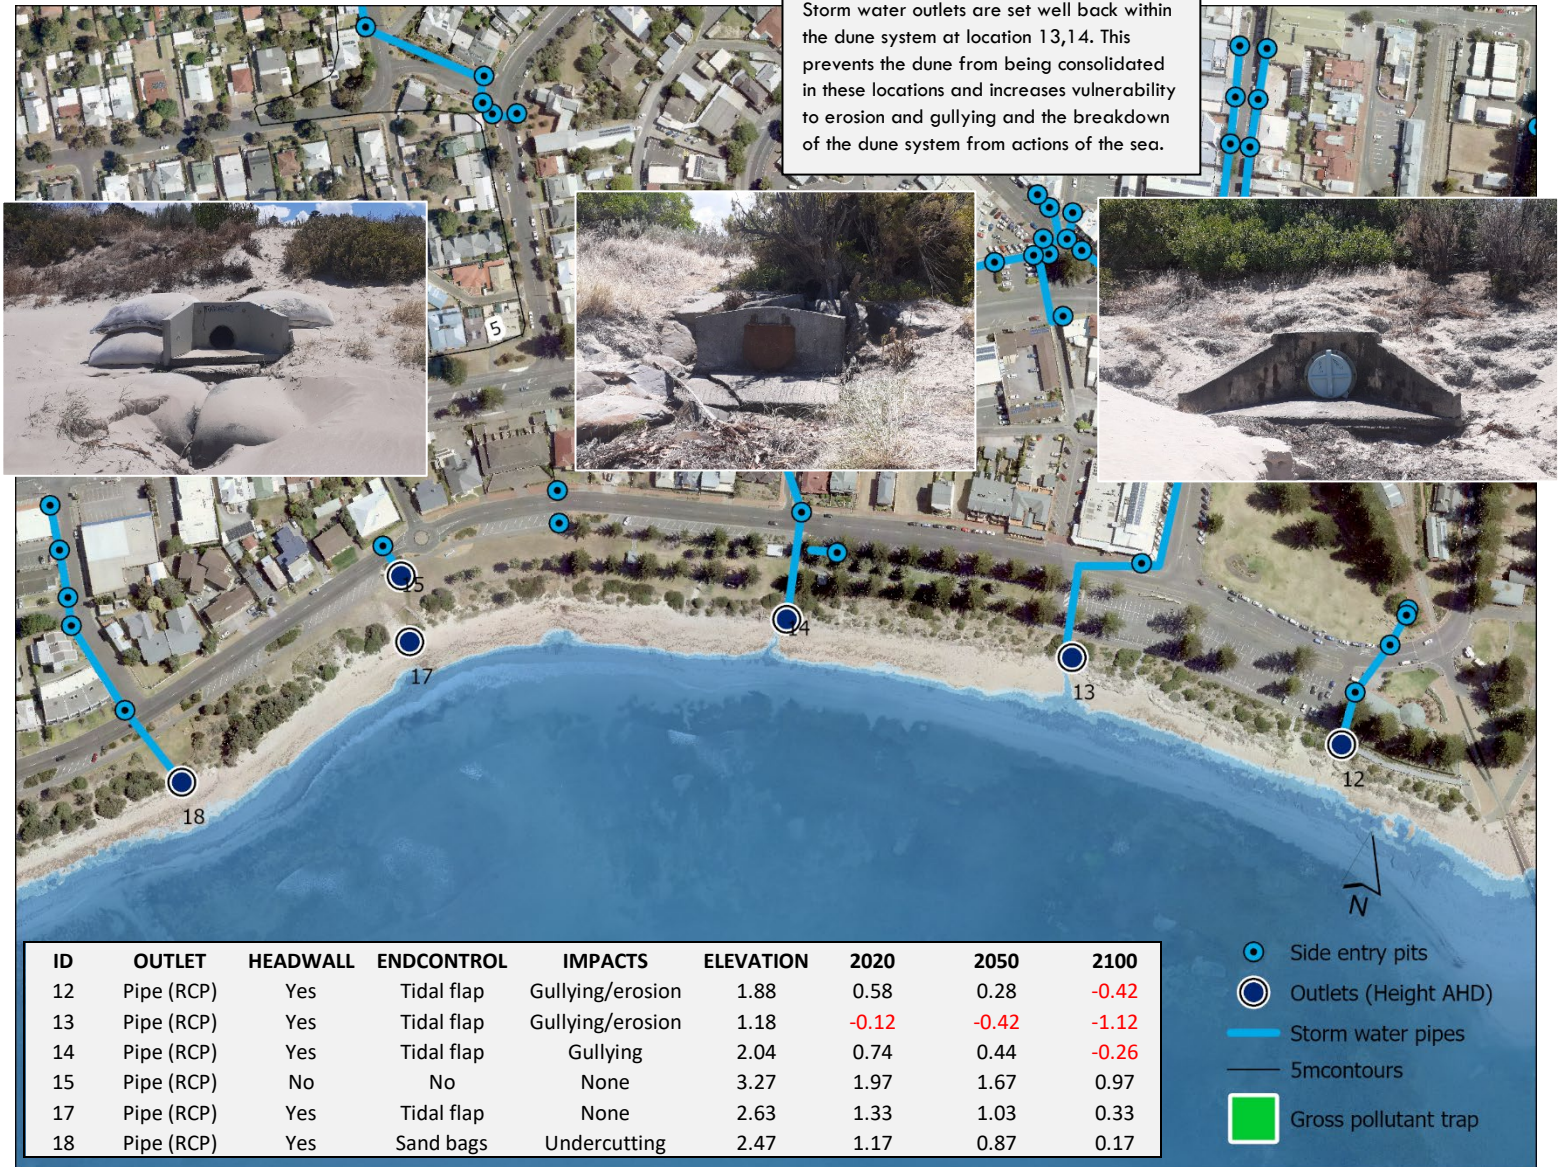
Inspection of the outlet reveals that wave runoff is sometimes interacting with the storm water outlet in this current era. However, it is unlikely that actions of the sea would close the tidal flap for routine tidal events up until 2050 (with the exception of location 13). Storm water does significantly lower sand levels on the beach. This will tend to increase the erosion and gullyng of the backshore. See also inset comment.

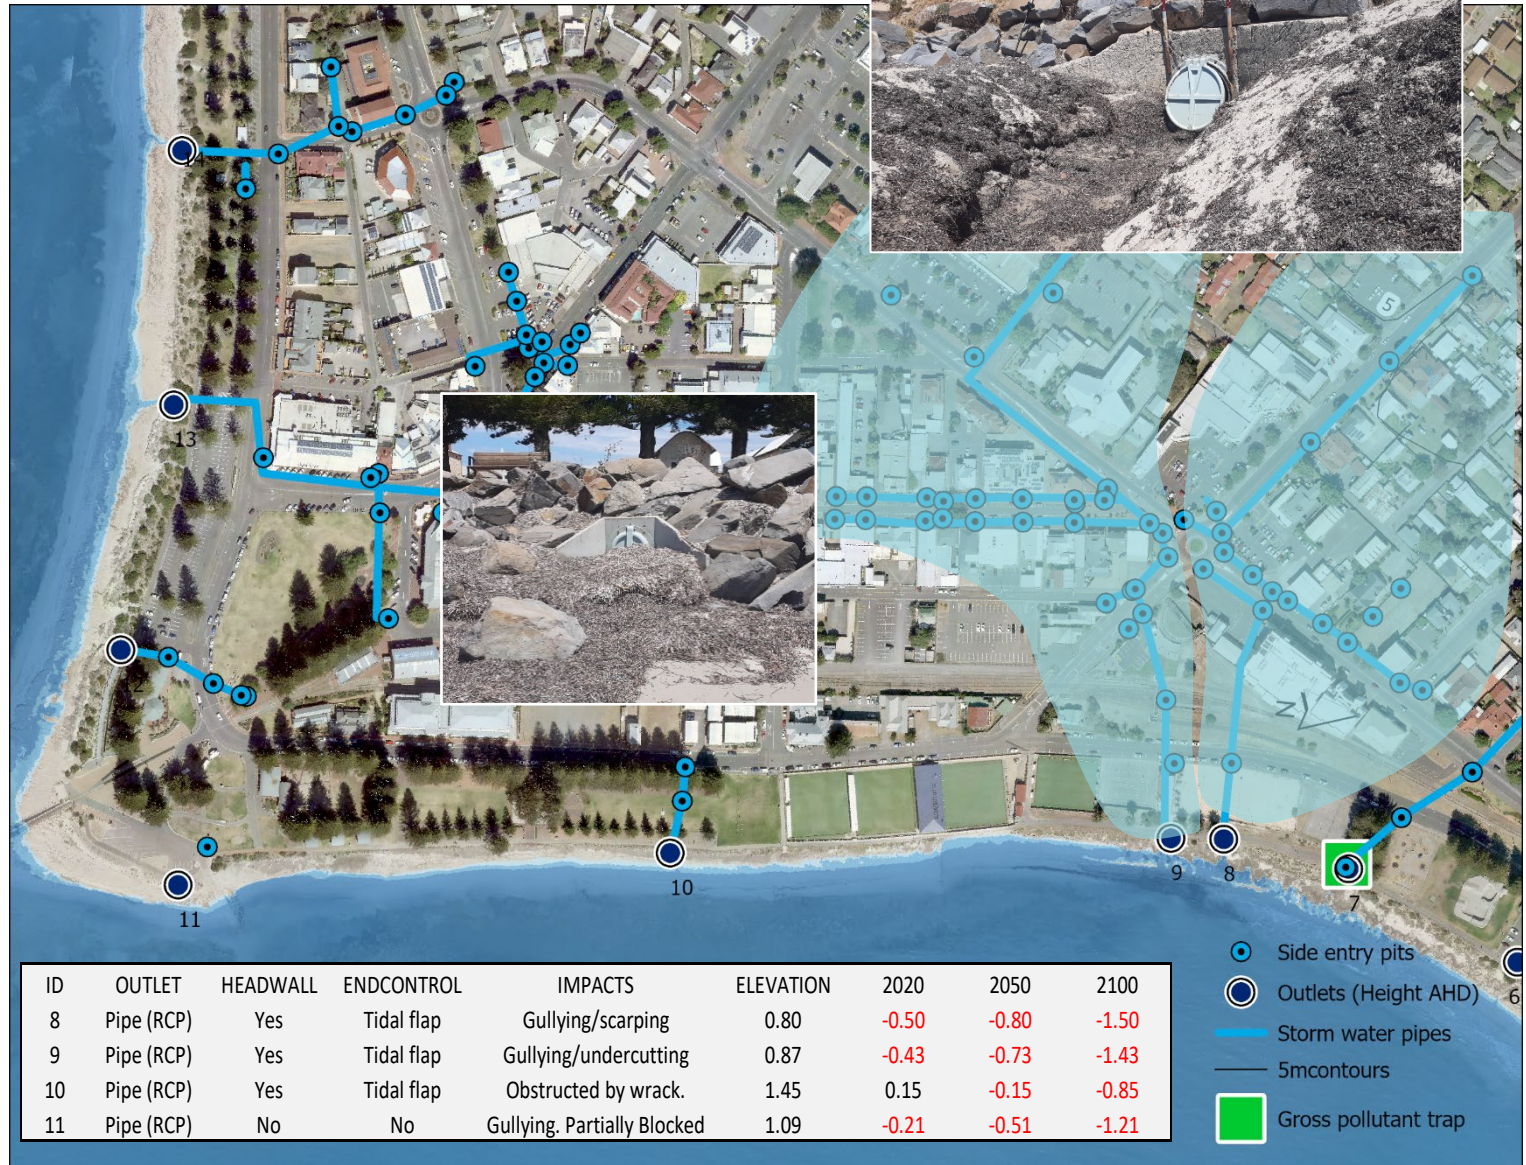
It is difficult to conceive that the current design will manage projected sea level rises of 0.30 by 2050 and 1.00 by 2100.

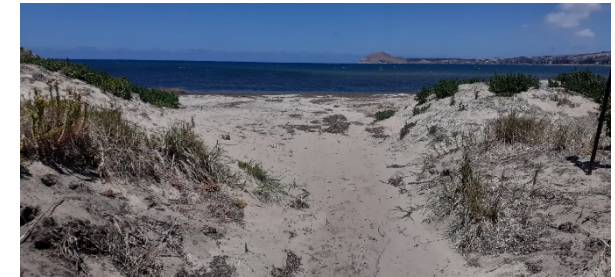
Figure a. Dunes cannot be built and consolidated in the gaps where storm water flows which will be the points in which increasing sea levels will flow and cause the rapid breakdown of the dunes.

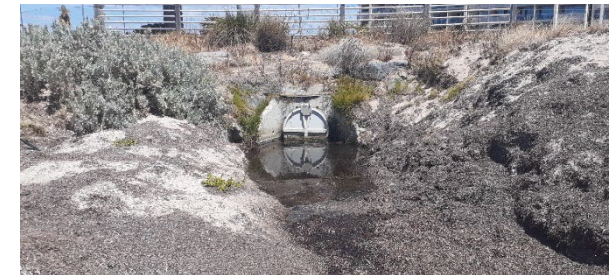
Figure b. Outlets along Flinders Parade are set at very low elevations. Increasing sea levels will increase the times at which these tidal flaps are closed and increase the risk that flooding will be exacerbated within the township.

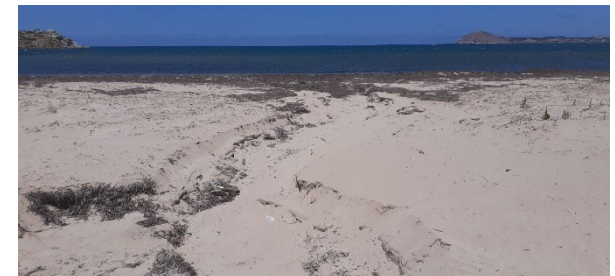
The assessment was undertaken in February at a time of low rainfall. However, significant gulying was observed on The Esplanade Beach (Figure c). Along

Figure c. Gulying on The Esplanade Beach. In the context of sea level rise, increasing actions of the sea will impact these areas first and break down the dunes in the backshore.

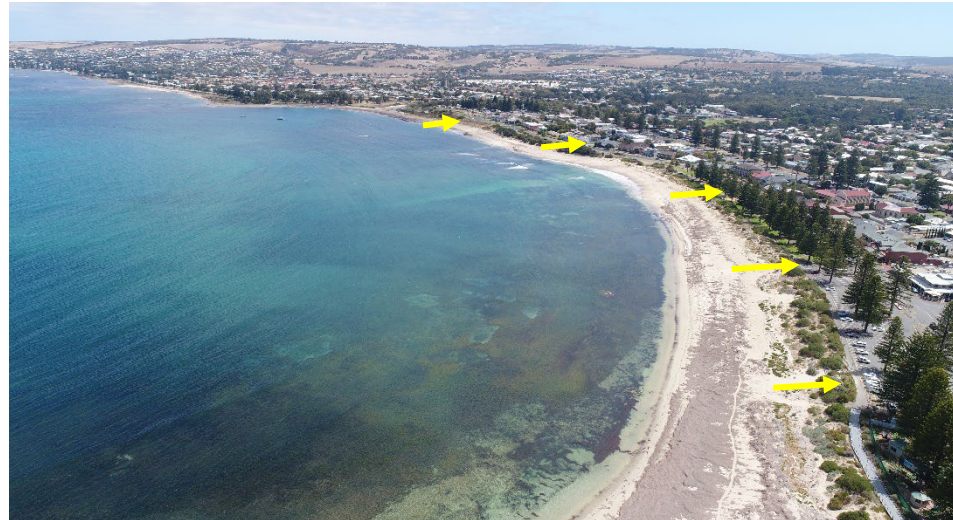
Figure a. The Esplanade Beach – erosion in the second half of this century is likely to impact carpark, reserve, visitor centre.

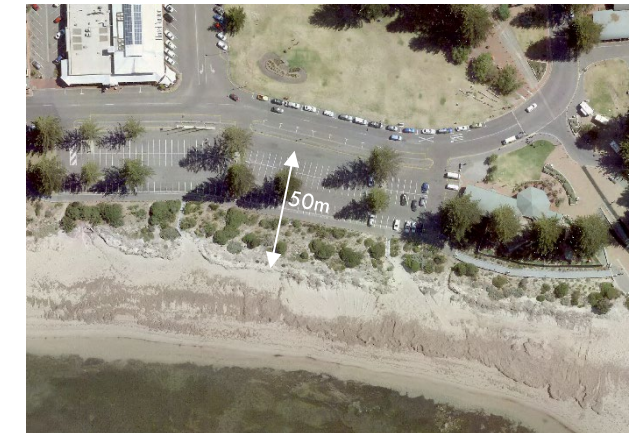
There are two main legacy issues. The first is the installation of carparking, buildings and to a lesser extent the Norfolk Pines and infrastructure within Memorial Gardens. These act as hold points to prevent the dune system from receding as it would do naturally in the context of rising sea levels. The carpark is positioned ~20m from the highwater mark and the pathway adjacent the visitors centre is 12-13m. The second legacy issue is the installation of four storm water outlets in the 1940s that are positioned at the rear of the existing dune system. It is impossible to build a stable dune system when storm water flows scour and channel the beach, and into these gaps tides routinely flow.

Figure b: Legacy issues- the carpark constructed ~20m from the highwater mark and storm water outlets that prevent a stable dune system from being established on the beach.

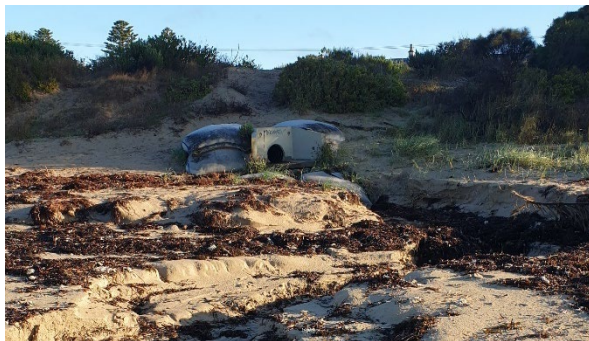
However, one of the problems associated with this technique is that the storm water outlets prevent the seaweed wrack, or any other imported sand, from being disbursed evenly along the beach which could create a consolidated dune (Figure a). This management technique, while managing the seaweed wrack, has limited long term usefulness for building and stabilising a dune system when storm water and seawater flows through the dunes. Furthermore, if seas rise as projected then the storm water outlet locations will be the most vulnerable to incursions from the sea.

Figure a: Flows from storm water outlets placed at the back of the beach prevent a consolidated and well vegetated dune from being built which could act as a natural defence in the context of rising sea levels.
