Coastal Adaptation Study &
Coastal Adaptation Strategy

VICTOR HARBOR CENTRAL

Cell
Fleurieu 11

For City of
Victor Harbor

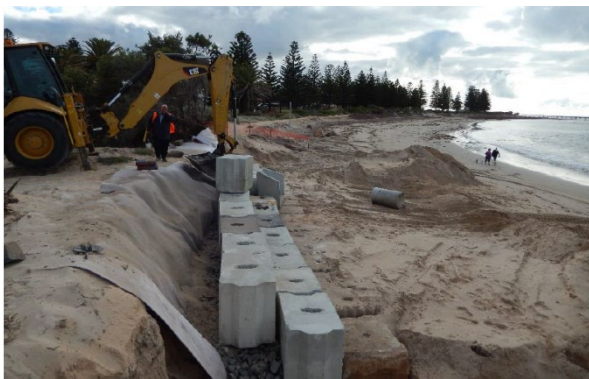
From a geomorphological perspective, the advantage of the concrete block seawall approach is that it is less intrusive in the backshore, it can be covered with sand and vegetated, and a more natural beach profile maintained. However, from an engineering perspective, Magryn and Associates advised: 'Where wave effects are higher, the rock revetment wall is the preferred protection solution. Randomly stacked rock armour is more effective to dissipate wave energy and has been utilised in other nearby locations. The concrete block wall option may be suitable in sheltered areas with minimal wave action. A more detailed wave analysis is required during the design phase, to confirm viability. The intent is for sand to be backfilled over the concrete blocks, establishing a more natural beach/dune. However, if wave action erodes the sand, the concrete block may be exposed to wave action. Waves tend to reflect off vertical faces such as this, which may lead to further erosion'.

Figure a: Concrete block seawall installed within the dune and covered over with sand (Coast and Marine Branch, email, 2021).
